DOT	US Department of Transportation
PHMSA	Pipeline and Hazardous Materials Safety Administration
OPS	Office of Pipeline Safety – Accident Investigation Division
Principal Investigator	Wesley Mathews
Acting Accident Investigation Director	Chris Ruhl
Date of Report	May 26, 2022
Subject	Failure Investigation Report - Denbury Gulf Coast Pipelines, LLC – Pipeline Rupture/ Natural Force Damage

Failure Investigation Report – Denbury Gulf Coast Pipelines LLC

Pipeline Rupture/Natural Force Damage

February 22, 2020

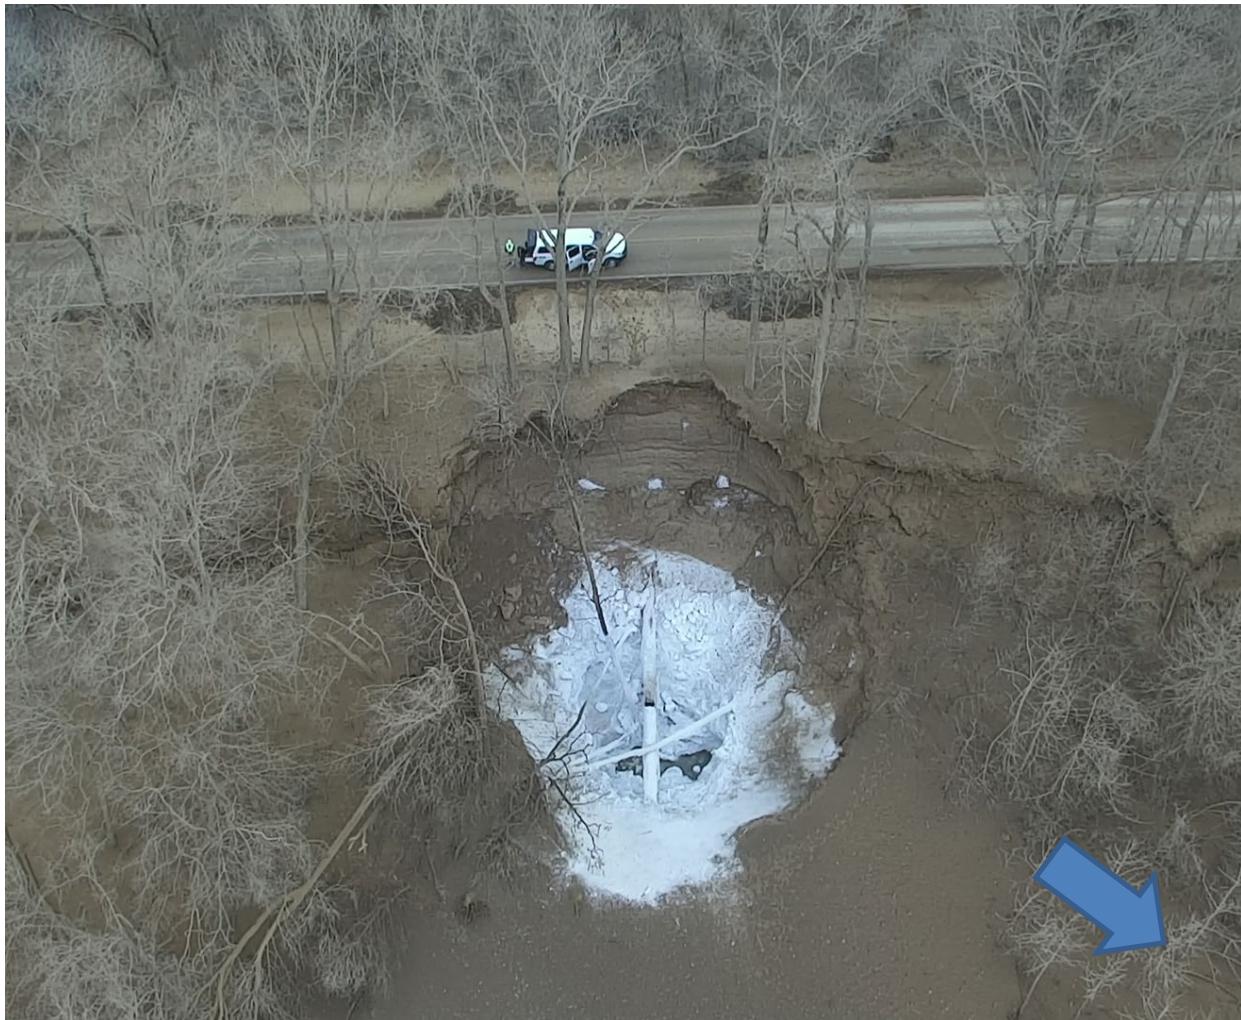
On February 23, 2020, at 10:09 a.m., a PHMSA AID investigator from Oklahoma City arrived at the intersection of HWY 433 and Highway 3 to meet with Denbury representatives and emergency response organizations. The group then proceeded to the site of the rupture (Figure 2). By that time, the IC had demobilized, and roadblocks had been removed. Denbury crews were in the process of setting up caution fencing and slowing traffic on HWY 433 for public and worker safety. The rupture crater was on the northeast side of HWY 433 (Figure 2).

*Figure 2: Vehicle is Parked on HWY 433 - The White is Ice Generated by the Release of CO₂ - The Blue Arrow Points North
(Aerial Drone Photograph Courtesy of the Mississippi Emergency Management Agency)*

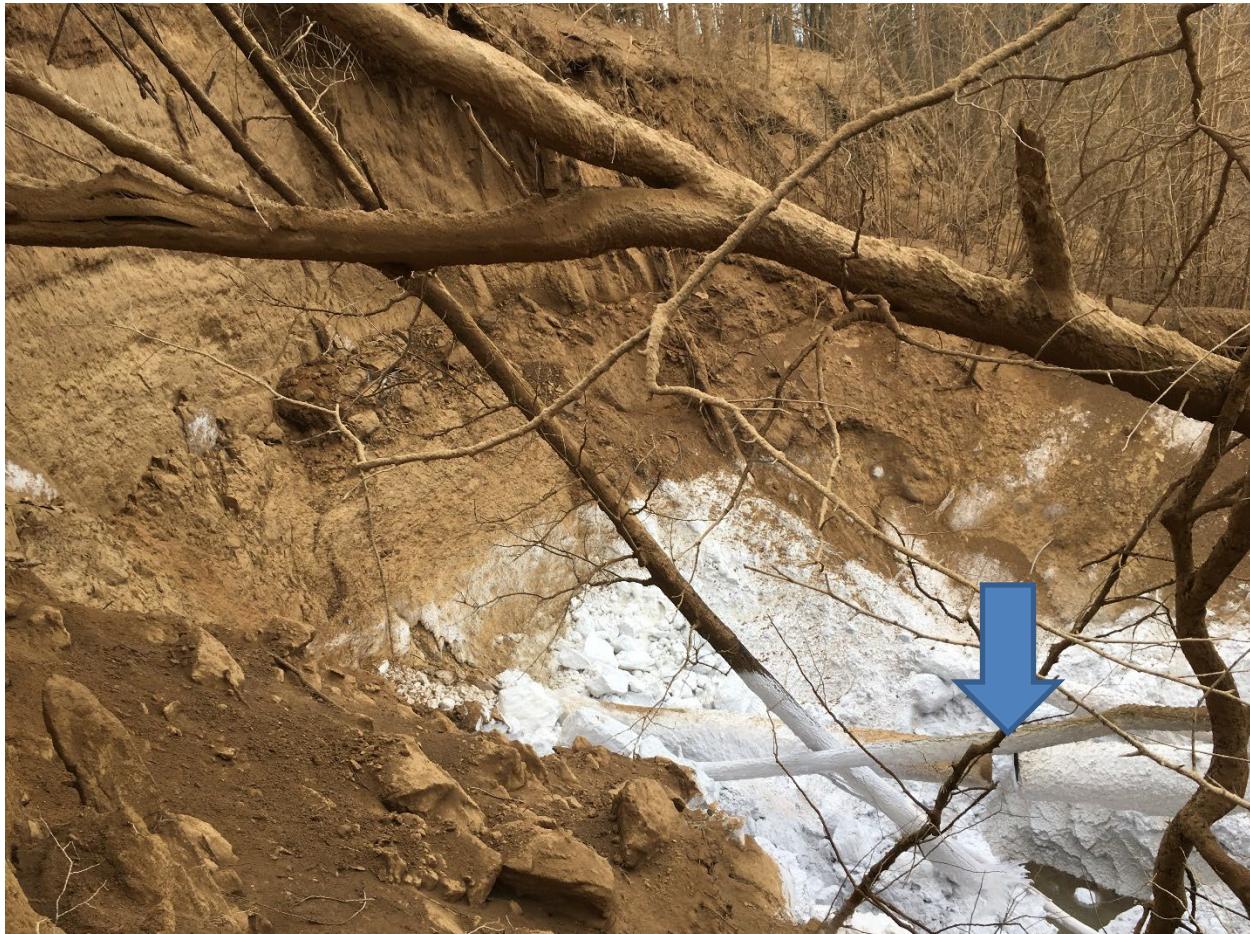
*Figure 3: Crater Created by the Rupture Containing Fallen Debris (dry ice, and the failed pipe sections)
(Blue Arrow is Pointing at the Pipeline Separation)*

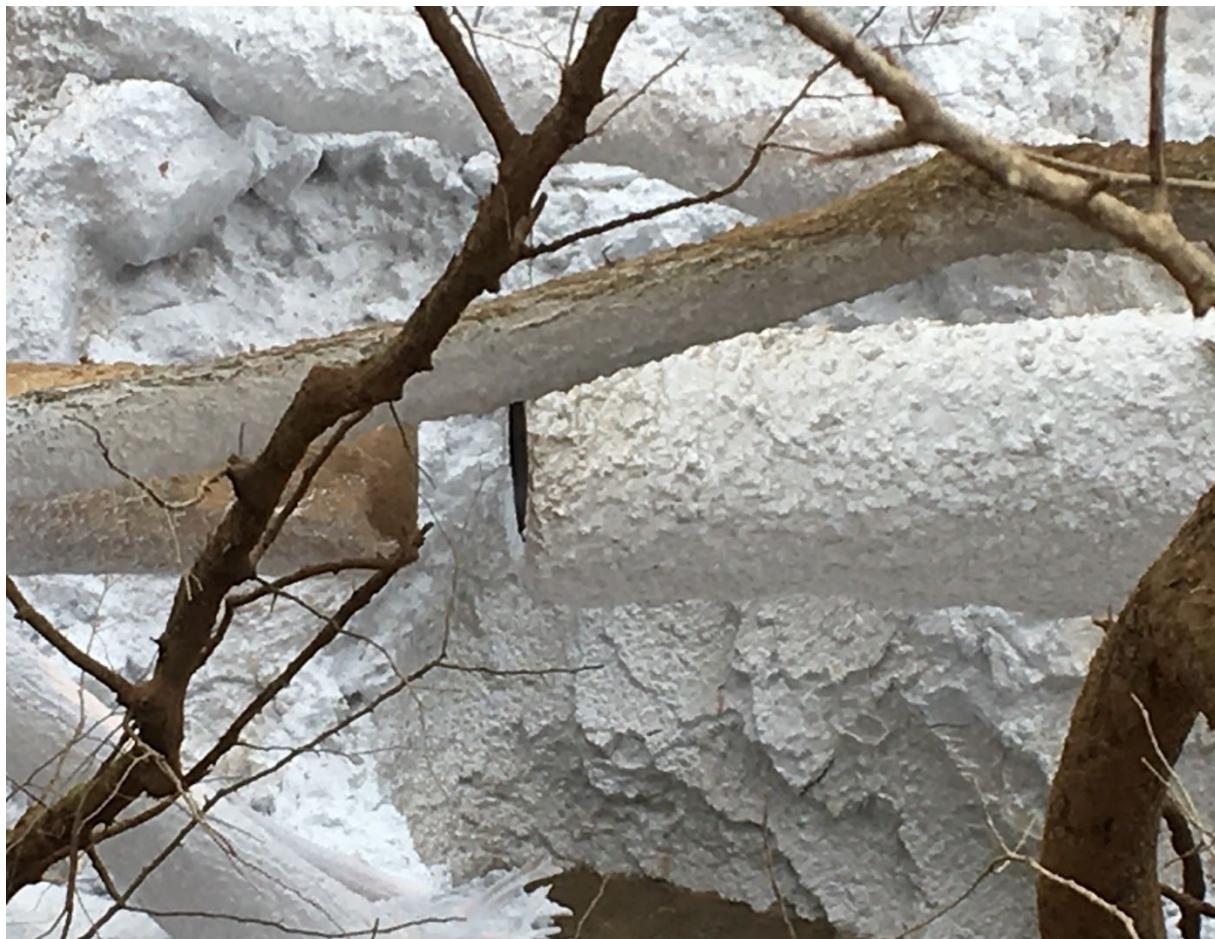
Figure 4: The failed pipe sections shown separated by a few inches.

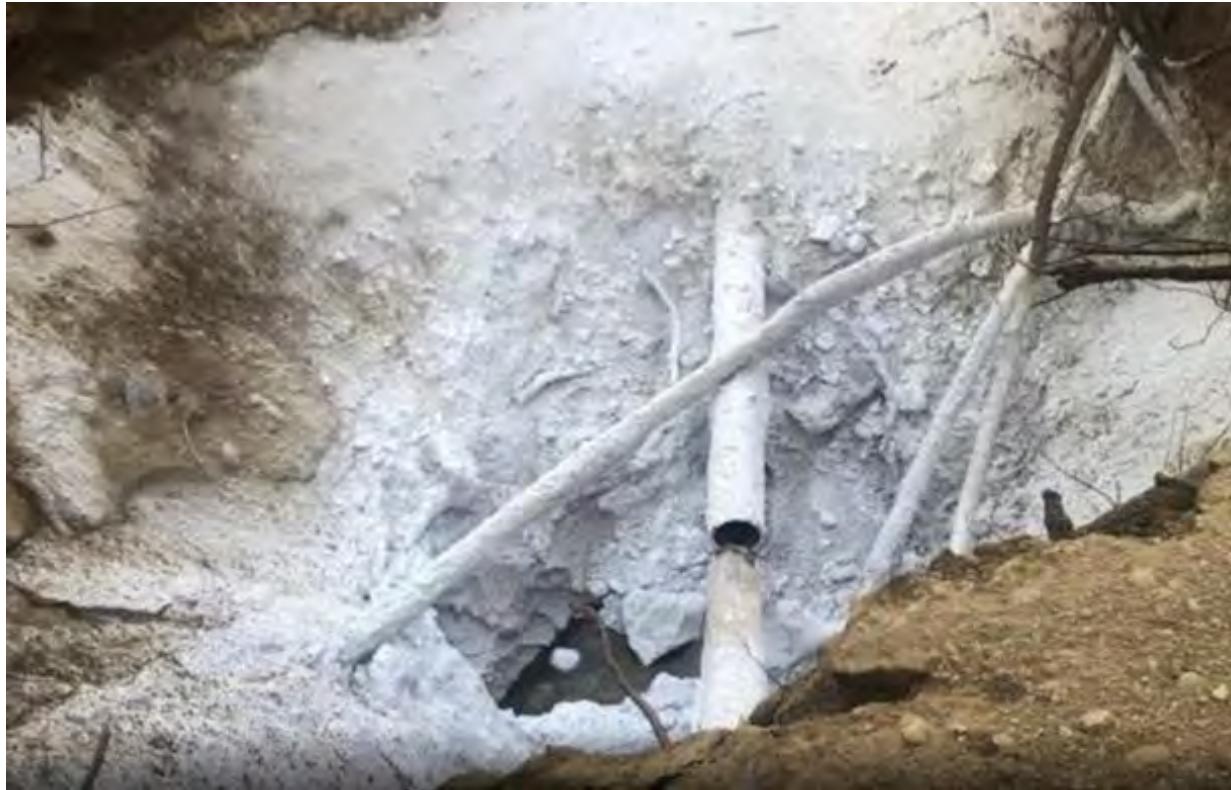
Figure 4. Post-Incident Photo of Failure Location (Downstream to Upstream)

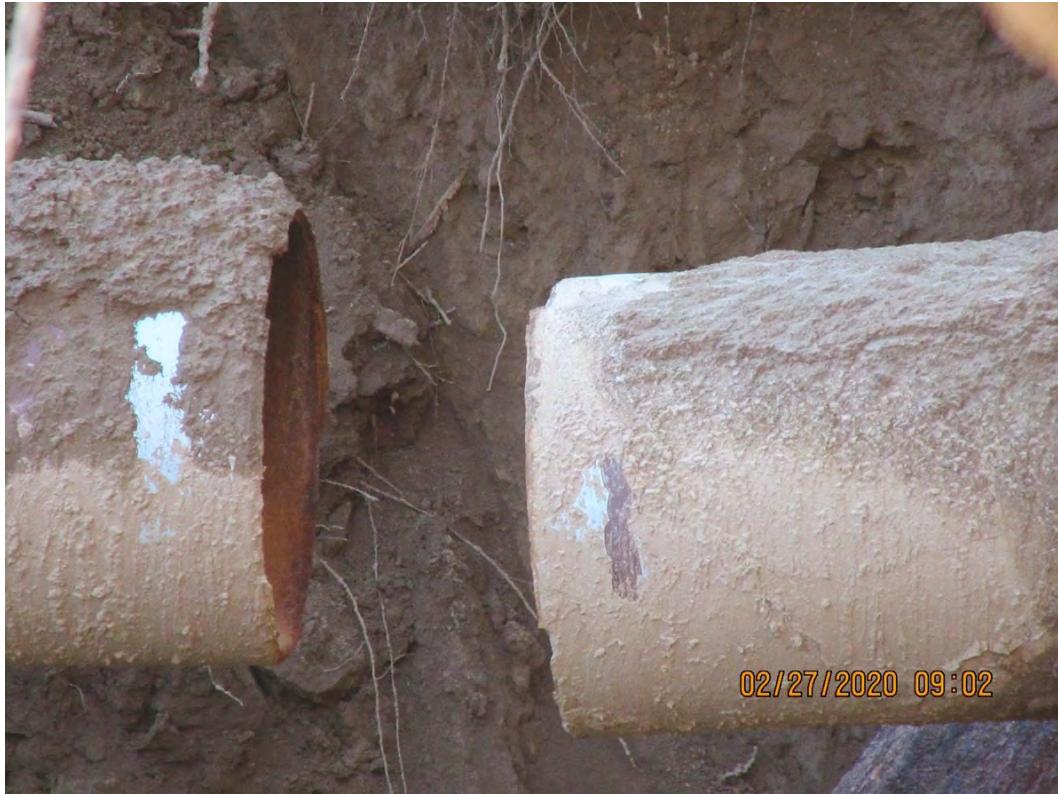
In-situ visual inspection of the exterior surface of the pipe identified a separation of the piping at a girth weld of approximately 8 inches, with slight misalignment between the upstream and downstream joints. Figure 8 provides a close-up of the as-found pipe and coating condition at the separation.

Figure 8. Delhi 24-inch Transmission Line Failure - As-Found Condition at Girth Weld

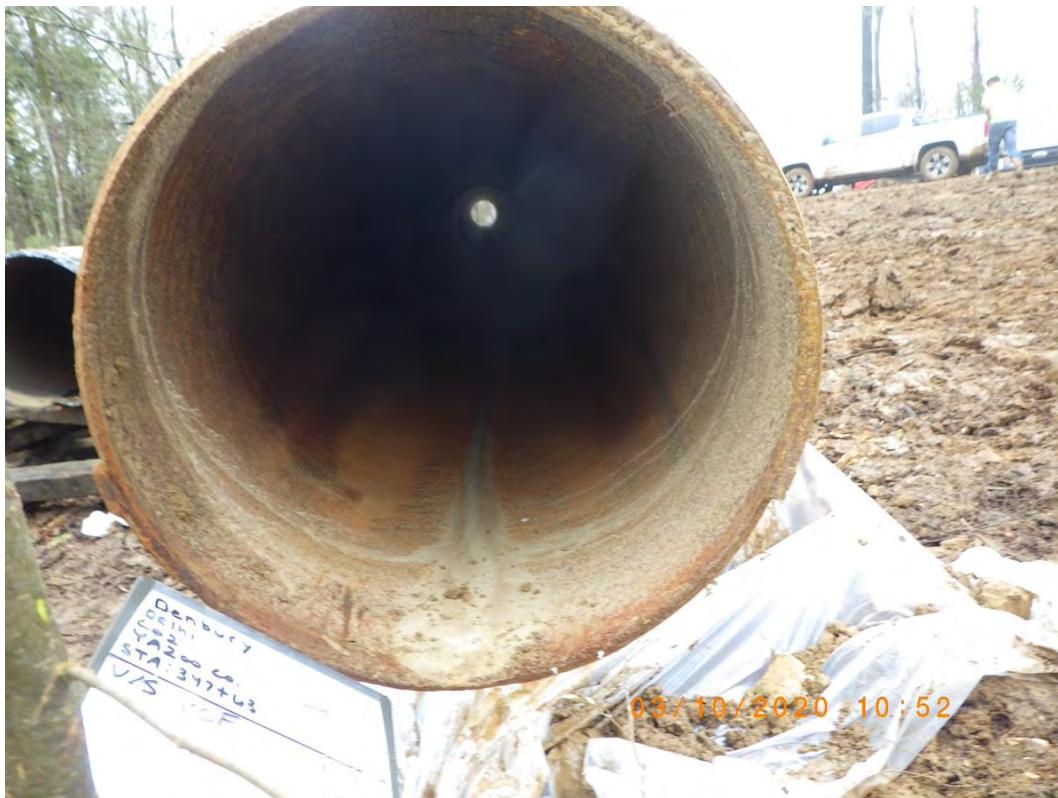
Initial visual inspection of the internal surface of the piping showed no accumulated solids or liquids in the pipe sample and no indications of pitting or corrosion. A view of the internal condition of the pipe section containing samples B & C after removal is provided in Figure 11.

Figure 11. Internal Condition of Pipe Sample During Removal

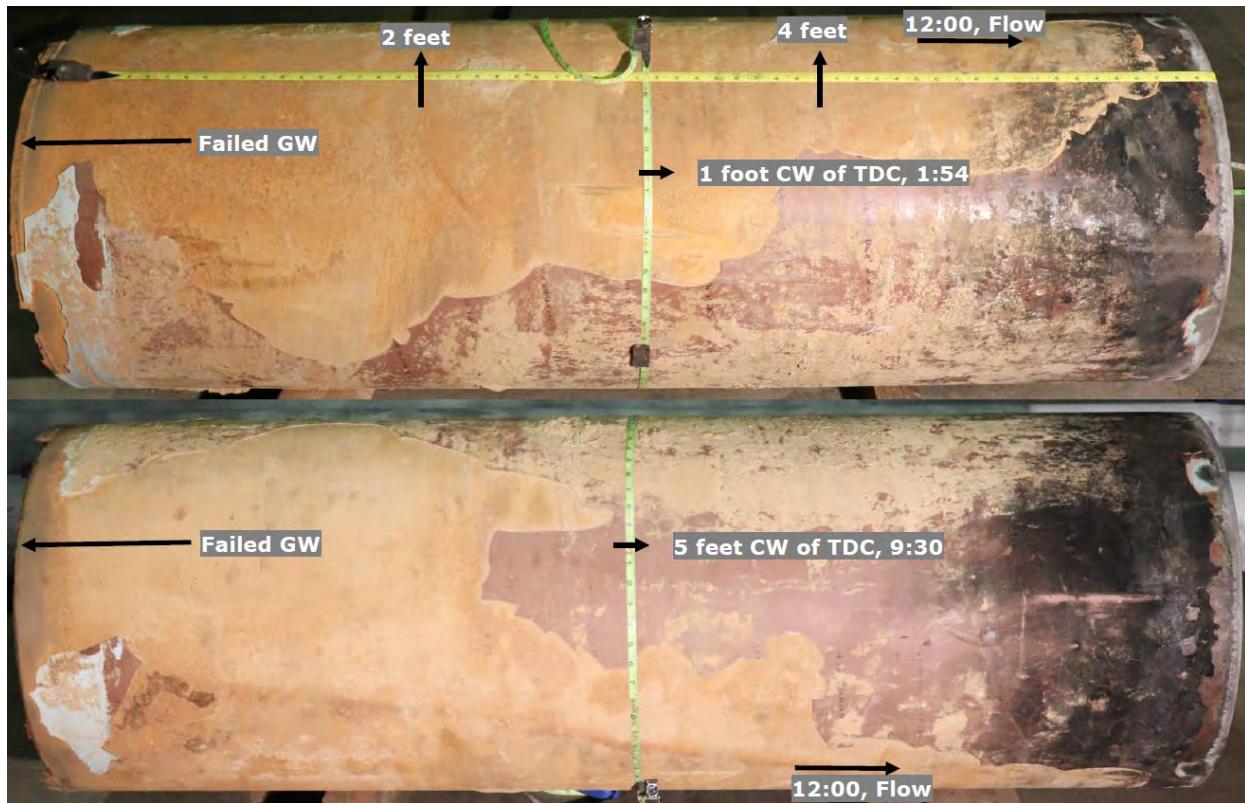
Figure 12. Pipe Sample A (PS A)

The pipe adjacent to the fracture surfaces and failed girth weld were visually inspected. The fractured surface was flat and generally at a 180-degree angle with no thinning and/or reduction of the affected area. The fracture path traversed or crossed over the weld at various locations.

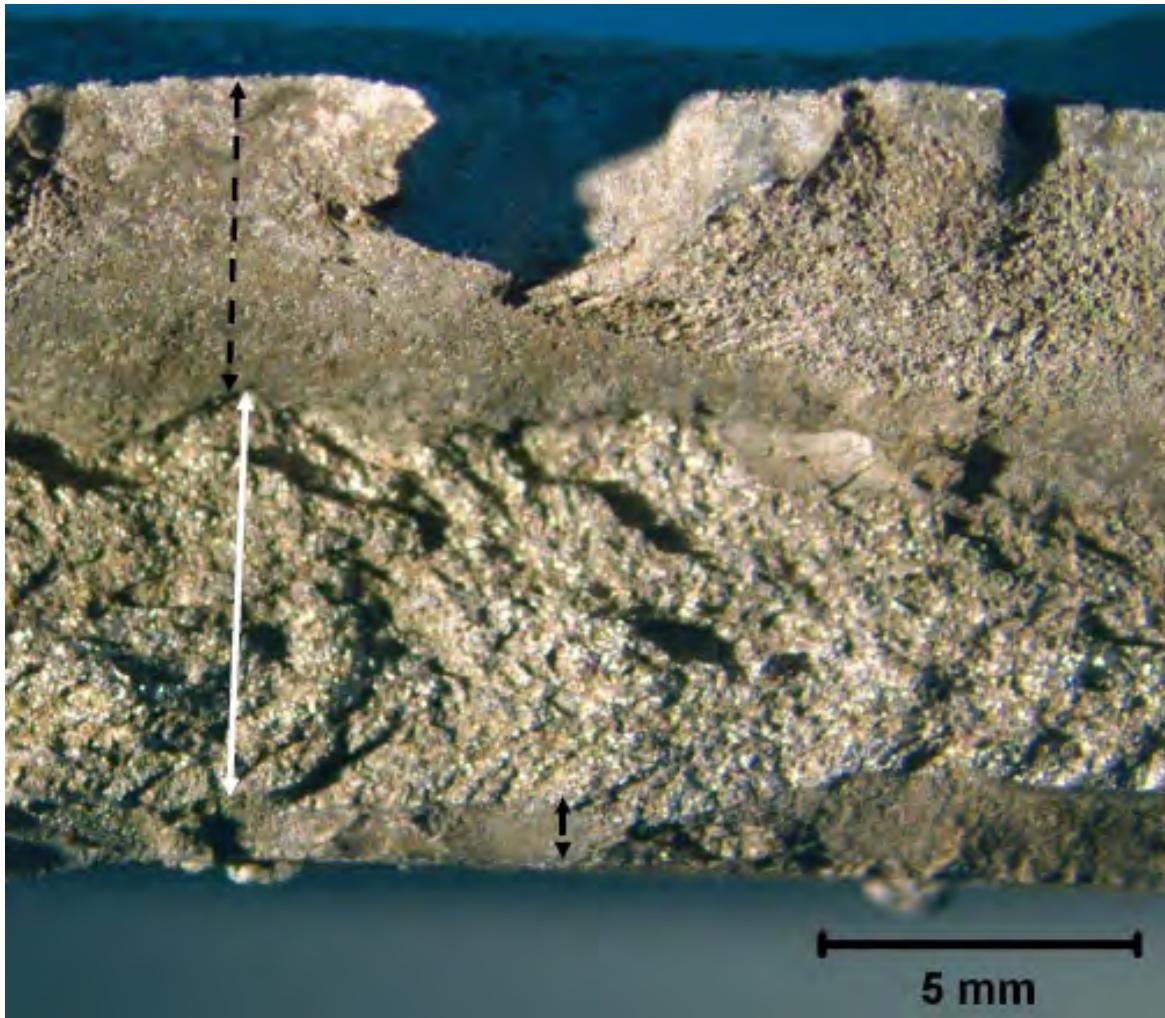
The internal and external surfaces of the failed girth weld were cleaned with a soft bristle brush to for more detailed examination. Five areas were selected for metallurgical analyses of the failed girth weld (PS A, PS B) and one area from the intact girth weld in PS C. The fracture surface consisted of smooth regions and rougher surfaces that varied in thickness throughout the rupture face. An example of these regions is provided in Figure 17. There was no evidence of pre-existing manufacturing flaws. It was not possible to determine the exact location of the failure initiation process due to the lack of chevrons on the fracture surface.

Figure 17. Image of Sample S2 - Smooth (Black Arrow) and Rough (White Arrow) Regions

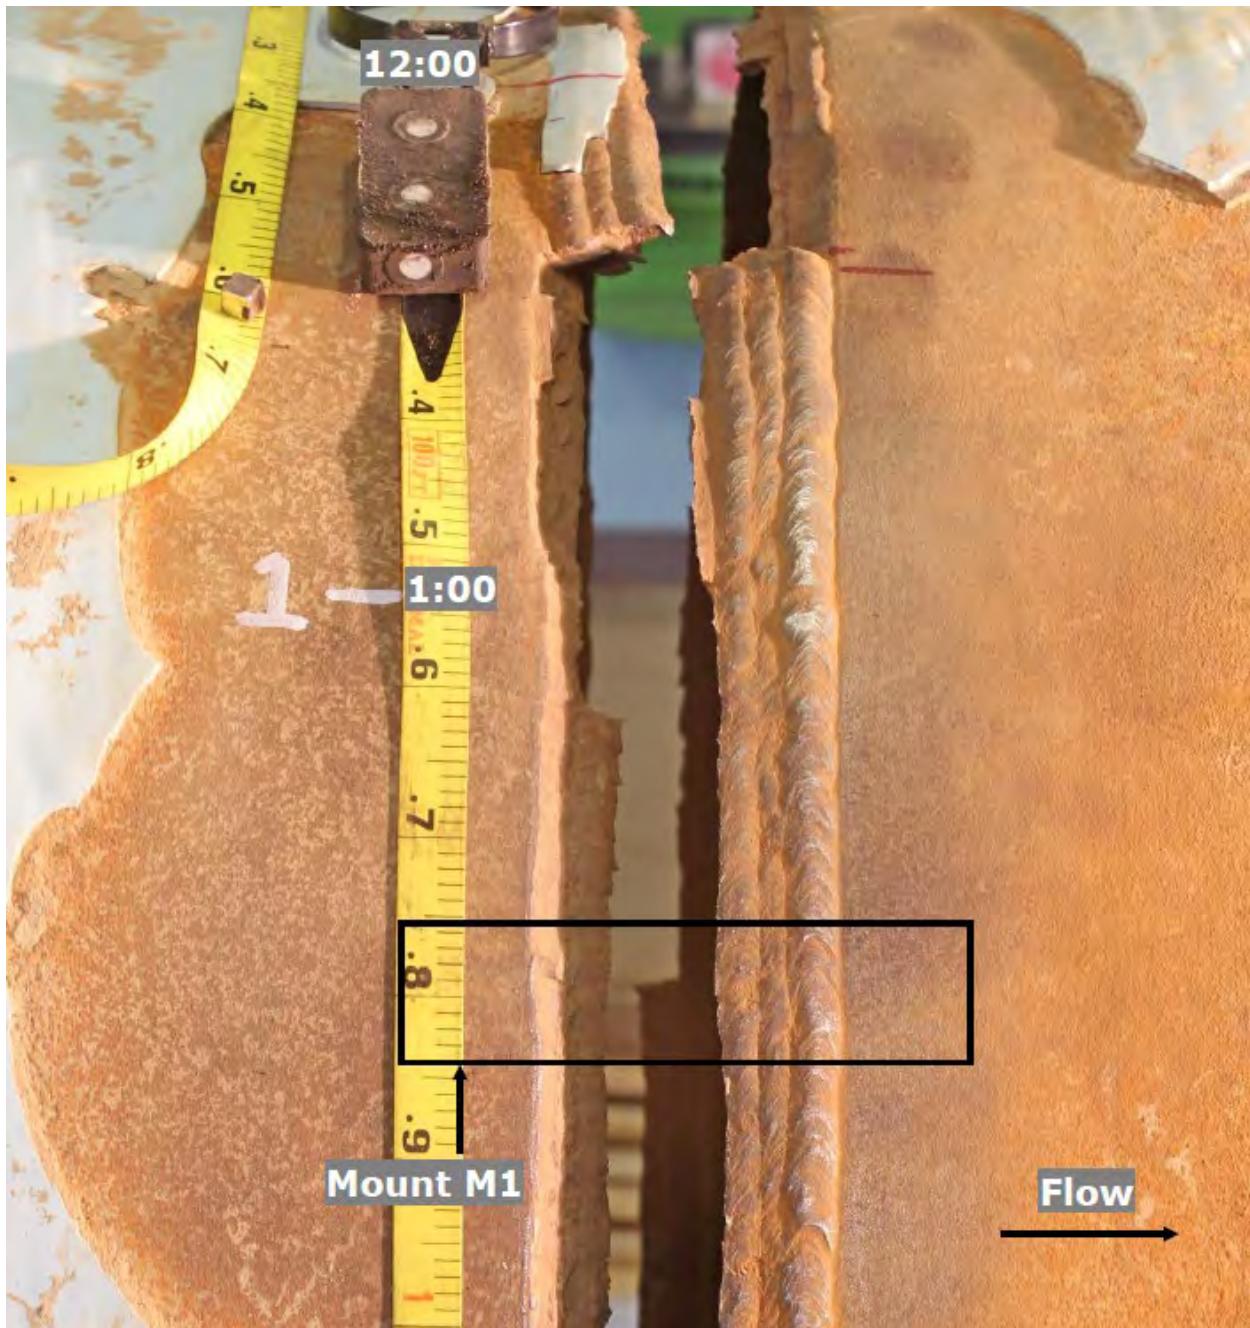
Figure 19. Overview of Mount M1

Sample M1 contains a fracture path at a shear angle. This sample was removed from the girth weld at the 1:35 o'clock orientation (see Figure 19).

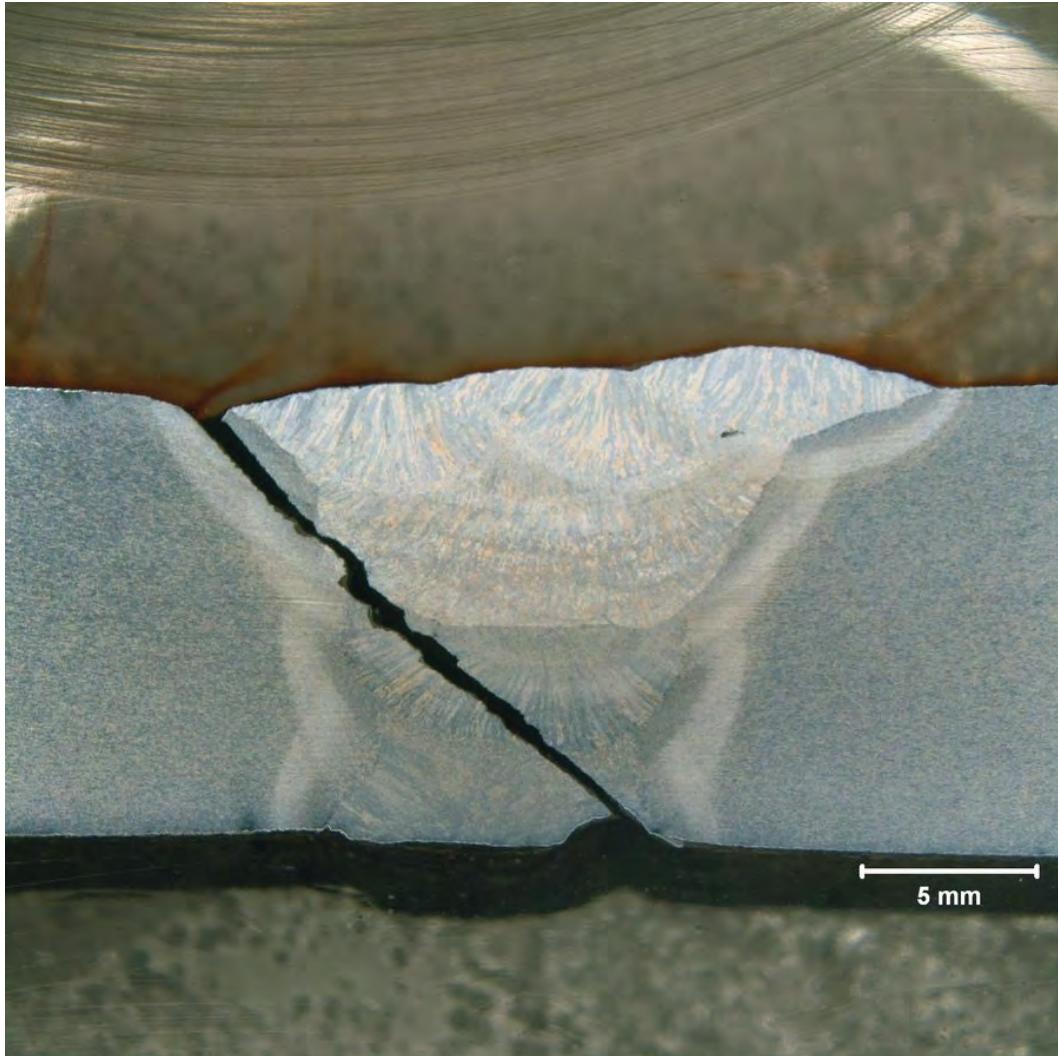
The fracture path of this sample is located in the HAZ near the toe of the weld at the OD surface. An image of the cross section of sample M1 is provided in Figure 20.

Figure 20. Representative Cross-Section from Sample M1

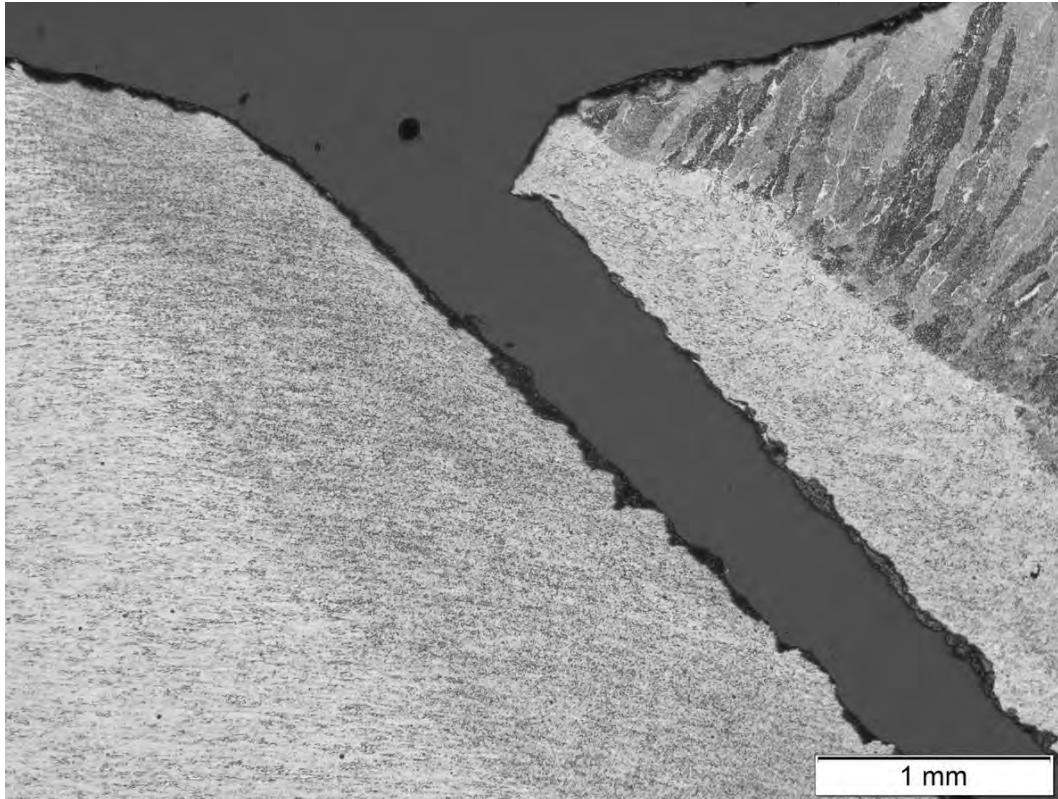
Figure 21. Close-Up of Sample M1

There is no indication of excessive porosity and/or inclusions. It shows a slight misalignment of the high-low weld of approximately 4.3% of the NWT. Higher magnifications are provided in the laboratory report which show grain elongation due to the cold work that took place during the rupture process. This is consistent with ductile overloading. The microstructure is typical of modern X80 line pipe. A close-up of sample M1 is provided in Figure 21.

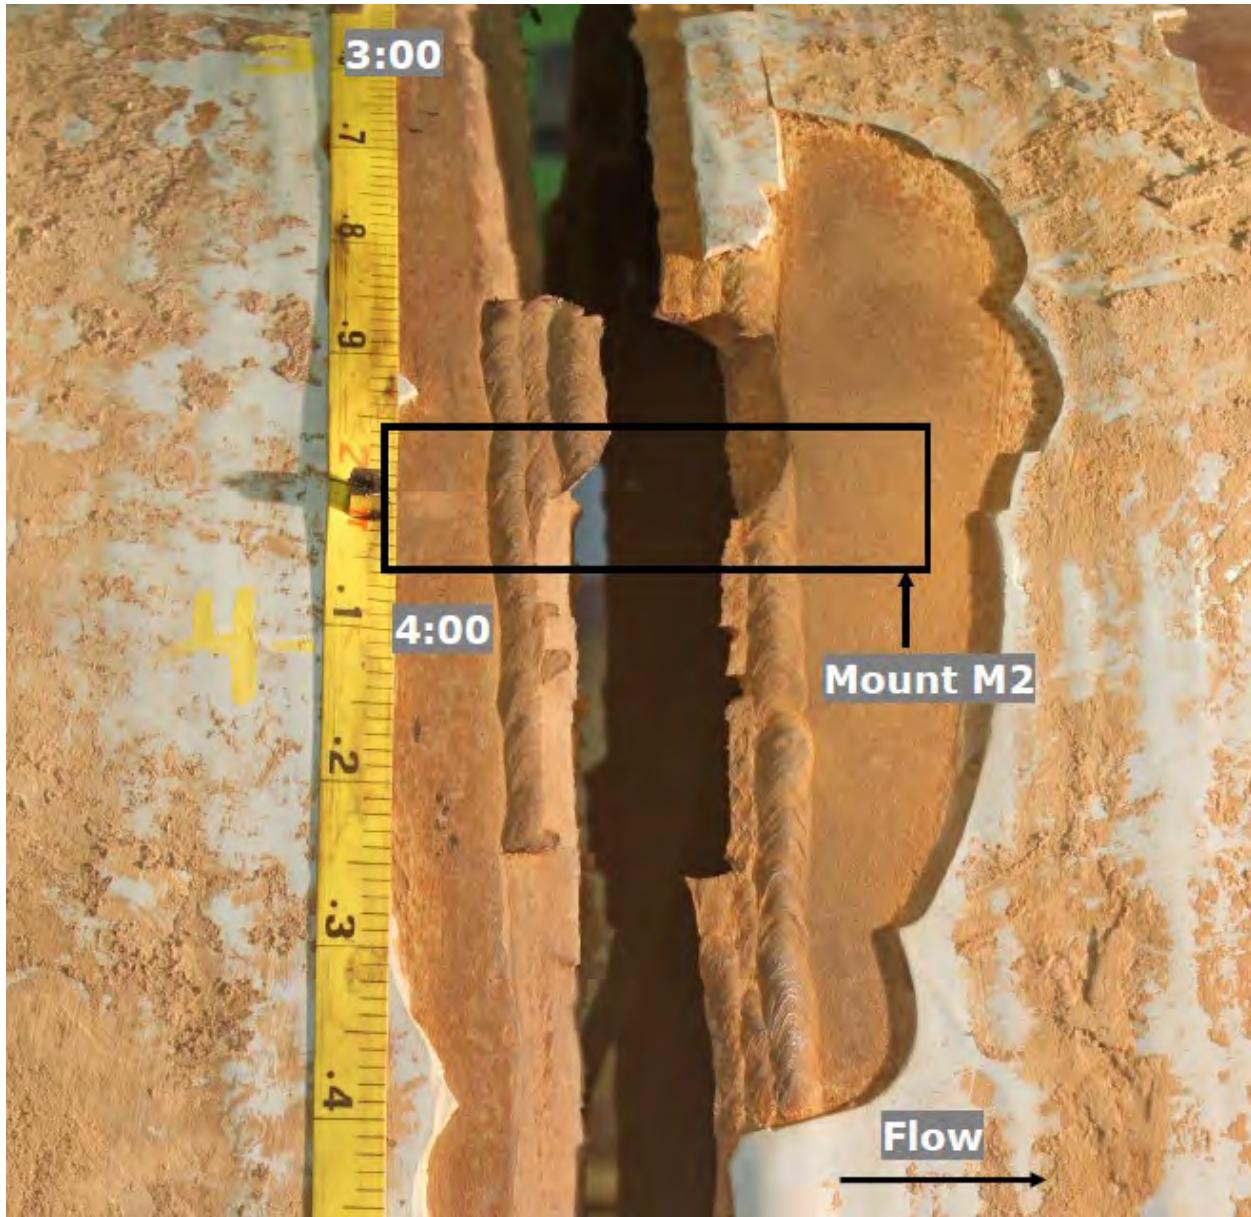
Figure 22. Overview of Mount M2

Sample 2 contains regions where the fracture path is perpendicular to the free surface and regions of shear failure. This sample was taken from the GW at the 3:55 o'clock orientation (see Figure 22).

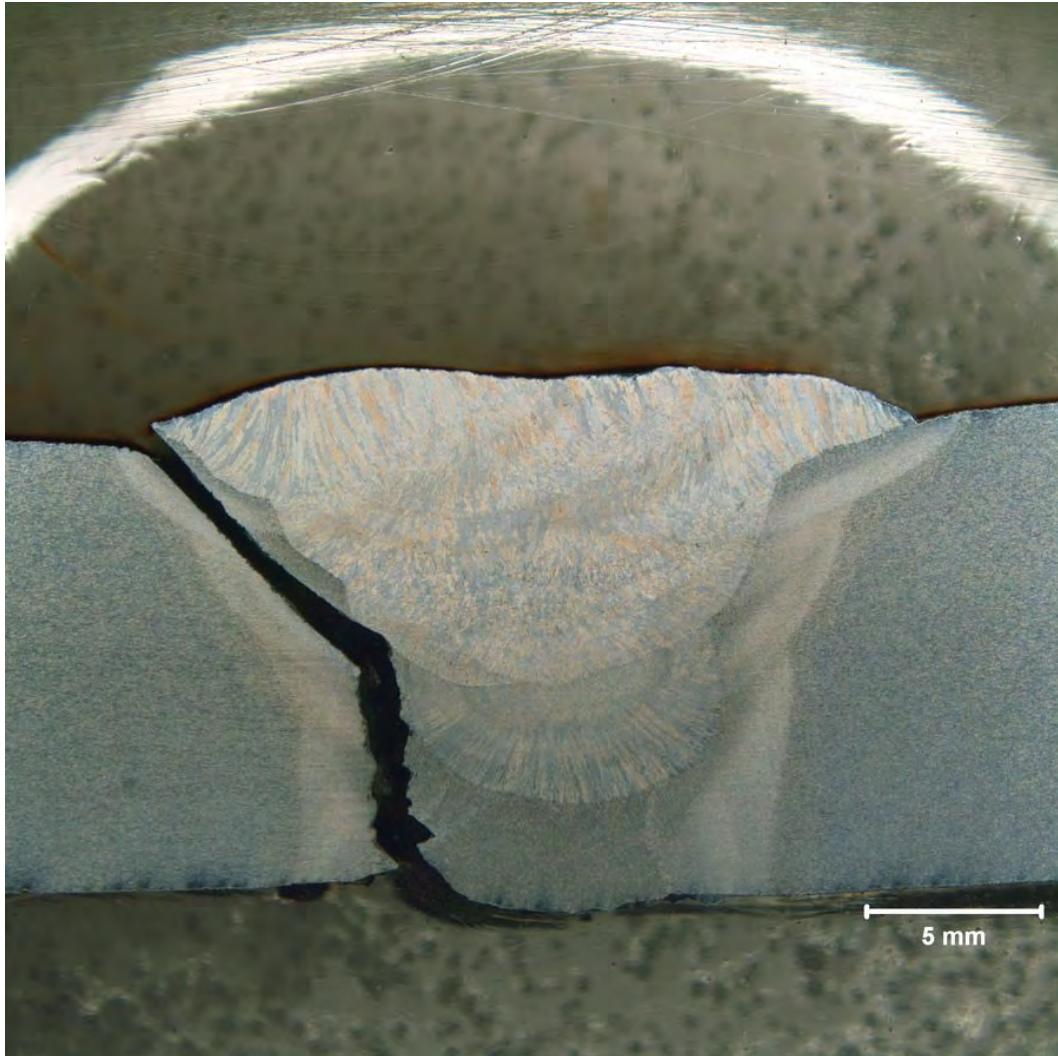
Figure 23. Representative Cross-Section from Sample M2

The cross section of M2 includes both the weld metal and HAZ. The cross section of sample M2 is provided in Figure 23.

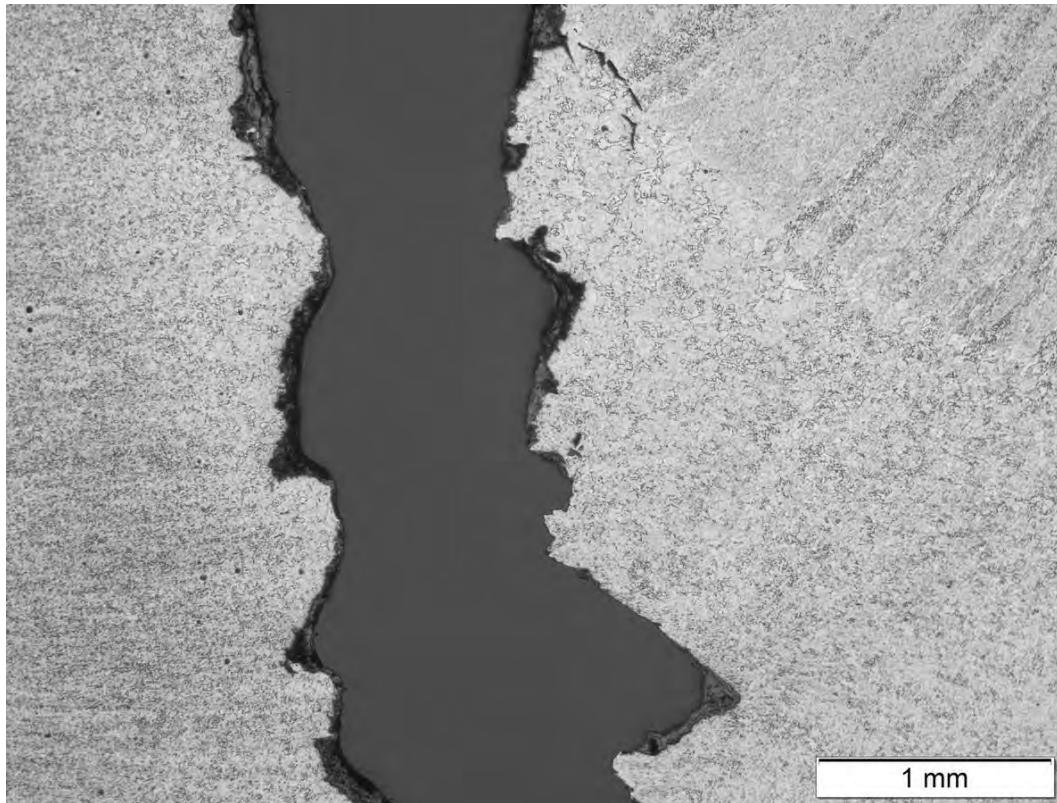
Figure 24. Close-Up of Sample M2

There are both smooth and rough regions in this sample. The high-low weld misalignment at this location is approximately 6.9% of the NWT. The fracture path at this location was mainly located at the HAZ. Fractography in the SEM shows the presence of a smooth region containing dimples (typical of ductile behavior) and cleavage facets (typical of brittle behavior) in the rough region. Some fissures were also found in the area where cleavage facets were located. These fissures are usually seen in girth weld overload areas (see Figure 24).

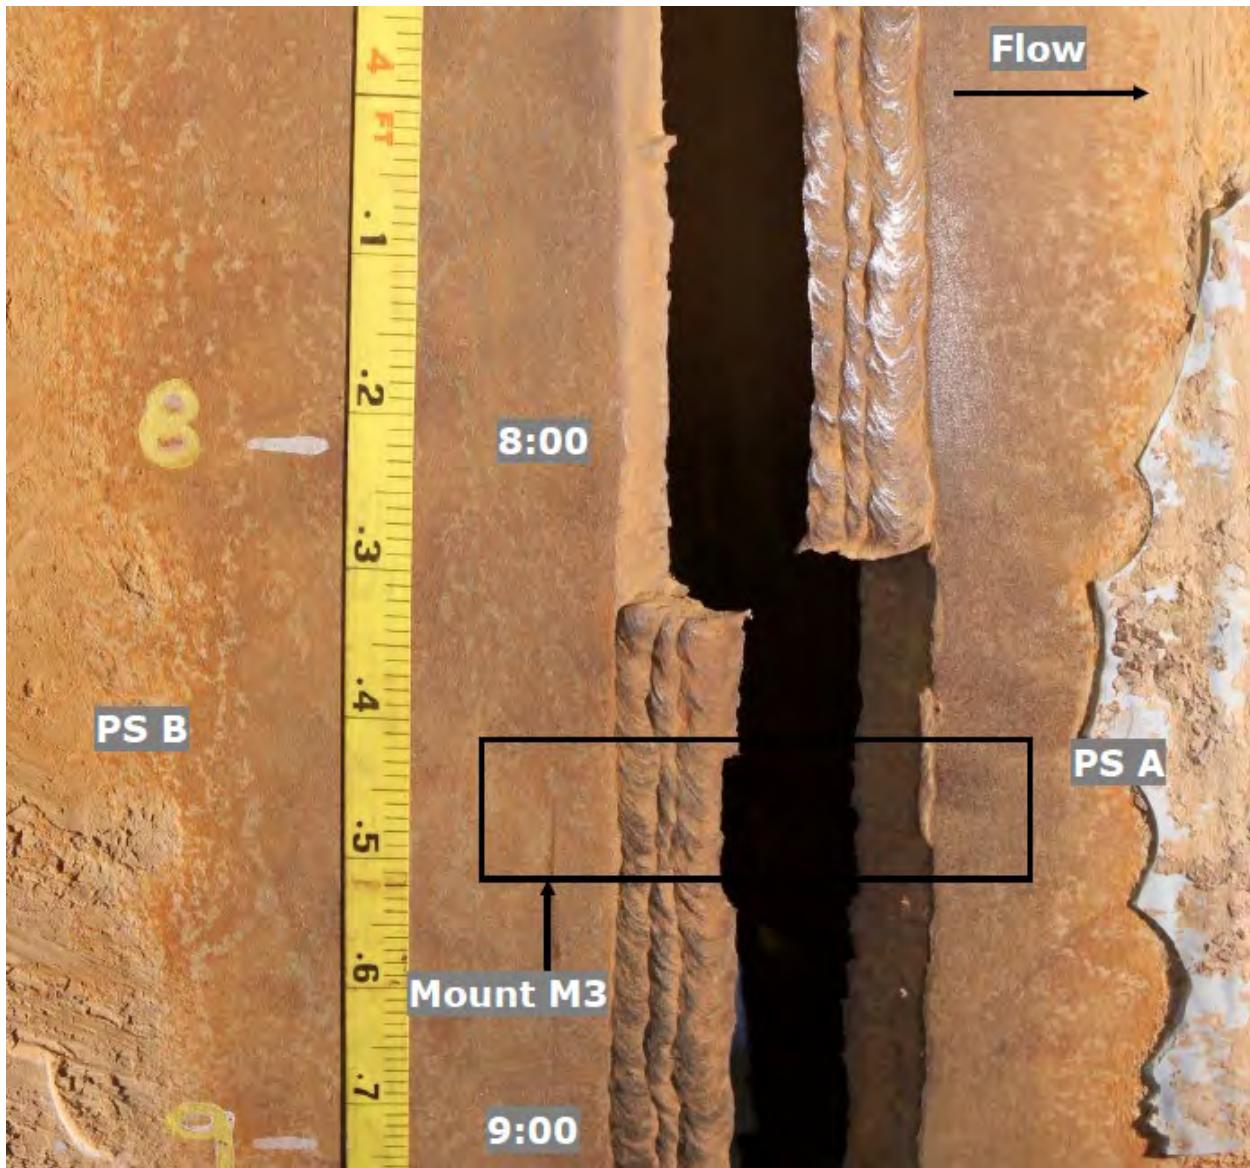
Figure 25. Overview of Mount M3

This sample was removed from the failed GW at the 8:35 o'clock orientation (Figure 25).

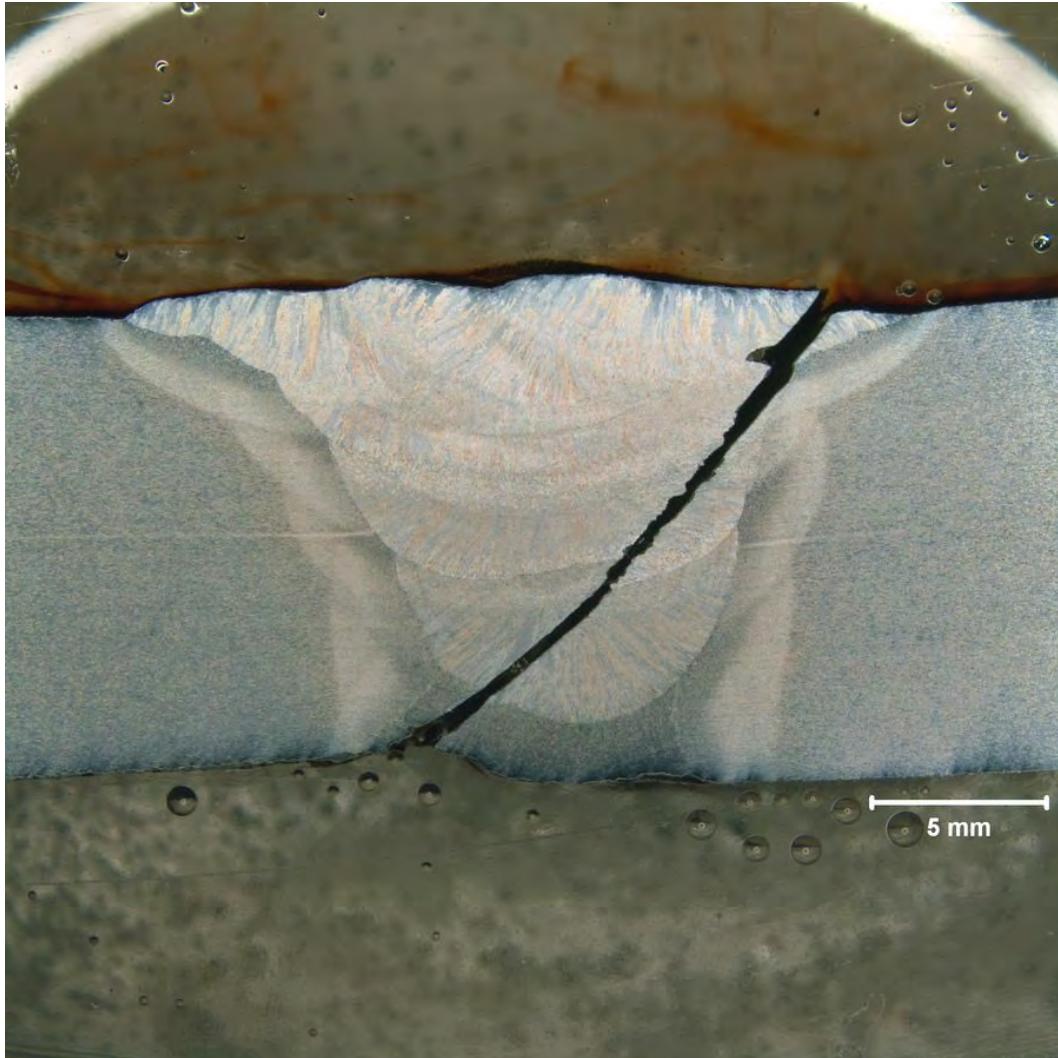
Figure 26. Location of Mount M3

The fracture path is at a shear angle and mainly located in the weld metal. The morphology of the weld is similar to samples M1 and M2. The high-low weld misalignment at this location was approximately 2.6% of the NWT. The microstructure is consistent with the findings in samples M1 and M2 (see Figure 26 and Figure 27).

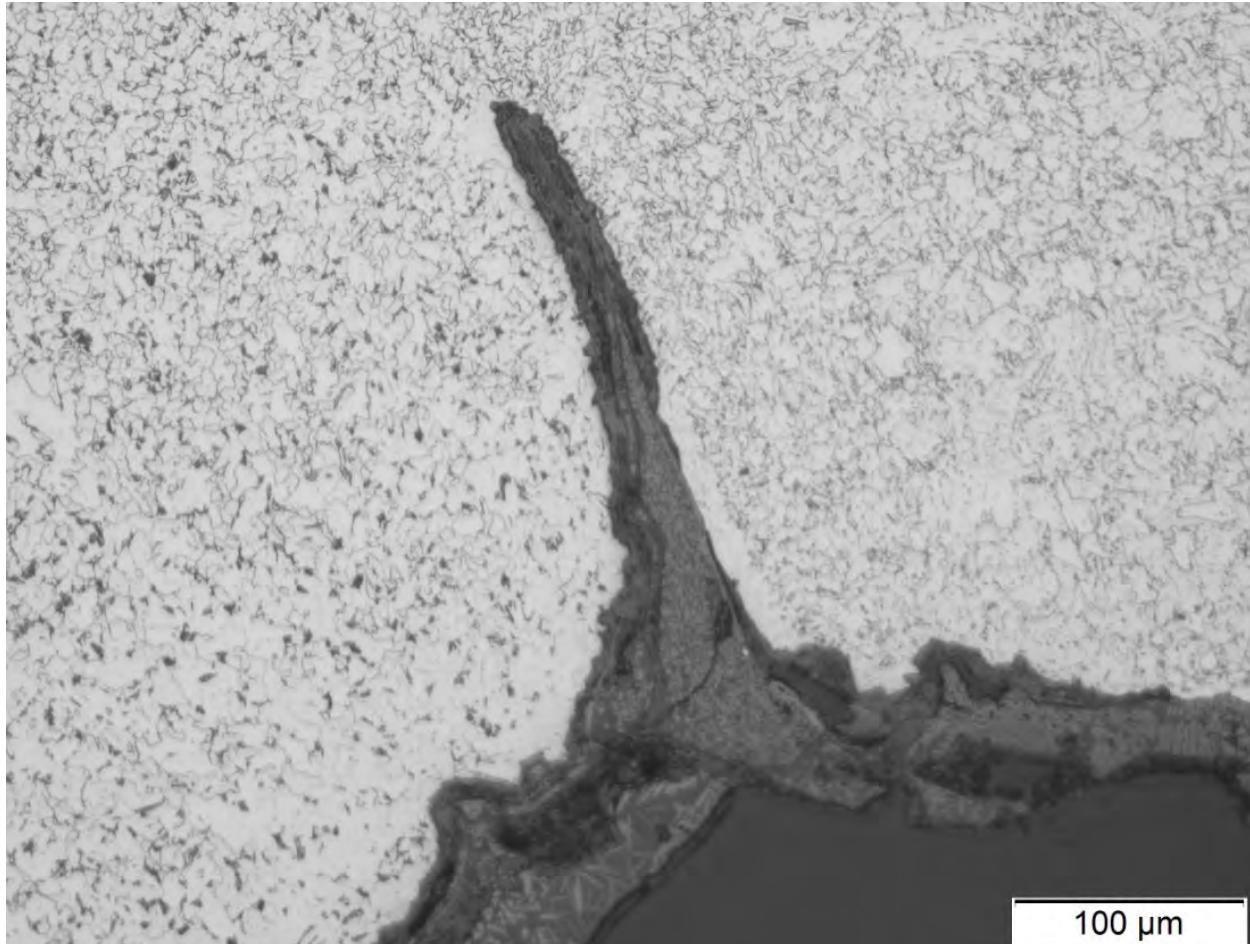
Figure 35. Close Up View of Sample MU1 Flaw

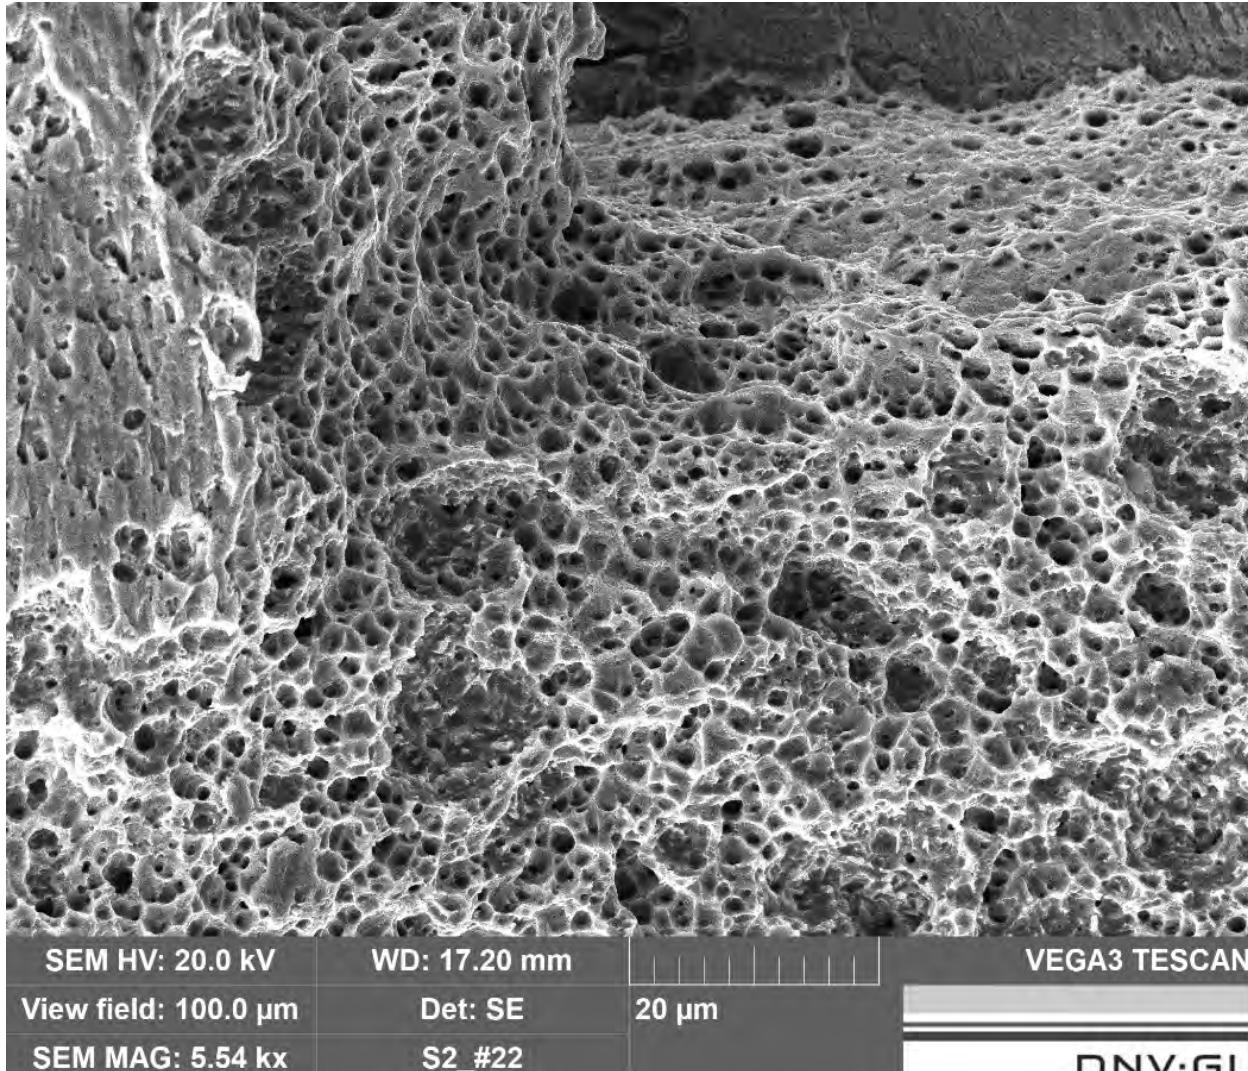
Figure 36. Sample S2 – Dimples Associated with Ductile Fracture
