DOT	US Department of Transportation
PHMSA	Pipeline and Hazardous Materials Safety Administration
OPS	Office of Pipeline Safety – Accident Investigation Division
Principal Investigator	Wesley Mathews
Acting Accident Investigation Director	Chris Ruhl
Date of Report	May 26, 2022
Subject	Failure Investigation Report - Denbury Gulf Coast Pipelines, LLC – Pipeline Rupture/ Natural Force Damage

Failure Investigation Report – Denbury Gulf Coast Pipelines LLC

Pipeline Rupture/Natural Force Damage

February 22, 2020

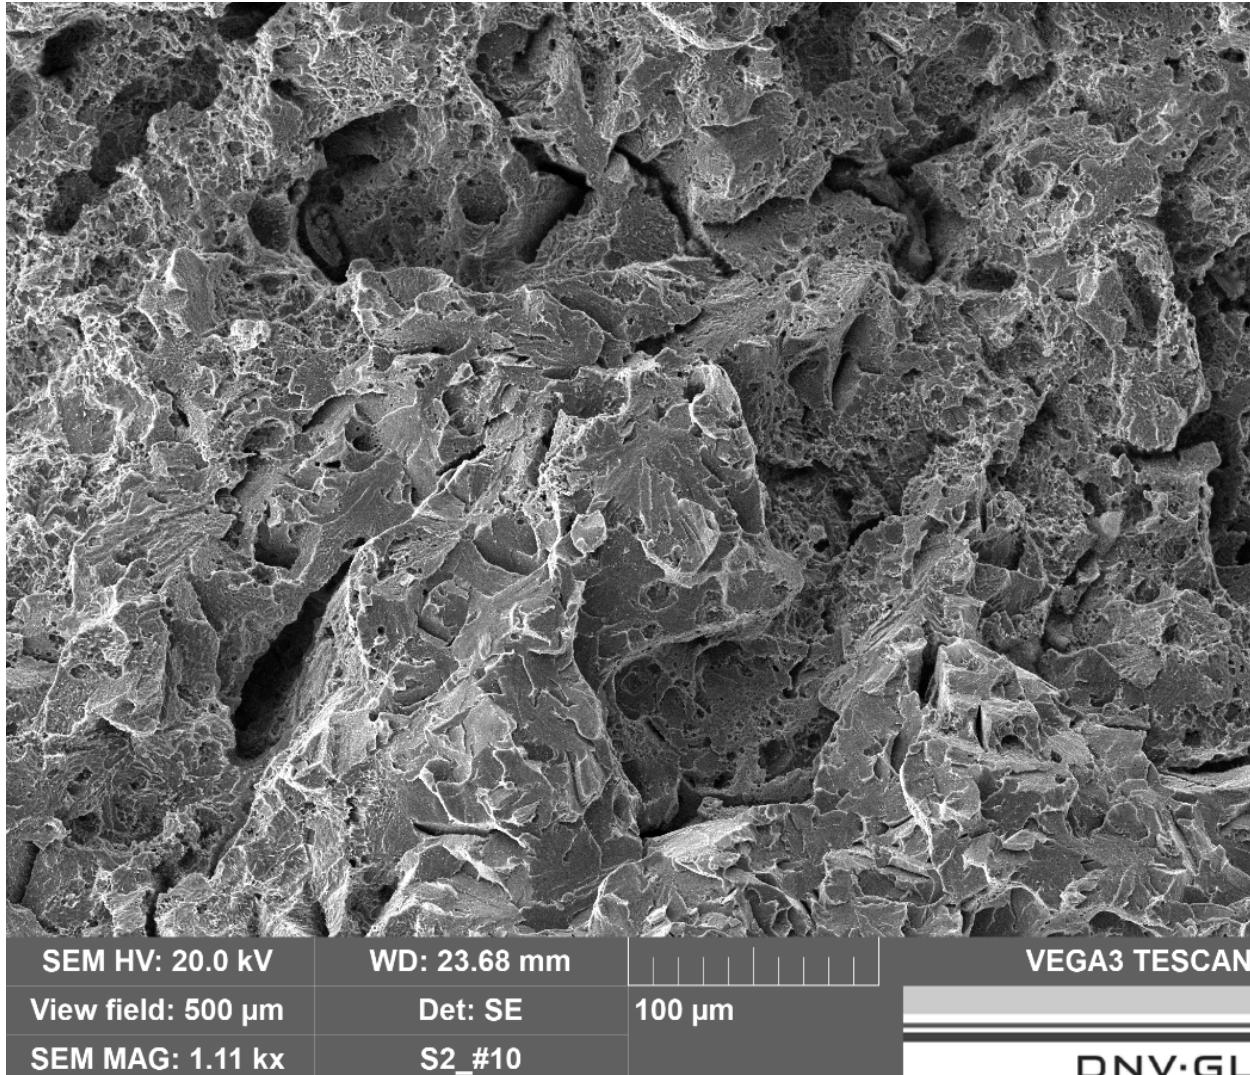
Figure 37. Sample S2 – Facets Associated with Brittle Fracture

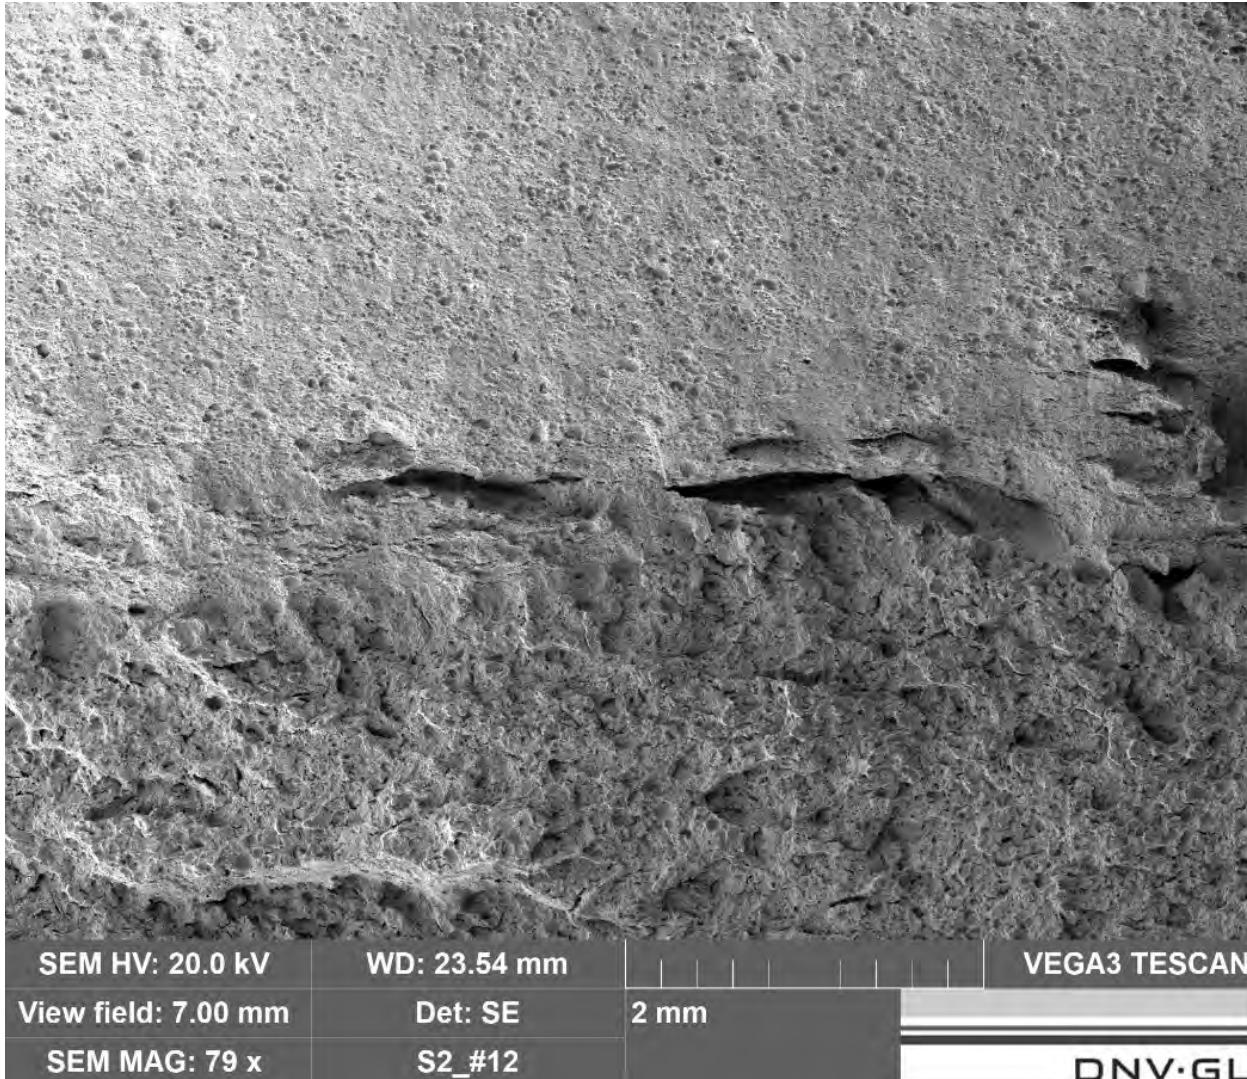
Figure 38. Sample S2 – Tears Mid-Wall (Smooth Region)

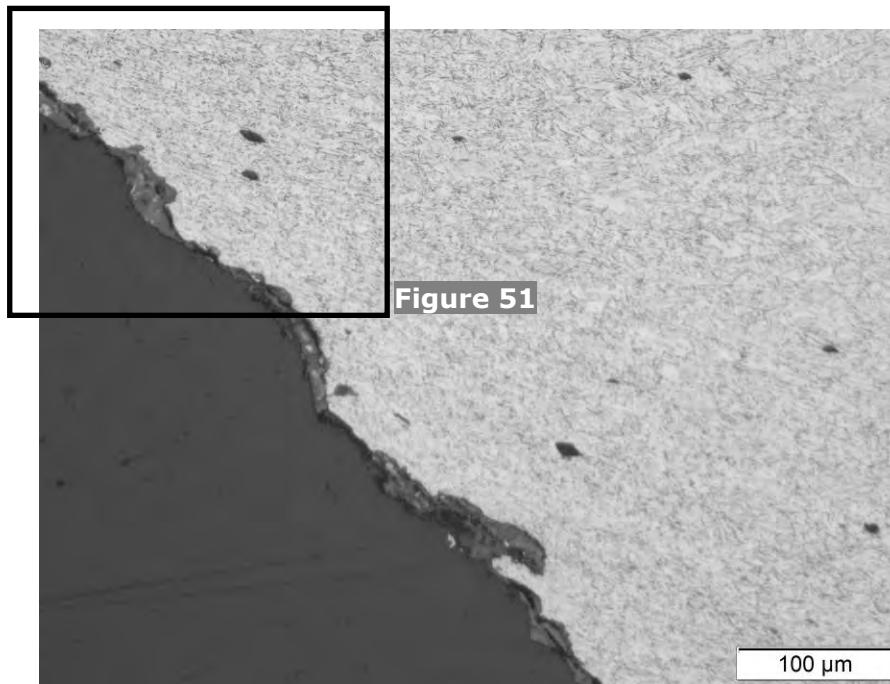
Figure 50. Light photomicrograph of Mount M1 showing inclusions in HAZ adjacent to the fracture surface; area indicated in Figure 49.

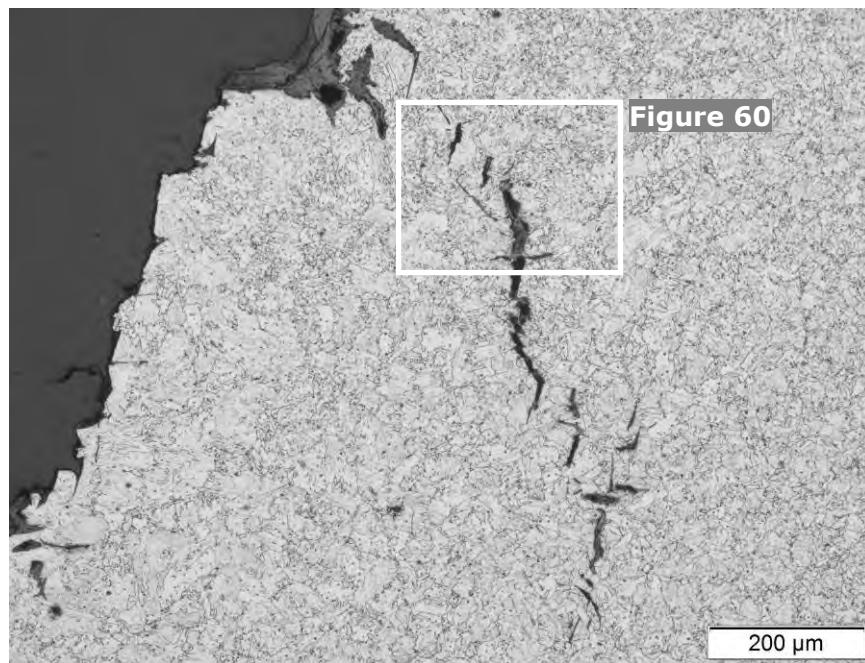
Figure 59. Light photomicrograph of Mount M2 adjacent to the fracture surface showing fissures (2% Nital Etchant); area indicated in Figure 58.

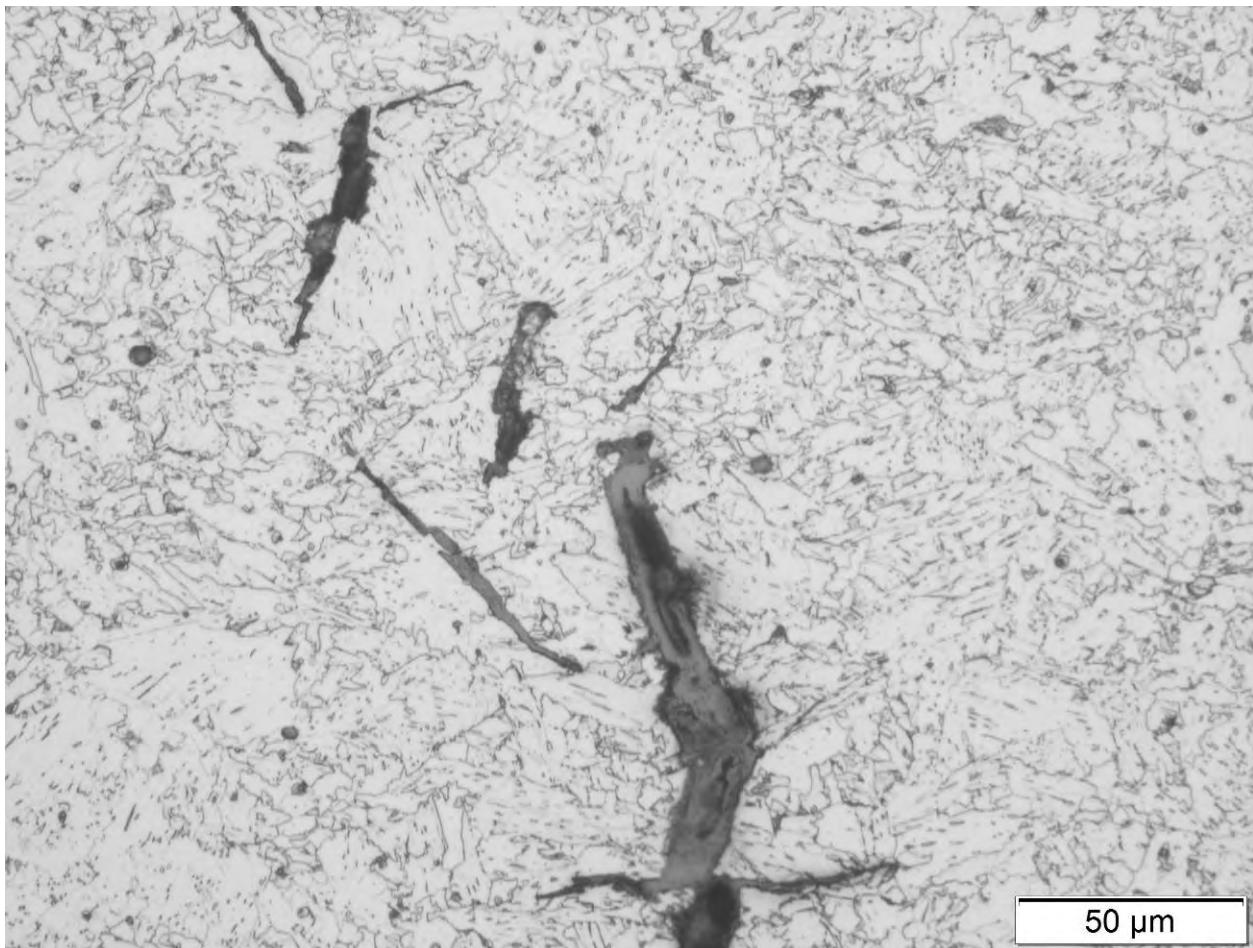
Figure 60. High magnification light photomicrograph of Mount M2 at fissures (2% Nital Etchant); area indicated in Figure 59.
