DOT	US Department of Transportation
PHMSA	Pipeline and Hazardous Materials Safety Administration
OPS	Office of Pipeline Safety – Accident Investigation Division
Principal Investigator	Wesley Mathews
Acting Accident Investigation Director	Chris Ruhl
Date of Report	May 26, 2022
Subject	Failure Investigation Report - Denbury Gulf Coast Pipelines, LLC – Pipeline Rupture/ Natural Force Damage

Failure Investigation Report – Denbury Gulf Coast Pipelines LLC

Pipeline Rupture/Natural Force Damage

February 22, 2020

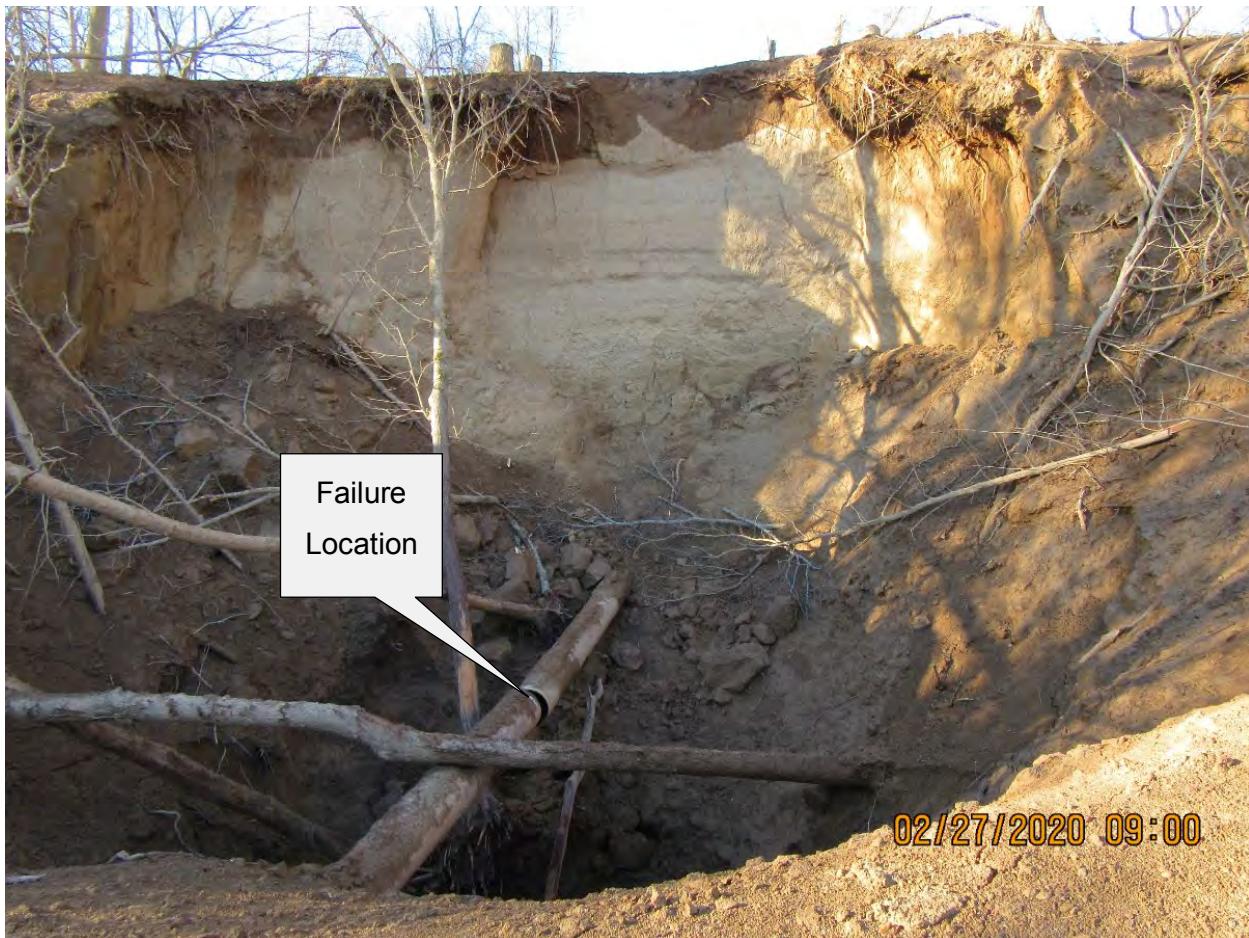
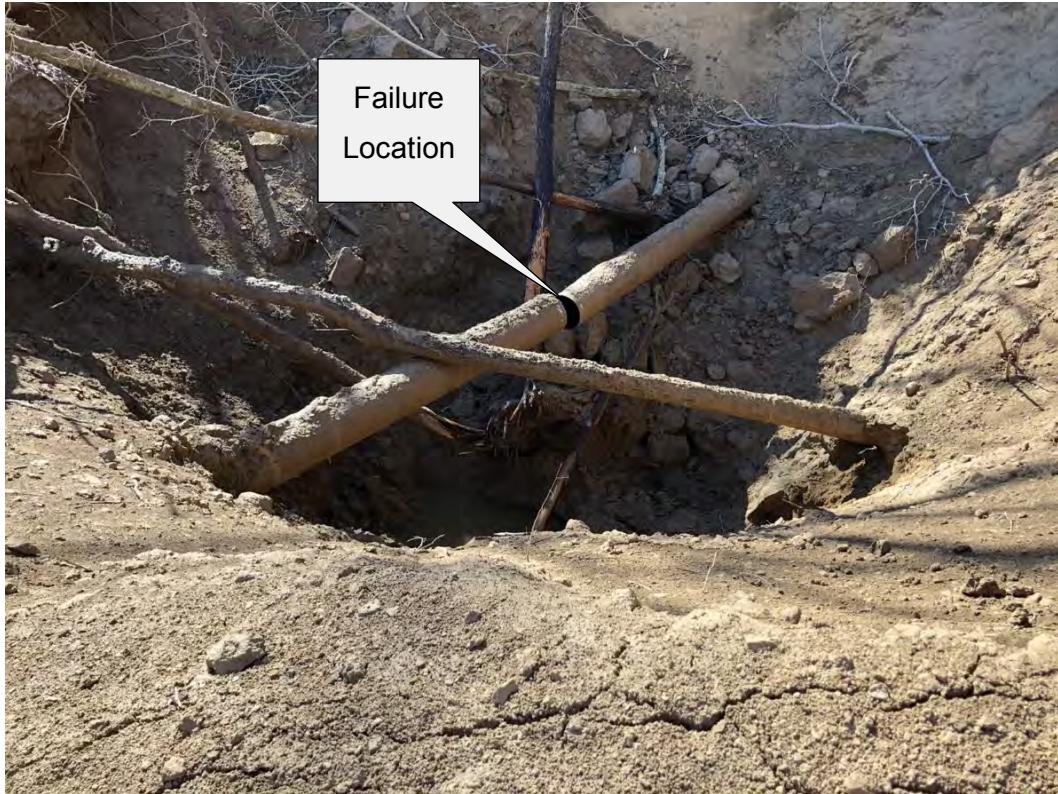
Figure 6. Failure Location (Upstream to Downstream)

From initial visual examination, the failure appeared to have occurred at least 40 feet in elevation below the roadway, with indications of soil subsidence in the vicinity of the failure. The release crater included trees and root debris, but based on the pipeline alignment sheet elevation profile, a significant volume of soil in the slick bore section between the failure and MS Highway 433 had collapsed. The soil in the vicinity of the failure appeared to be extremely wet.

Personnel were unable to access the pipe at the failure location due to the depth of the crater and instability of the soil on the downstream side of the crater.

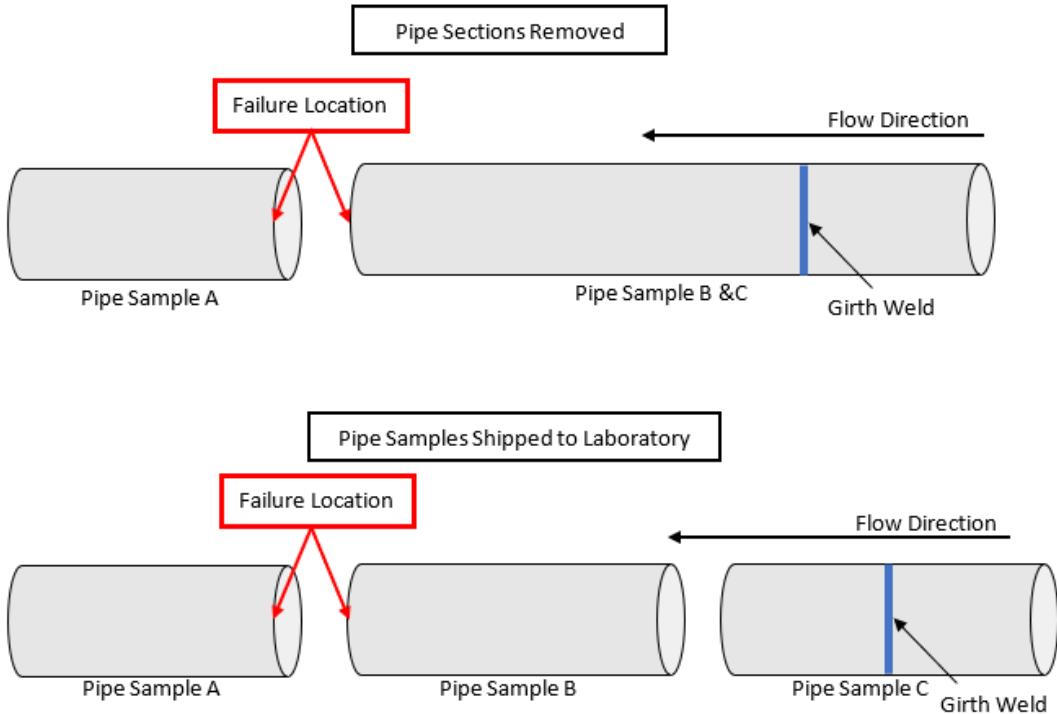
Figure 10. Overview of Pipe Sections and Samples

Visual inspection of the external surface of the pipe sections identified an area of coating damage near the failure, which appeared to have occurred as a result of the failure (no pitting, attached solids, and apparent adhesive failure). No external corrosion was observed and the pipe coating on the remainder of the section appeared to be in excellent condition.

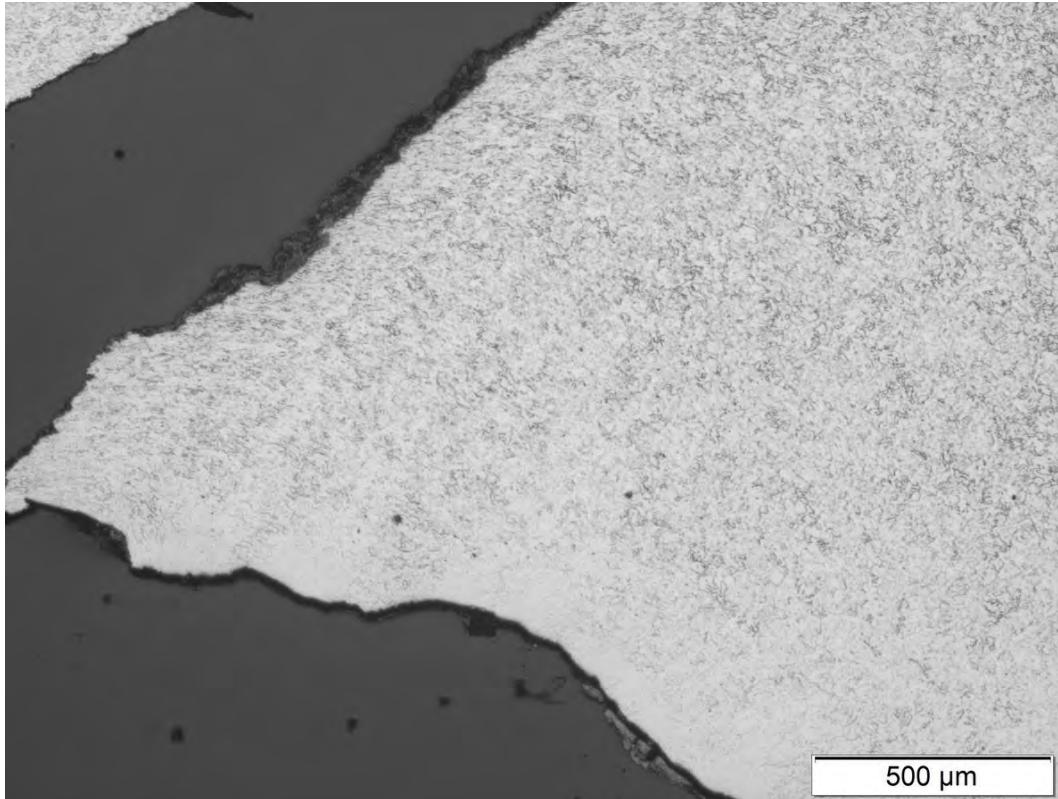
Figure 27. Close-Up of Sample M3

The fracture path is at a shear angle and mainly located in the weld metal. The morphology of the weld is similar to samples M1 and M2. The high-low weld misalignment at this location was approximately 2.6% of the NWT. The microstructure is consistent with the findings in samples M1 and M2 (see Figure 26 and Figure 27).

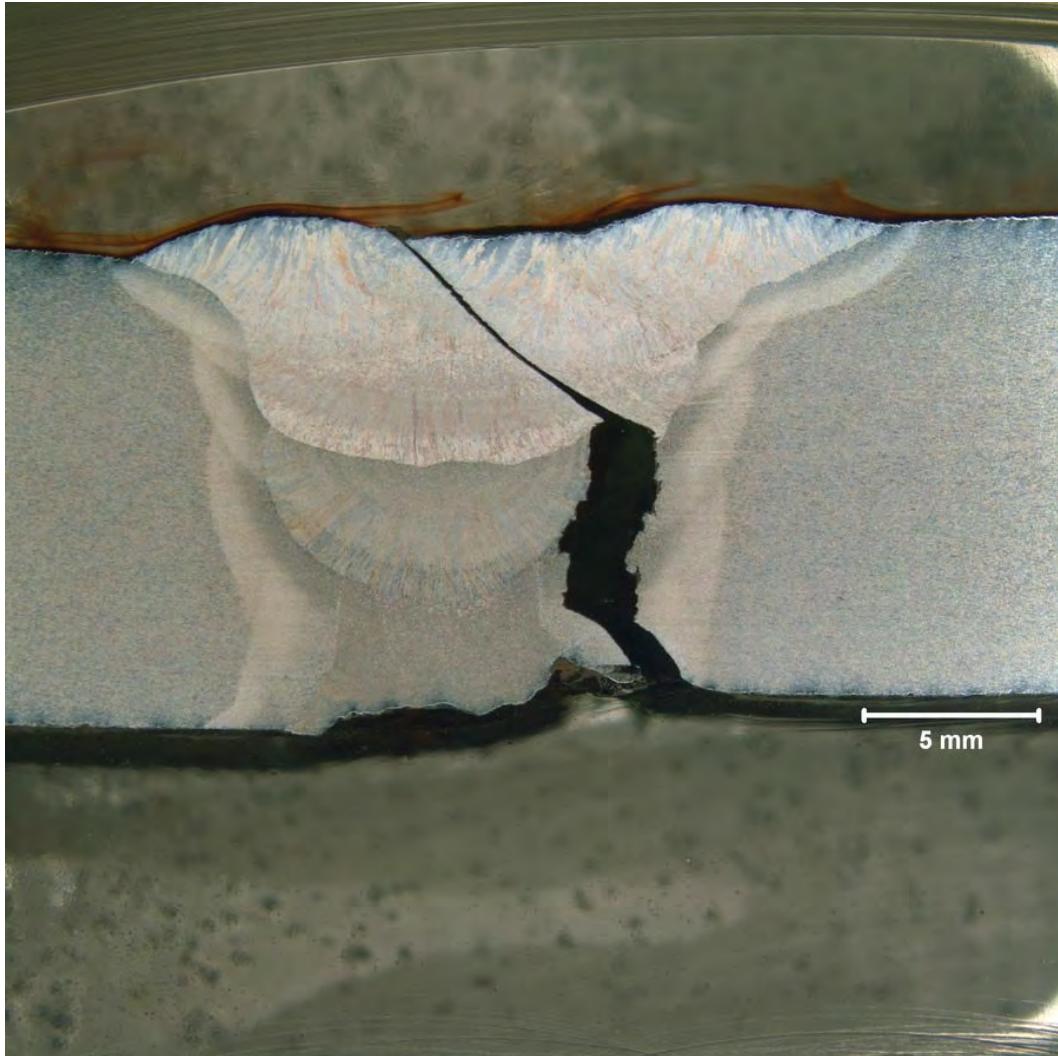
Figure 29. Representative Cross-Section from Sample M4

There is a smooth shear angle region and a rough region. The fracture path at this location is mainly in the HAZ. (see Figure 29).

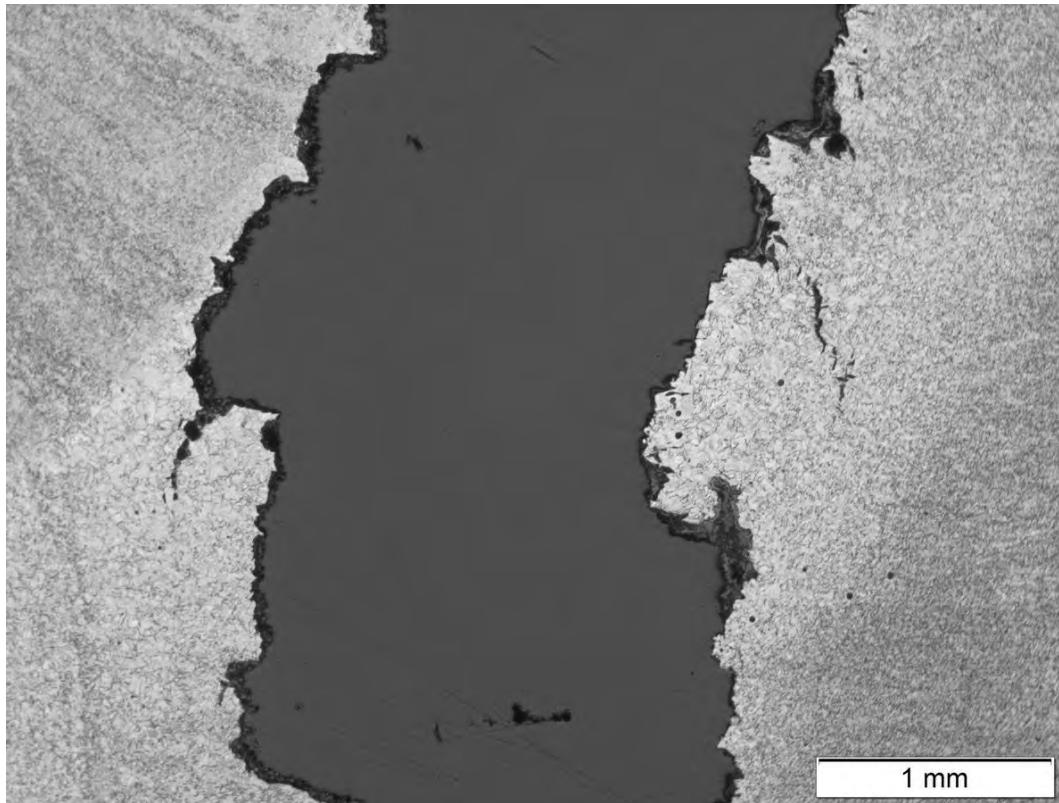
Figure 30. Close-Up of Sample M4

The sample shows grain elongation and an inclusion orientated parallel to the fracture surface which is consistent with ductile overload. There are also fissures in this sample that have the same morphology shown in M2 sample. A close-up of the M4 sample is provided in Figure 30.

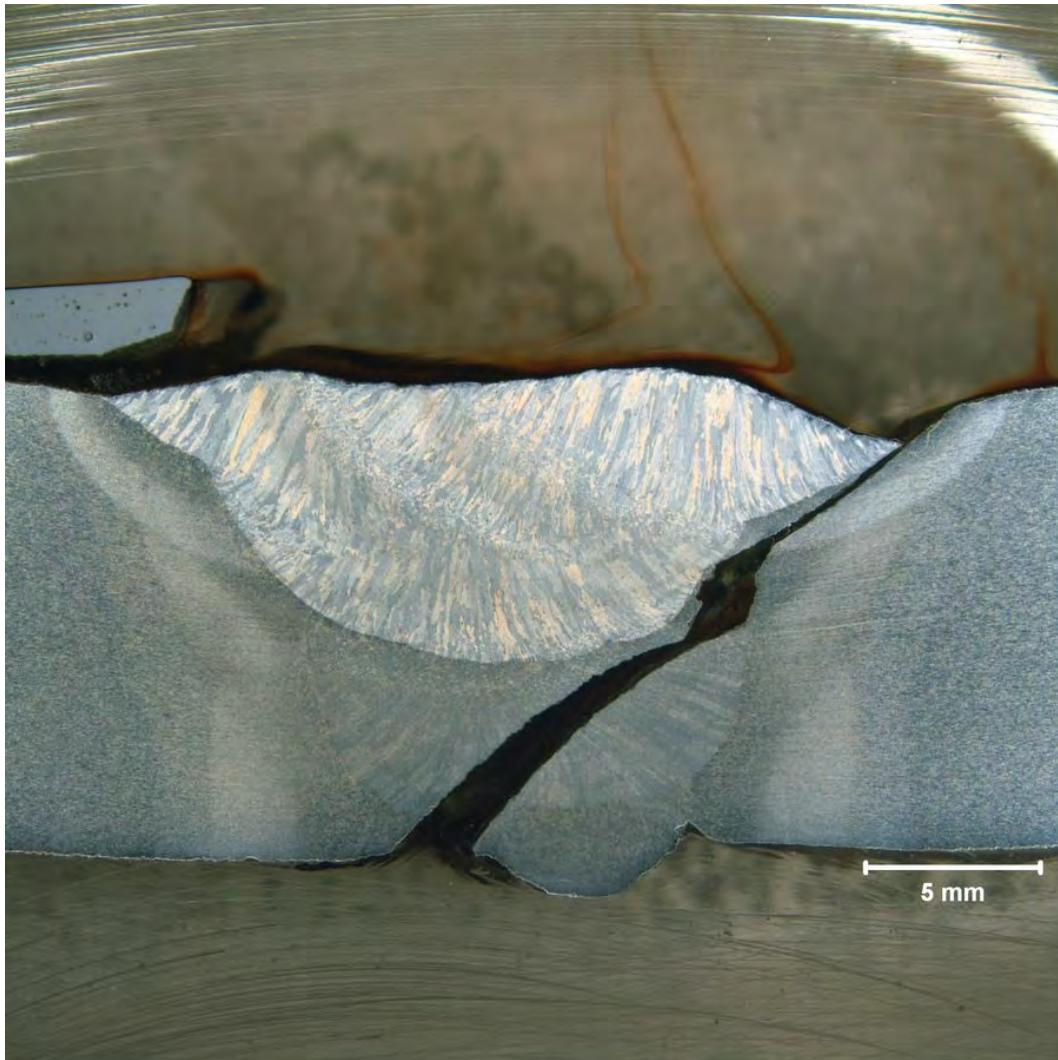
Figure 32. Representative Cross-Section from Sample M5

This sample has a smooth shear region on most of the fracture surface, located in both the weld metal and base metal. There is a shallow flaw between the weld metal and HAZ which is consistent with incomplete fusion. The high-low weld misalignment at this location was approximately 4.6% of the NWT. There is no evidence of crack extension at the flaw in this sample. A view of the cross section of sample M5 is provided in Figure 32.

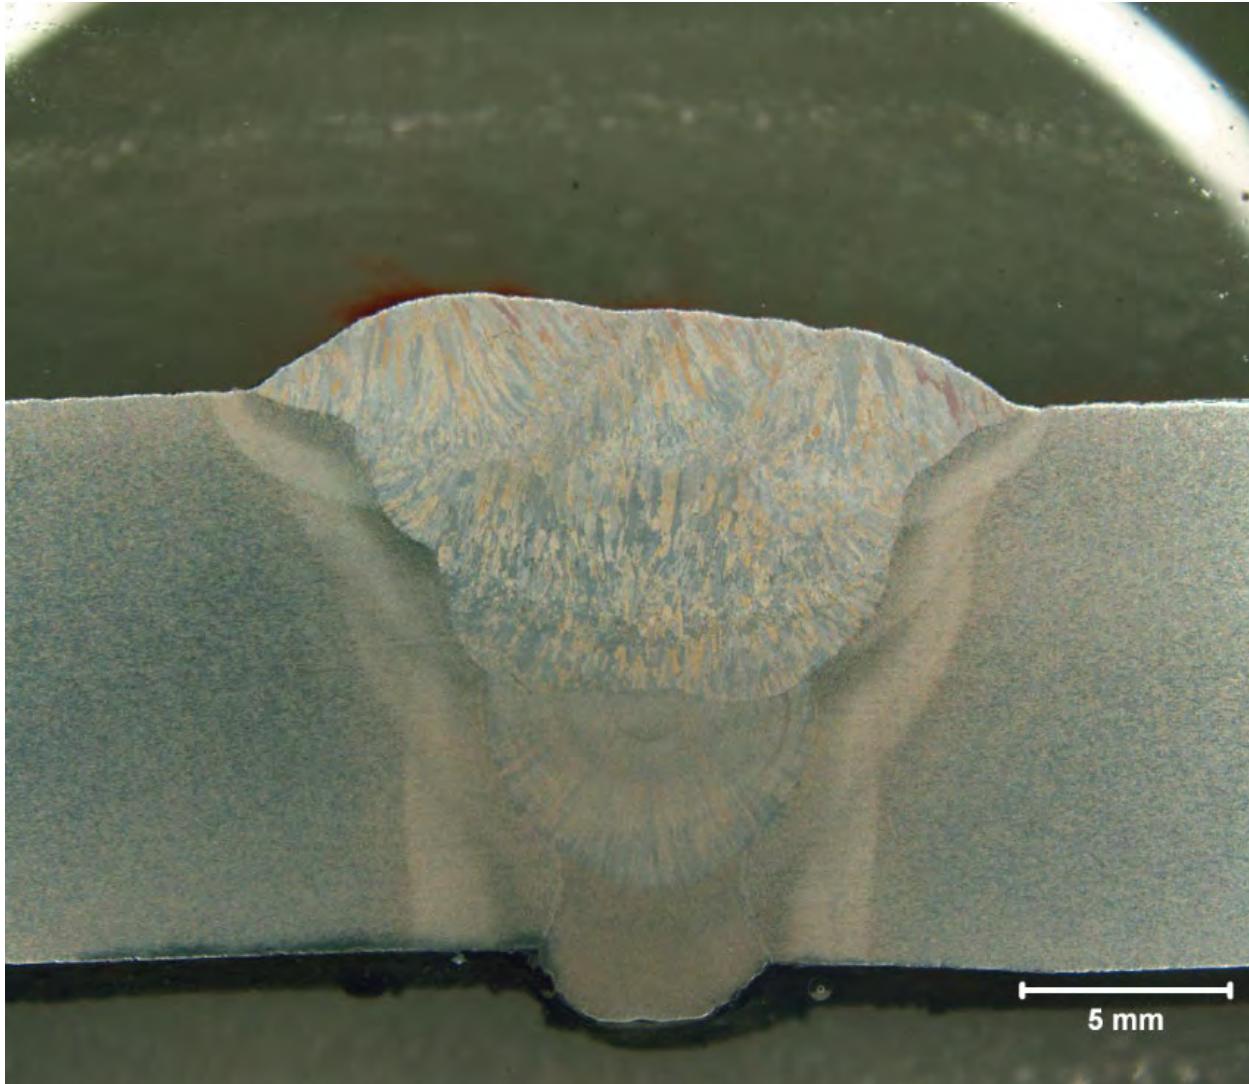
Figure 34. Cross Section of Mount MU1

This sample was removed from the intact GW at the 12:24 o'clock position. The morphology is similar to the previous mounts. The high-low weld misalignment at this location is approximately 4.6% of the NWT. The figure shows a shallow incomplete fusion flaw (1.9% of the NWT) between the weld metal and the HAZ. An image of the cross section of sample MU1 is provided in Figure 34.

A shallow flaw was identified between the weld metal and HAZ, with no evidence of cracking or extension of the flaw. A close up view of the flaw is provided in Figure 35.

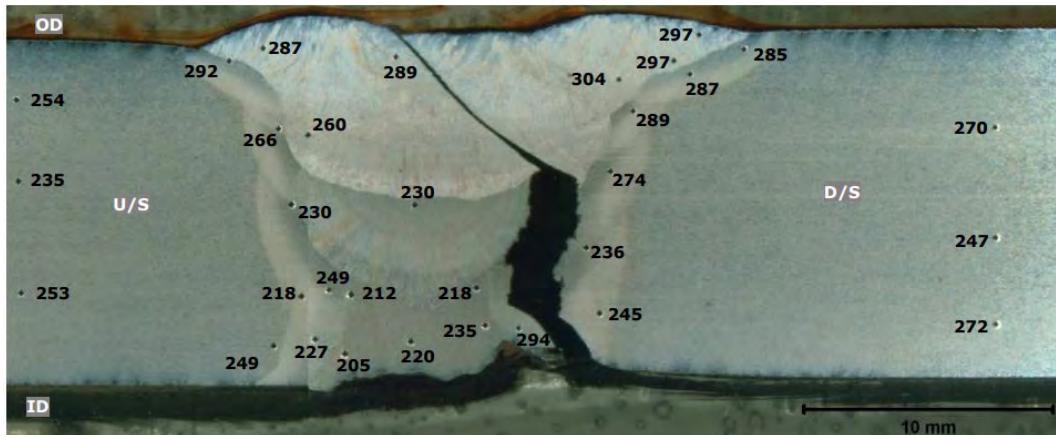
Figure 39: Light Photomicrograph of M2 Axial Cross-Section Showing Hardness Levels in HV

Vickers hardness testing was conducted on all six metallographic cross sections. No areas of unusually high hardness were identified. Hardness testing of the failed girth weld exhibit variability that is likely associated with cold work sustained during the failure. The hardness testing of the intact weld are the best representation of the base hardness of the welds preceding the failure. The results indicate a lower hardness of the weld metal compared to the pipe metal, which indicating that the weld metal is softer than the parent metal. Typically, the parent metal

is harder than the weld metal. The axial tensile tests on the intact girth weld show similar failure to the actual fracture, further indicating that the lower hardness typical of the weld was the preferred location for the overload failure under applied axial stress. Hardness levels at varying points on sample M2 from the failed girth weld are shown in Figure 39.

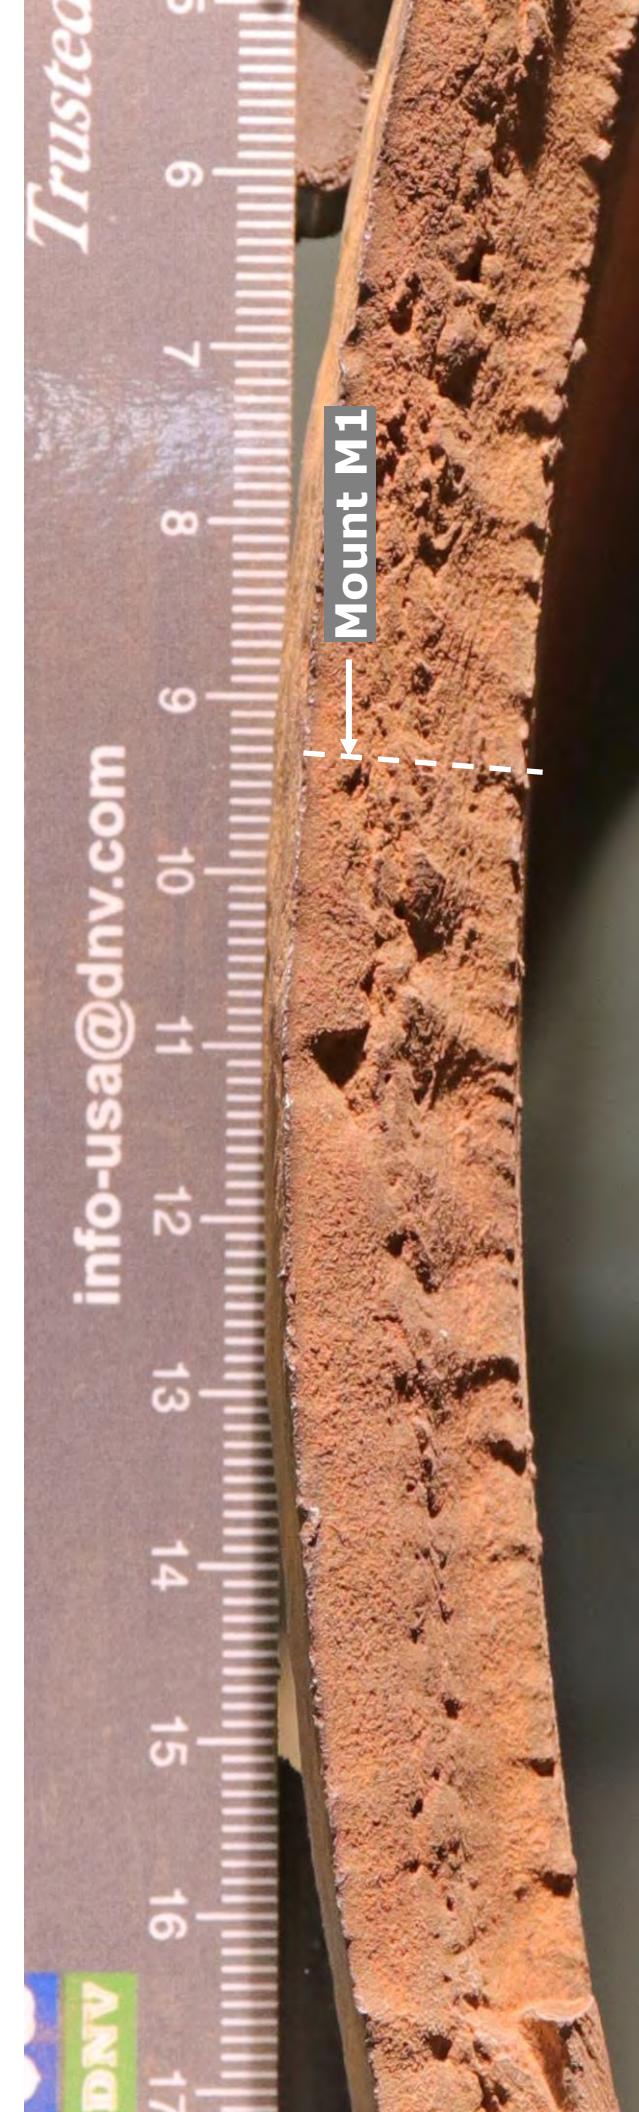
Figure 21. Photograph of the fracture surface of PS A between the 1 and 2 o'clock orientations. Units of ruler are in cm. Flow direction is into the photograph.

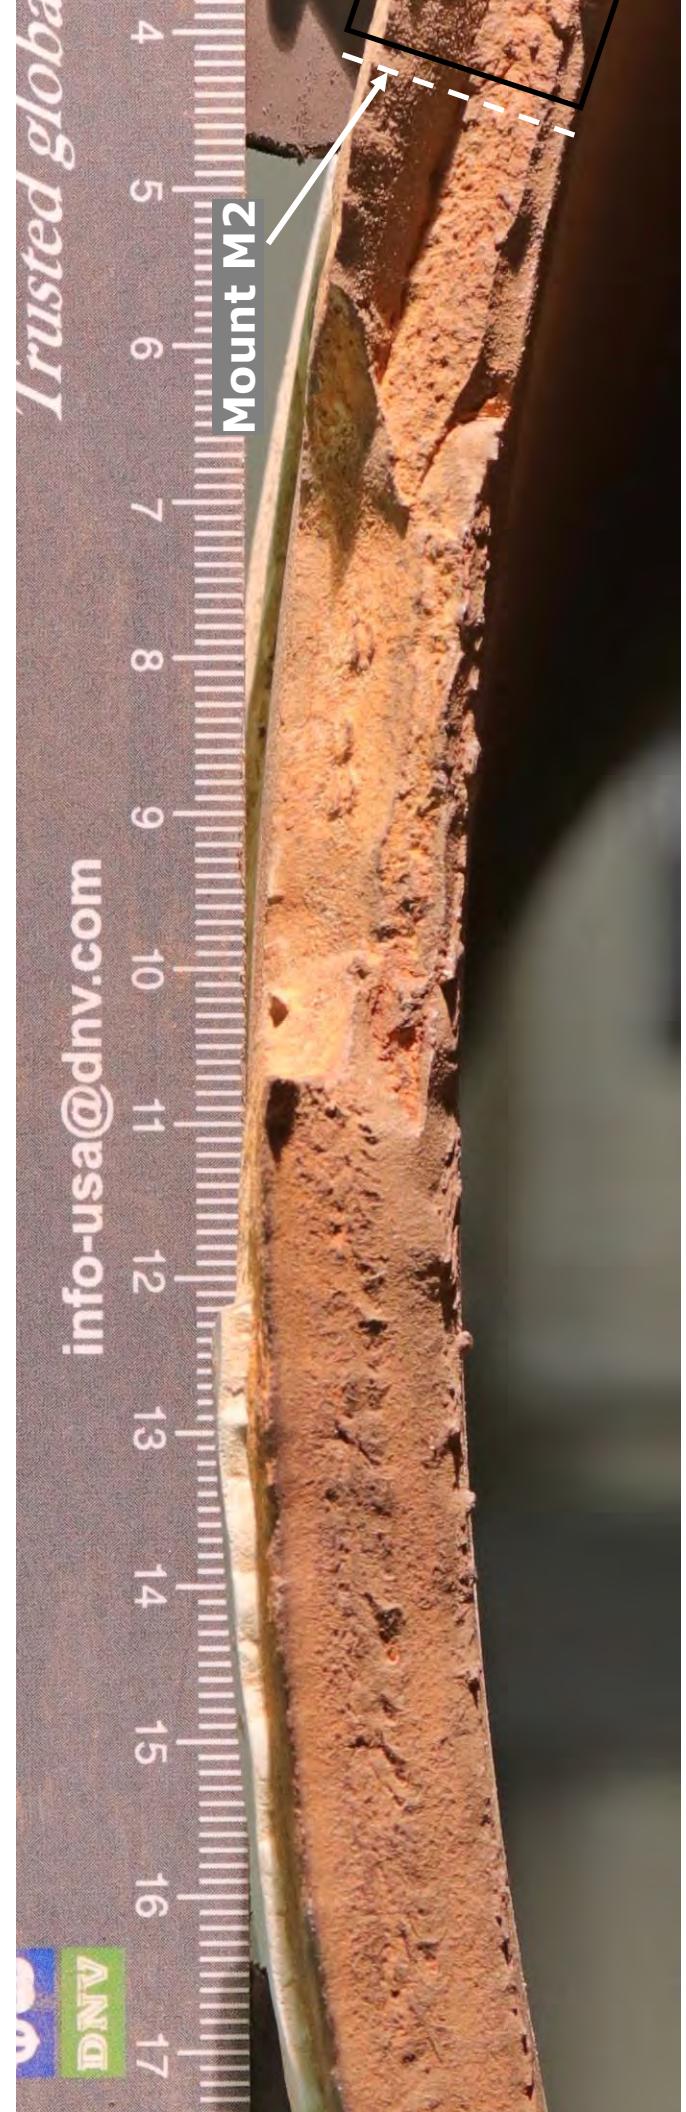
Figure 23. Photograph of the fracture surface of PS A between the 3 and 4 o'clock orientations. Units of ruler are in cm. Flow direction is into the photograph.

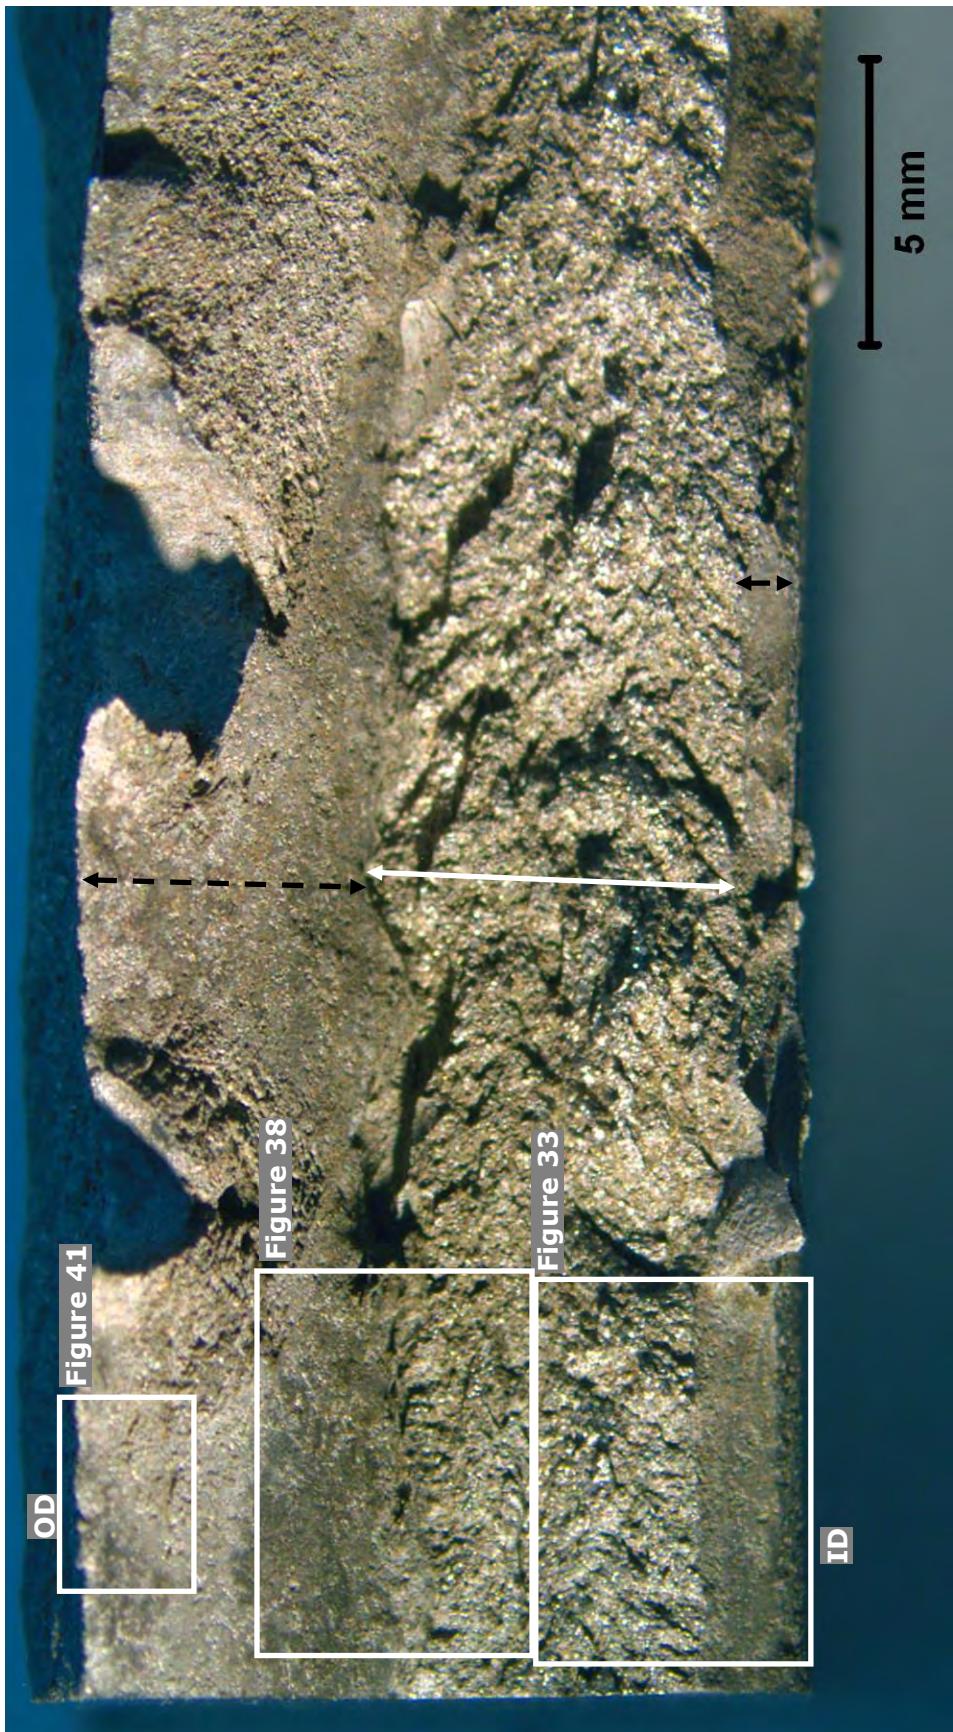
Figure 32 is a light photomicrograph of the fracture surface of Sample S2, following cleaning in ENPREP® 214. Sample S2 was removed near the 4:00 orientation. The figure shows smooth regions (black dashed double arrows) adjacent to the OD and ID surfaces, and a rougher region (white double arrow) midwall. There is no evidence of any pre-existing (present prior to the failure) flaws on the fracture surface. Figure 33 is an SEM image of Sample S2 adjacent to the ID surface. The figure shows a smooth region (adjacent to the ID surface) and a rough region of the fracture surface. Figure 34 is an SEM image of Sample S2 at the interface of a smooth and rough region. The black box in the figure is just below the interface and the figure shows dimples in the smooth region. Dimples indicate ductile (overload) fracture, which occurred during the failure. Figure 35 is a high magnification SEM image of Sample S2 in the smooth region. The figure clearly shows the dimples. Figure 36 and Figure 37 are SEM images of Sample S2 in a rough region. The fracture surface contains cleavage facets, which indicates brittle (overload) fracture, which occurred during the failure.

Figure 32. Light photomicrograph of the fracture surface of Sample S2, following cleaning in ENPREP® 214. The sample was removed near the 4:00 orientation from PSA; area indicated in Figure 23. The black, dashed double arrows indicate smooth regions and the white double arrow indicates a rough region.

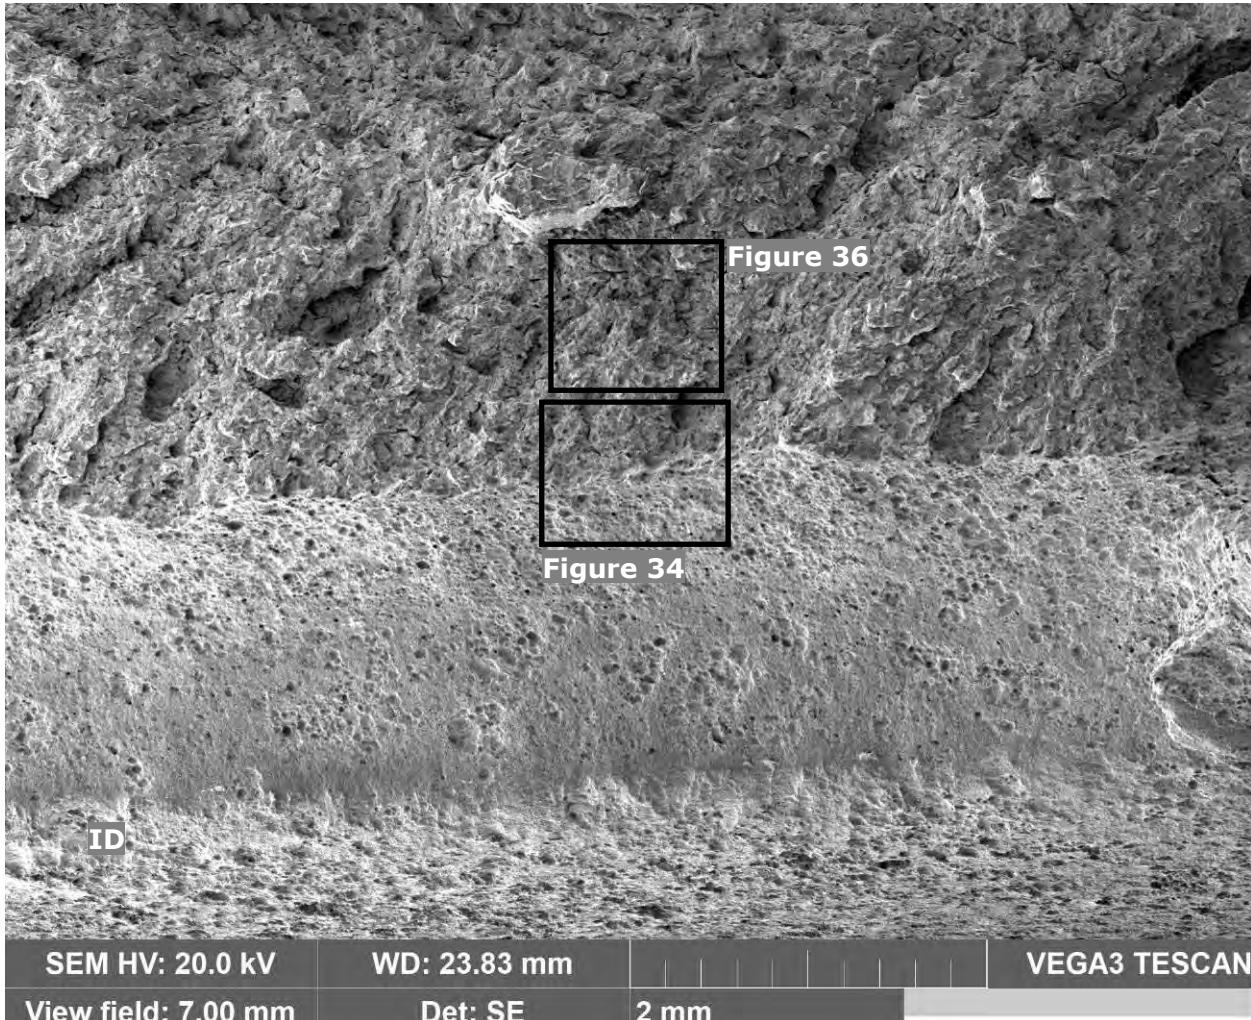
Figure 33. SEM image of Sample S2 adjacent to the ID surface; area indicated in Figure 32.

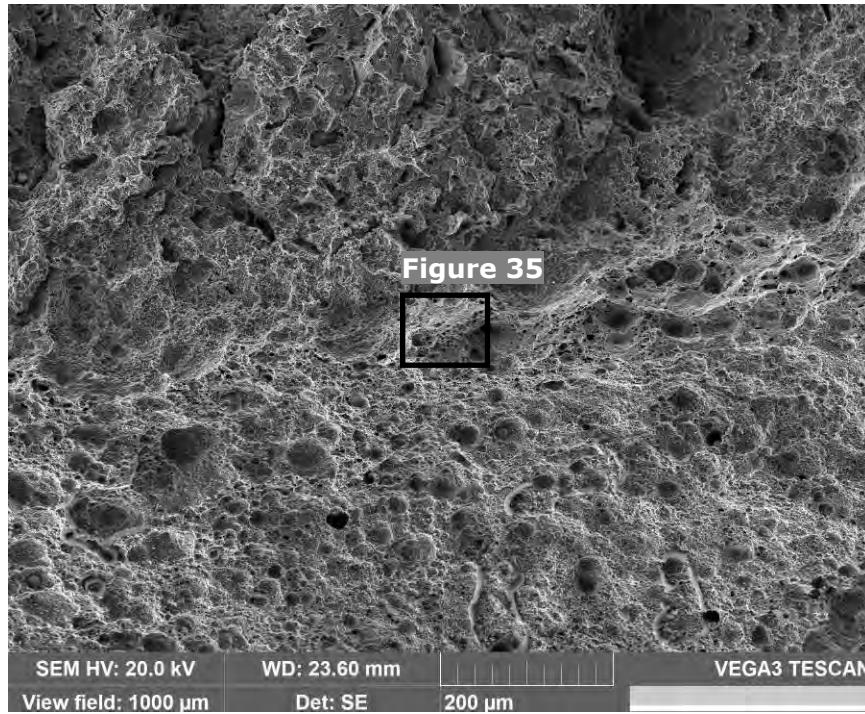
Figure 34. SEM image of Sample S2 at the interface of a macroscopically smooth and rough region; area indicated in Figure 33.

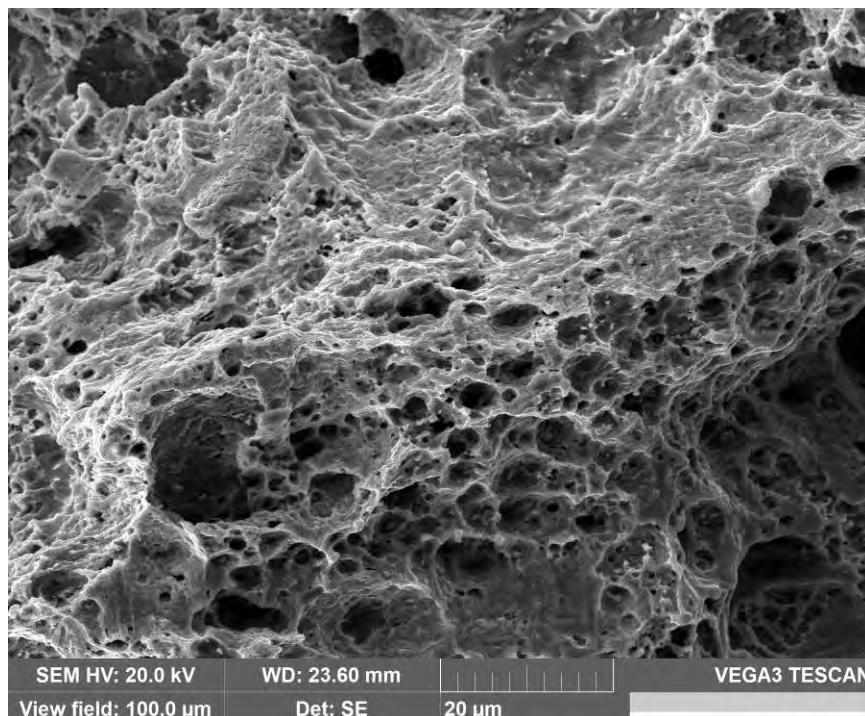
Figure 35. High magnification SEM image of Sample S2 in the macroscopically smooth region; area indicated in Figure 34.

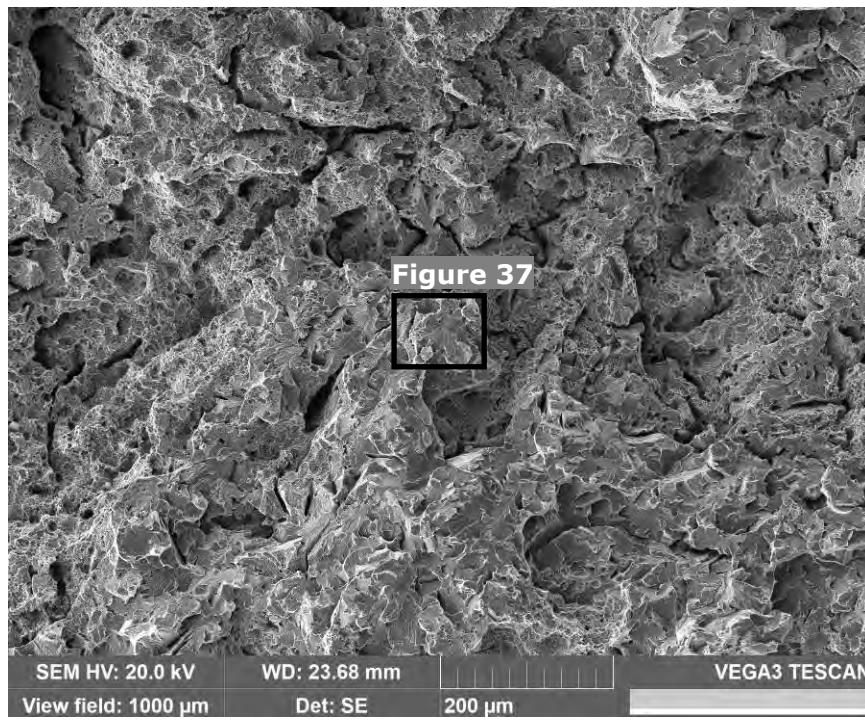
Figure 36. SEM image of Sample S2 in a macroscopically rough region; area indicated in Figure 33.

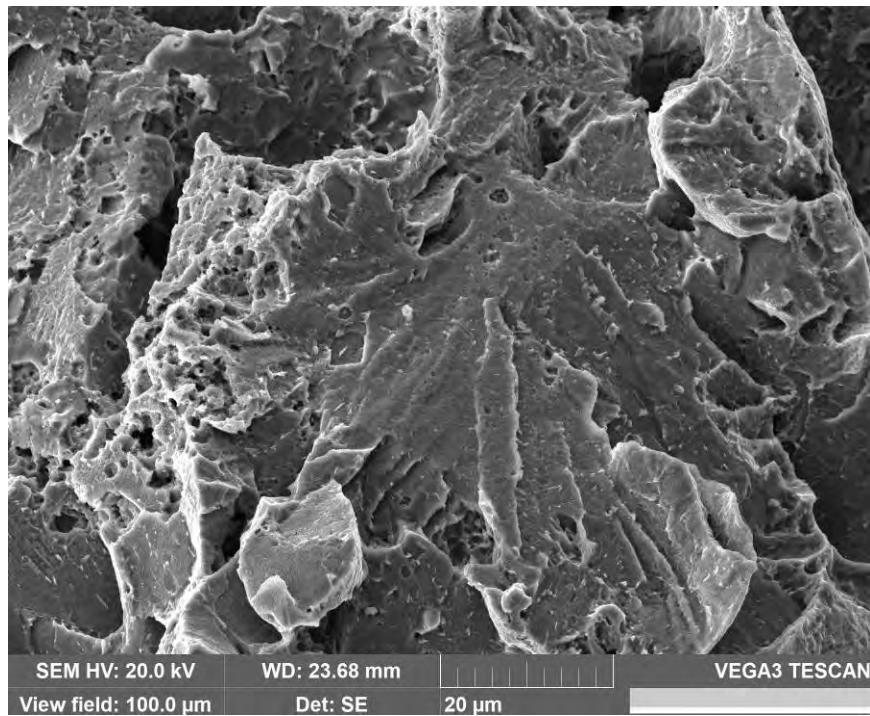
Figure 37. High magnification SEM image of Sample S2 in a macroscopically rough region; area indicated in Figure 36.

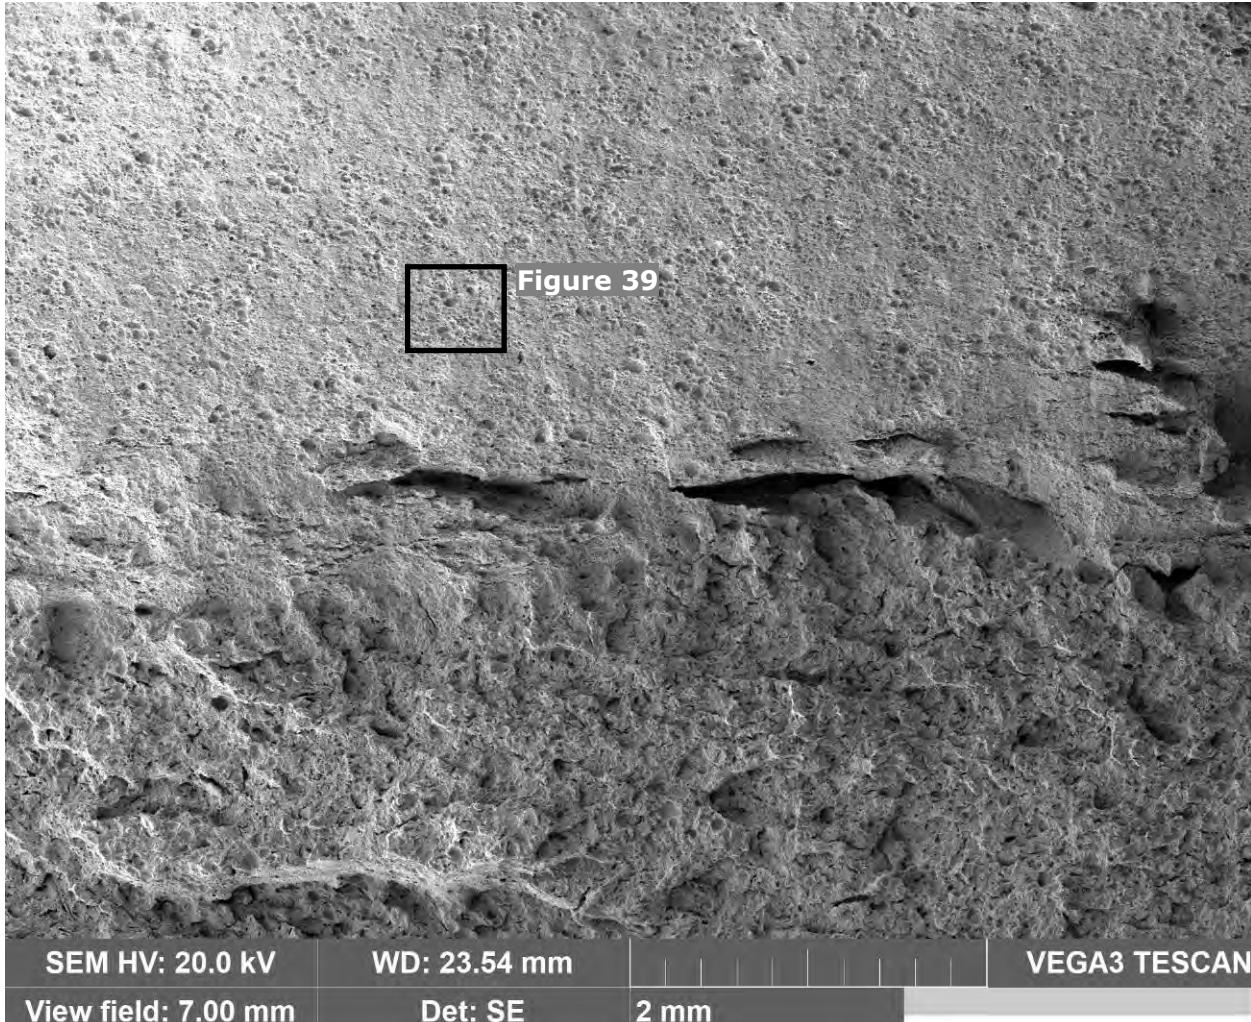
Figure 38 is an SEM image of Sample S2, midwall at a second interface of the smooth and rough regions. The figure shows what appear to be some tears in the smooth region, above the rough region. Figure 39 and Figure 40 are SEM images in the smooth region. The figures show dimples, consistent with ductile (overload) fracture.

Figure 38. SEM image of Sample S2 midwall, showing macroscopically rough and smooth regions; area indicated in Figure 32.

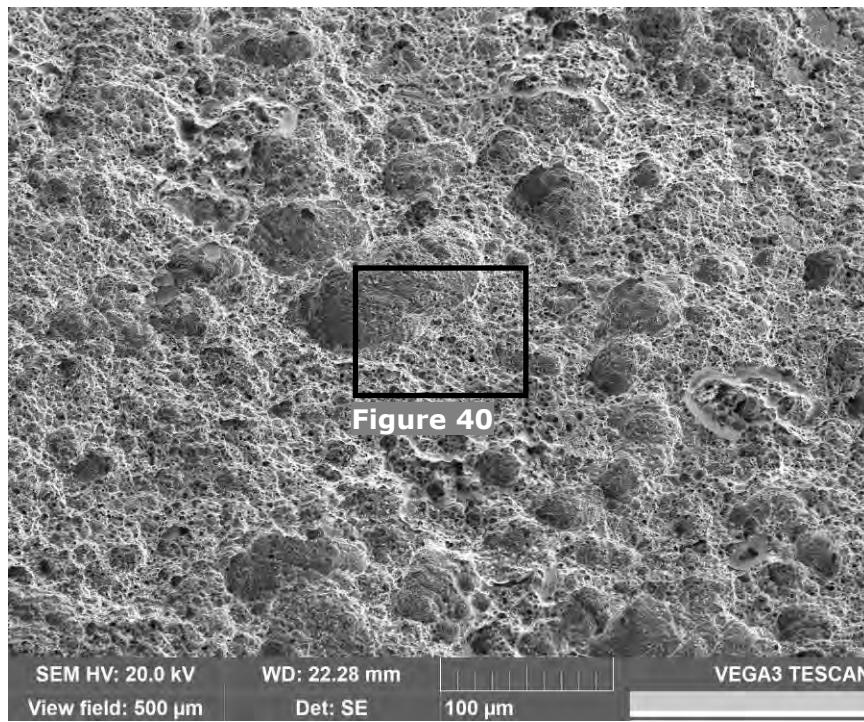
Figure 39. SEM image of Sample S2 in a macroscopically smooth region, near the OD surface; area indicated in Figure 38.

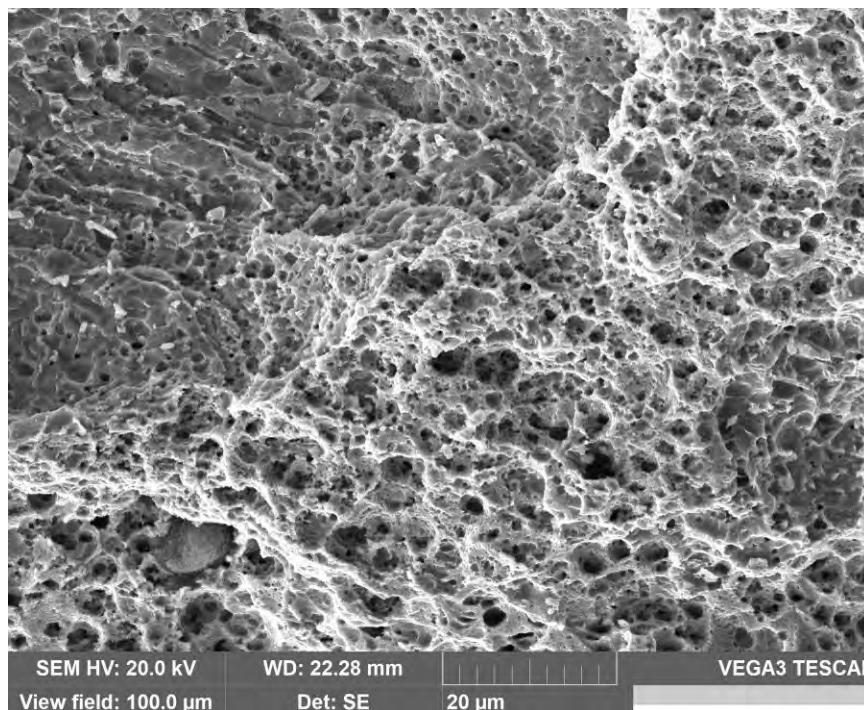
Figure 40. High magnification SEM image of Sample S2 in a macroscopically smooth region, near the OD surface; area indicated in Figure 39.

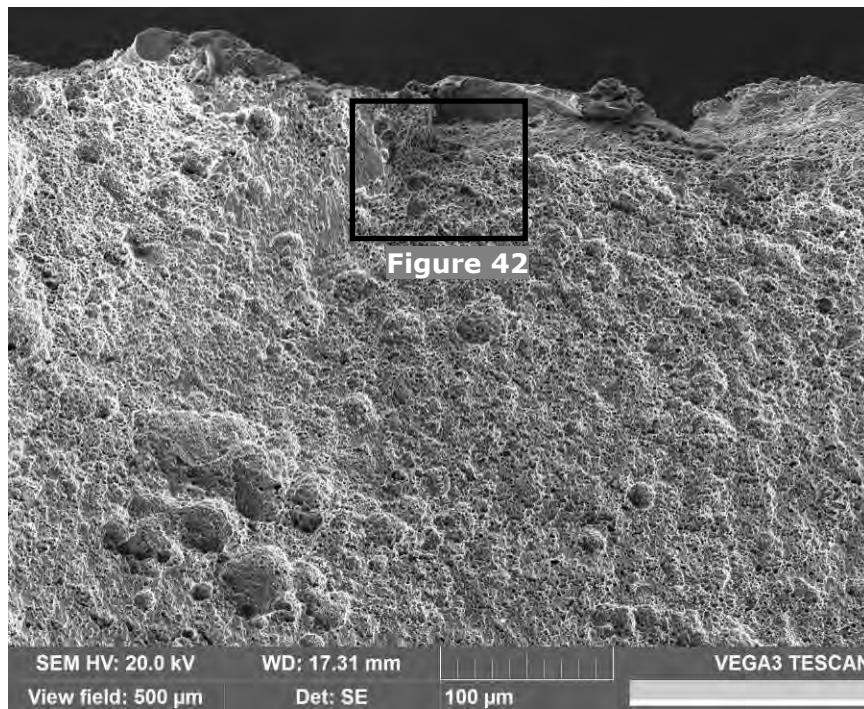
Figure 41 and Figure 42 are SEM images of Sample S2 in a smooth region adjacent to the OD surface. The figures show dimples, which is very clear in the high magnification SEM image. Again, the dimples indicate ductile (overload) fracture and are consistent with ductile fracture in the smooth region.

Figure 41. SEM image of Sample S2 adjacent to the OD surface; area indicated in Figure 32.

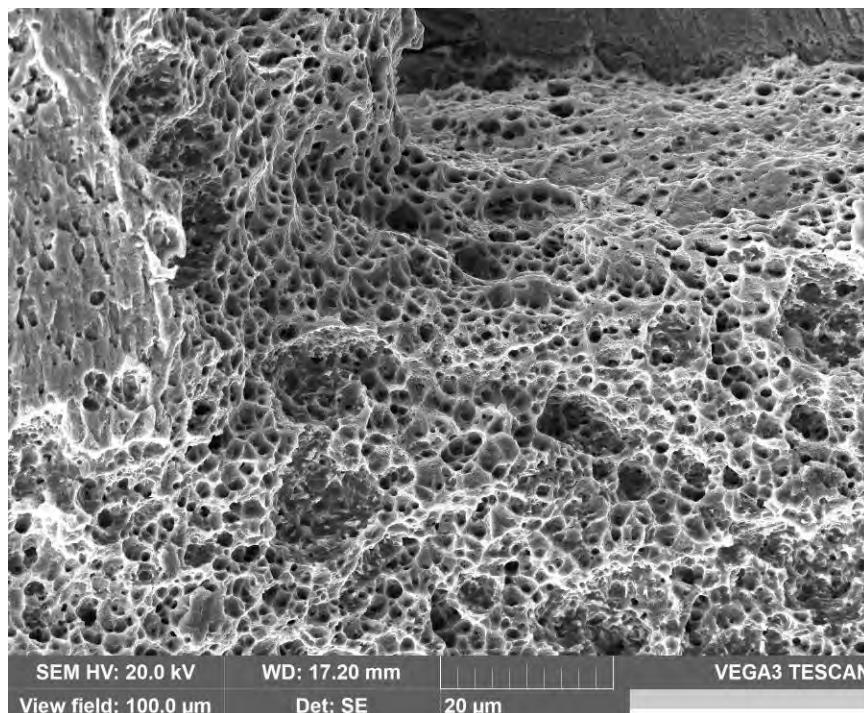
Figure 42. High magnification SEM image of Sample S2 adjacent to the OD surface; area indicated in Figure 41.
