DOT	US Department of Transportation
PHMSA	Pipeline and Hazardous Materials Safety Administration
OPS	Office of Pipeline Safety – Accident Investigation Division
Principal Investigator	Wesley Mathews
Acting Accident Investigation Director	Chris Ruhl
Date of Report	May 26, 2022
Subject	Failure Investigation Report - Denbury Gulf Coast Pipelines, LLC – Pipeline Rupture/ Natural Force Damage

Failure Investigation Report – Denbury Gulf Coast Pipelines LLC

Pipeline Rupture/Natural Force Damage

February 22, 2020

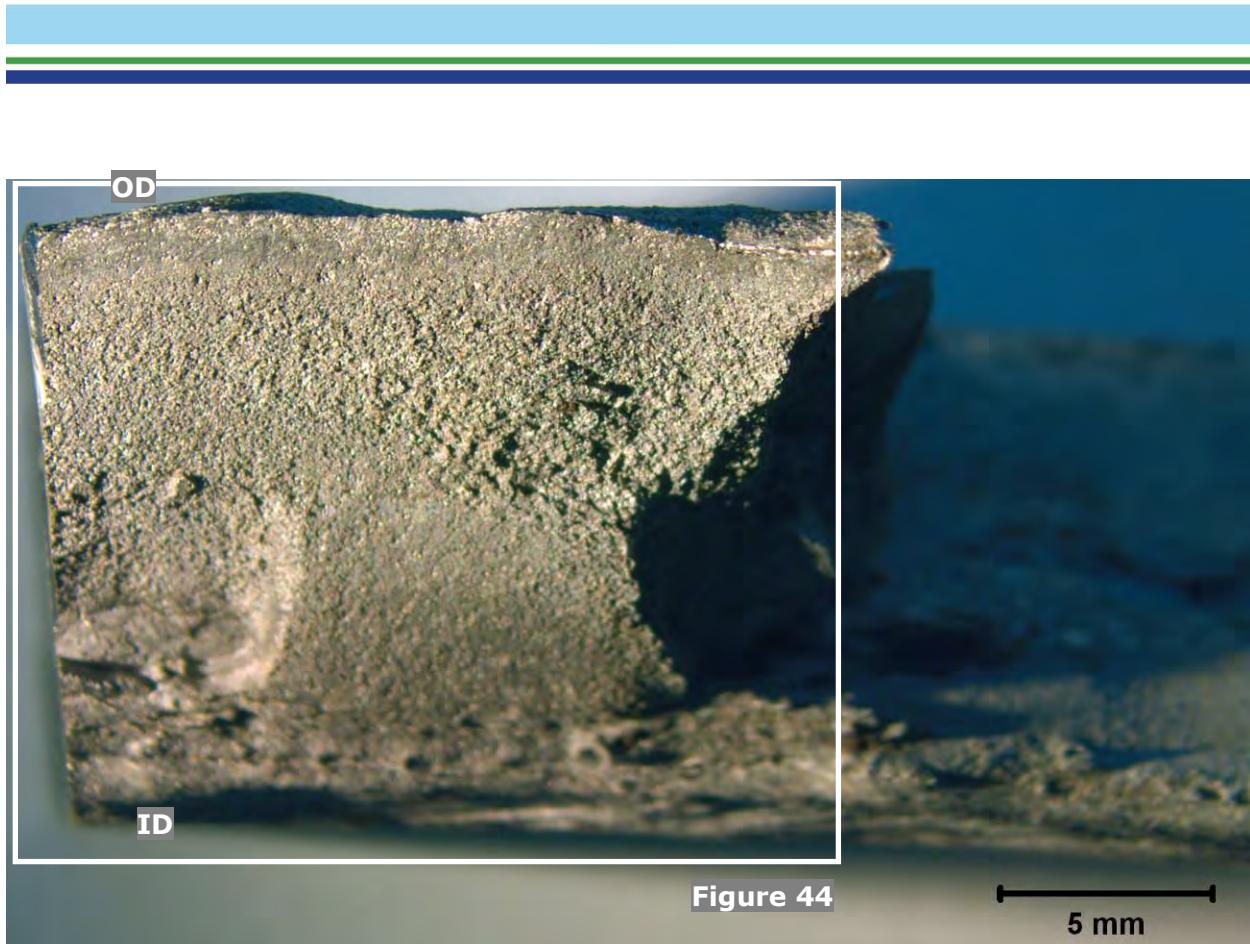
Figure 43 is a light photomicrograph of the fracture surface of Sample S3, following cleaning in ENPREP® 214. Sample S3 was removed near the 8:30 orientation. Figure 44 is an SEM image of Sample S3. The fracture surface is macroscopically smooth and at a shear angle to the free surfaces, and consists of mainly, if not entirely, smooth regions. Figure 45 is an SEM image of Sample S3 midwall. The figure shows small and larger dimples. Figure 46 is a high magnification SEM image of Sample S3 in the smooth region. The figure clearly shows the dimples.

Figure 43. Light photomicrograph of the fracture surface of Sample S3, following cleaning in ENPREP® 214. The sample was removed near the 8:00 orientation; area indicated in Figure 28.

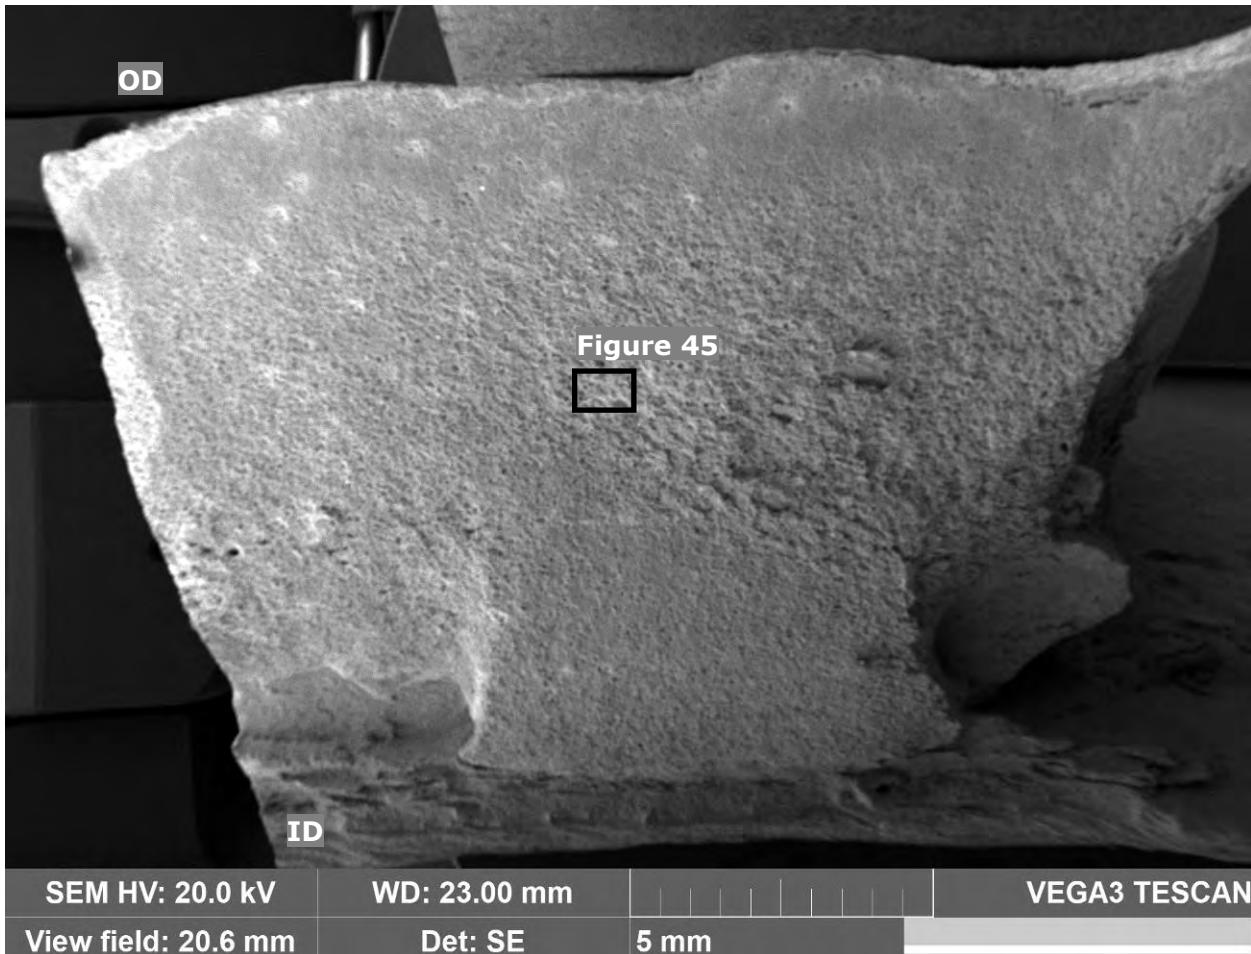
Figure 44. SEM image of Sample S3; area indicated in Figure 43.

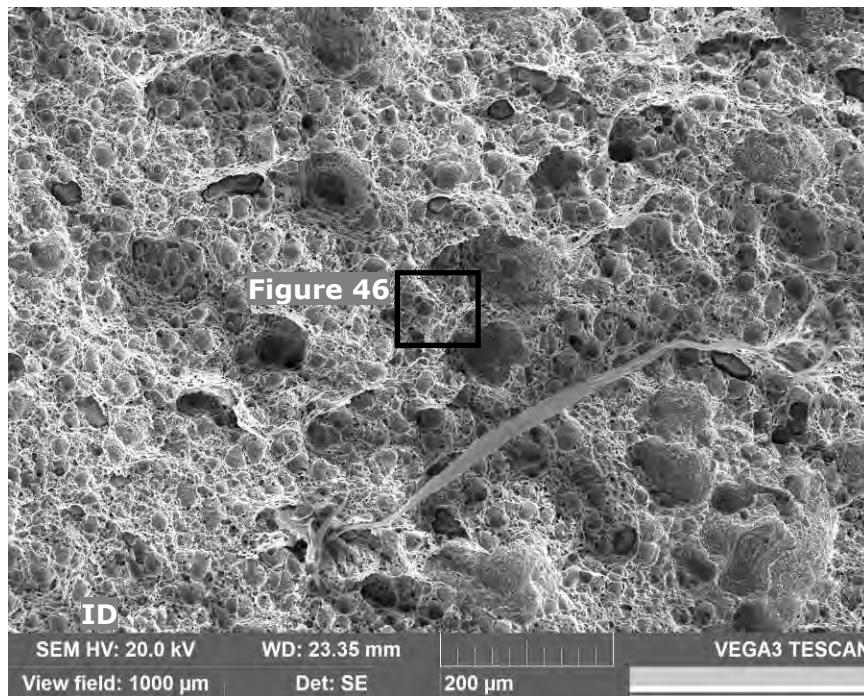
Figure 45. SEM image of Sample S3 midwall; area indicated in Figure 44.

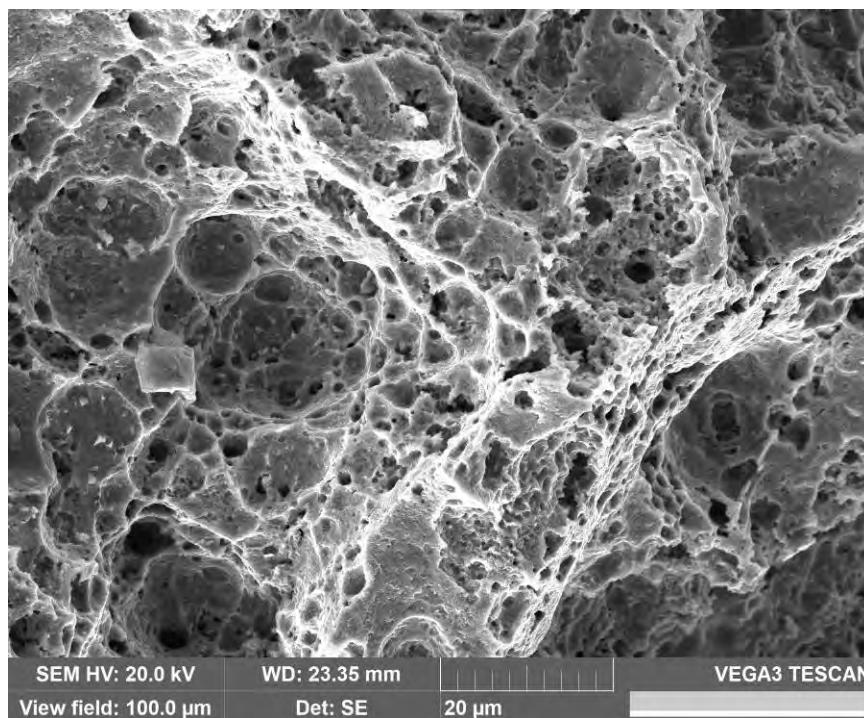
Figure 46. High magnification SEM image of Sample S3 midwall; area indicated in Figure 45.

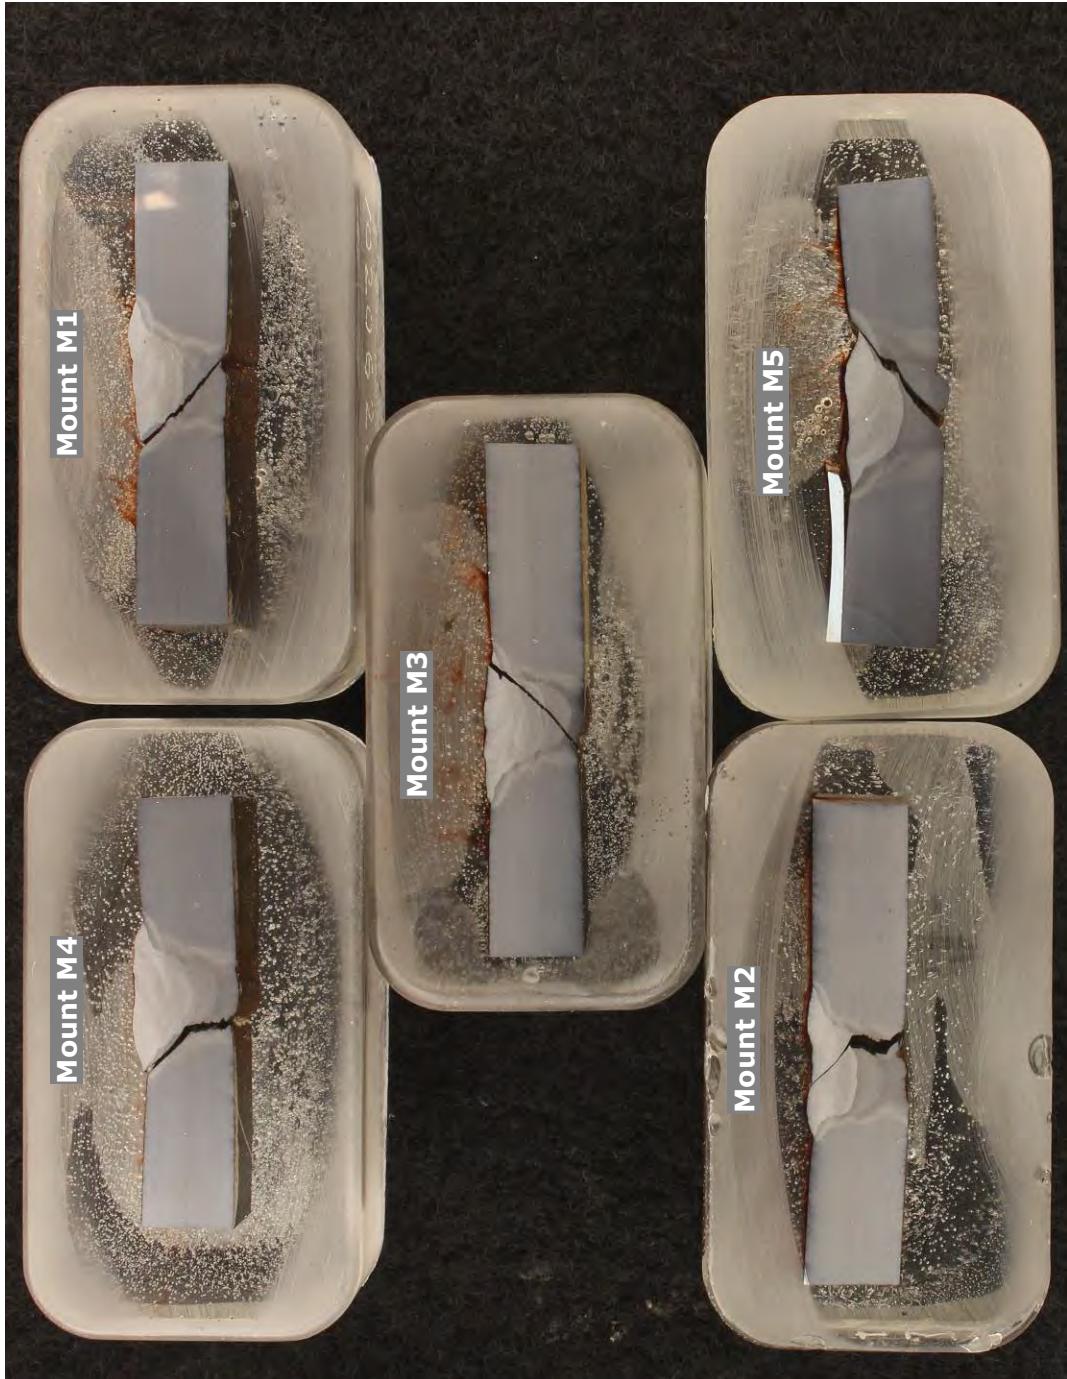
Axial (cross girth weld) cross-sections were removed from the failed girth weld (five total) and the intact girth weld (one total) for metallographic analysis. Figure 47 is a photograph of the mounts that were removed from across the failed girth weld. The figure shows that Mounts M1 and M3 contain fracture paths at a shear angle, which is indicative of ductile overload failure. Mounts M2 and M4 (and a small portion of M5) contain regions where the fracture path is perpendicular to the free surface and regions of shear failure. The perpendicular portions are where the fracture surfaces are rough and the shear angle portions are where the fracture surfaces are smooth.

Figure 47. Photograph of the mounts (M1, M2, M3, M4, and M5) that were removed across the failure opening (2% Nitric Etchant).

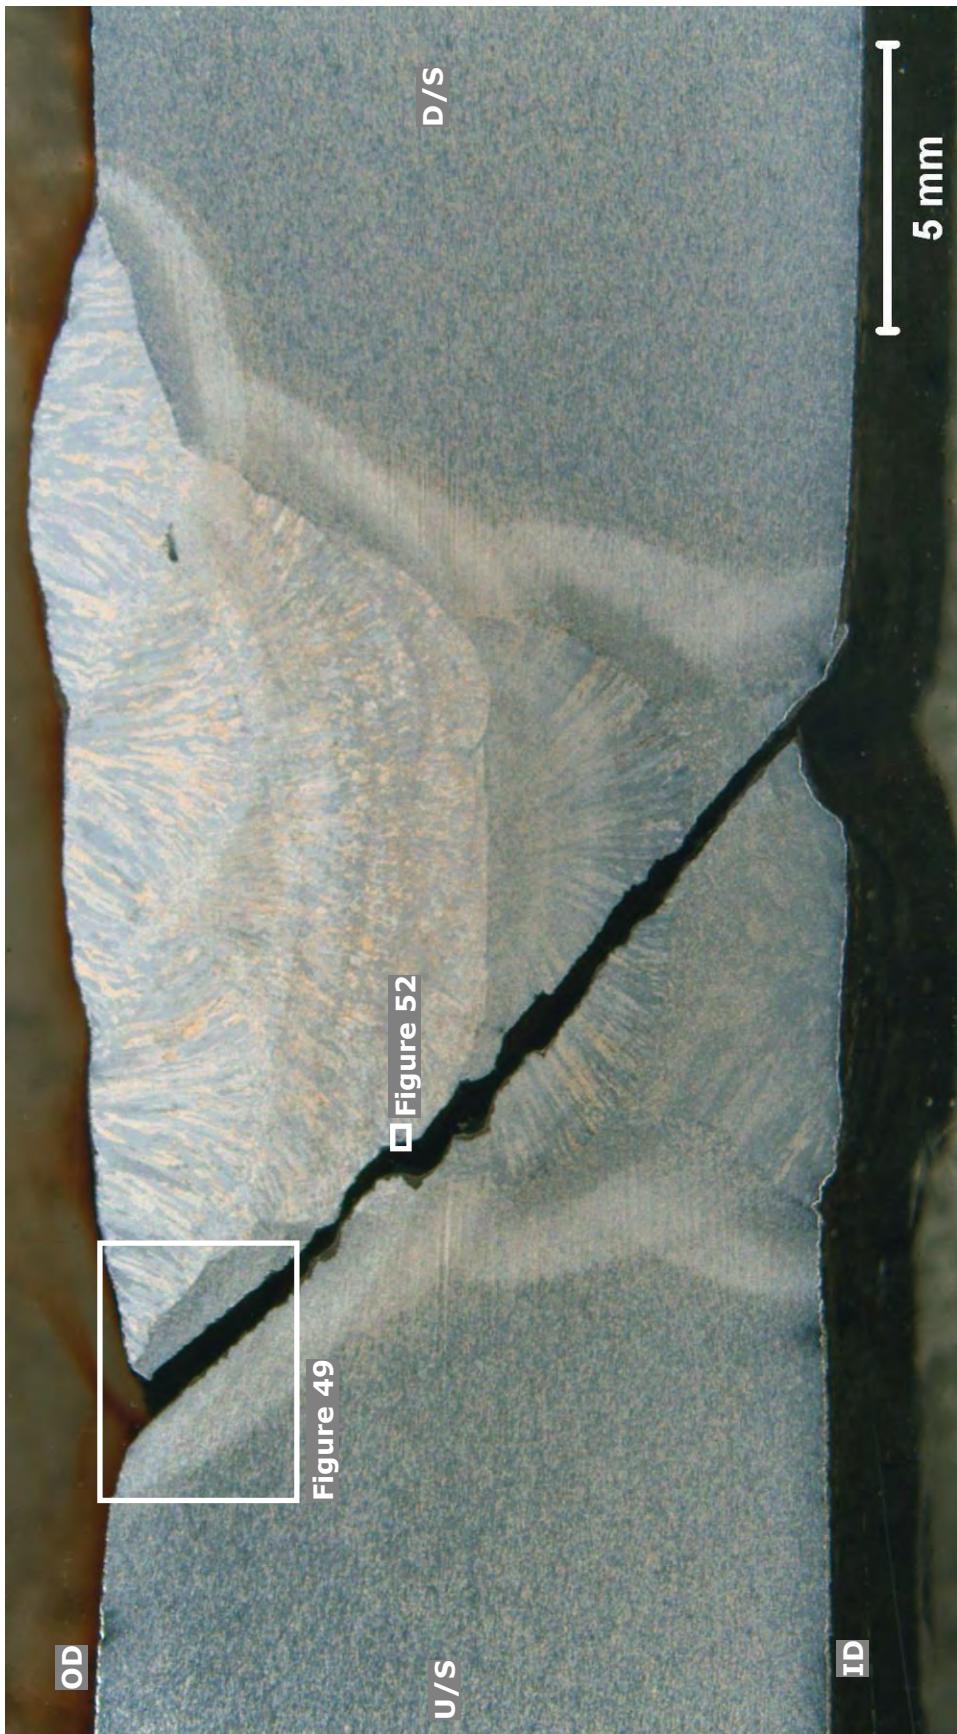
Figure 48 is a light photomicrograph of the axial metallographic cross-section (Mount M1), which was removed from the failed GW at the 1:35 o'clock orientation; refer to Figure 1 and Figure 11 for the location. The sequence of the welding is typical of a pipeline girth weld consisting of a root pass, a hot pass, several fill passes (depending on o'clock orientation), and cap passes. There is no evidence of excessive porosity or slag inclusions in the weld. The fracture path is at a shear angle and mainly located in the weld metal. The high-low weld misalignment at this location is approximately 0.023 inches (4.3% of NWT); note the misalignment is difficult to measure on the fracture cross-section and is an approximation.

Figure 48. Light photomicrograph of Mount M1 (axial cross-section), which was removed from the failed GW at the 1:35 orientation; refer to Figure 1, Figure 11, and Figure 21 for location (2% Nitral Etchant).

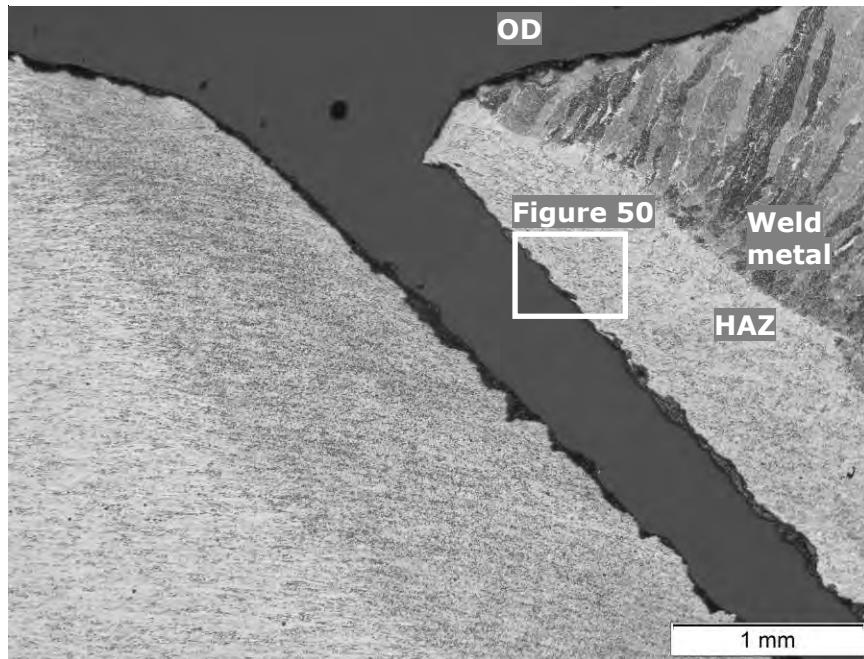
Figure 49 is light photomicrograph of Mount M1 adjacent to the OD surface. The figure shows the fracture path is located in the HAZ, near the toe of the weld at the OD surface. Figure 50 is a light photomicrograph of Mount M1 adjacent to the fracture surface, near the OD surface. The figure shows inclusions aligned at an oblique angle with the fracture surface. The orientation of the inclusions is a result of cold work from the failure. Figure 51 is a high magnification light photomicrograph of Mount M1 adjacent to the fracture surface. The figure shows some grain elongation adjacent to the fracture surface and inclusions. The presence of the grain elongation from cold work and orientation of the inclusions is consistent with ductile overload. Figure 52 is a high magnification light photomicrograph of Mount M1 midwall adjacent to the fracture surface. The figure clearly shows the change in the grain orientation and thus more grain elongation adjacent to the fracture surface.

Figure 49. Light photomicrograph of Mount M1 adjacent to the OD surface (2% Nital Etchant); area indicated in Figure 48.

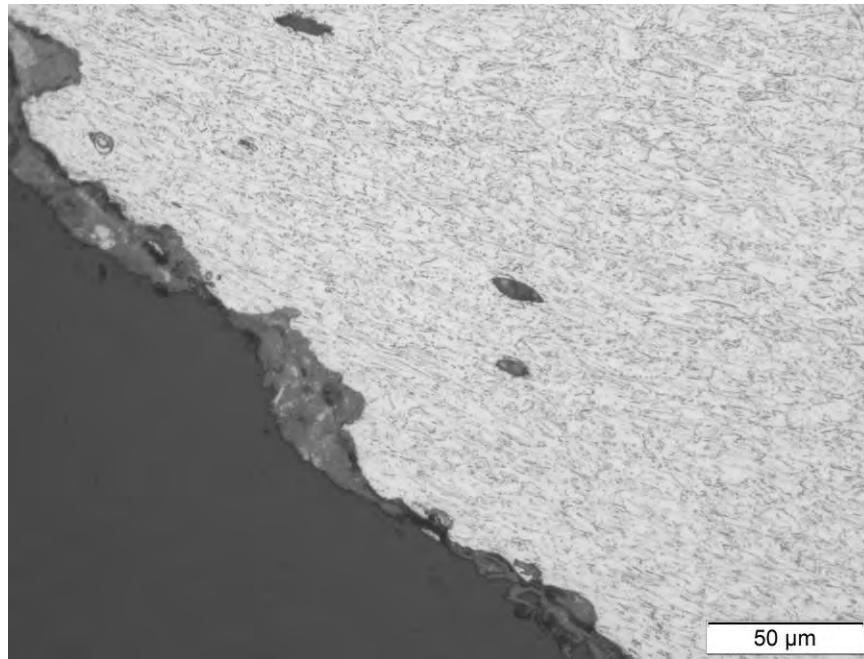
Figure 51. High magnification light photomicrograph of Mount M1 showing grain elongation adjacent to the fracture surface; area indicated in Figure 50.

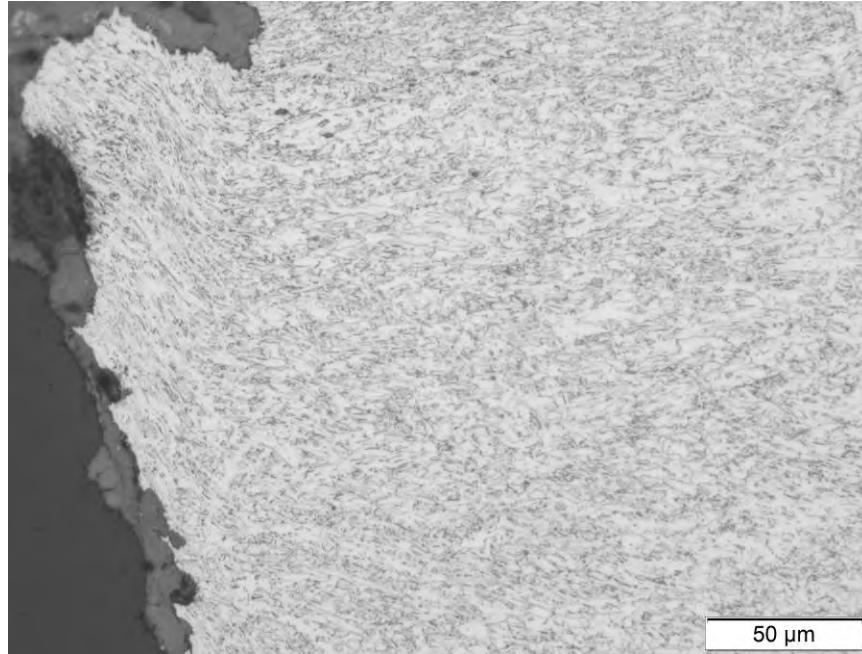
Figure 52. High magnification light photomicrograph of Mount M1 midwall adjacent to the fracture surface (2% Nital Etchant); area indicated in Figure 48.

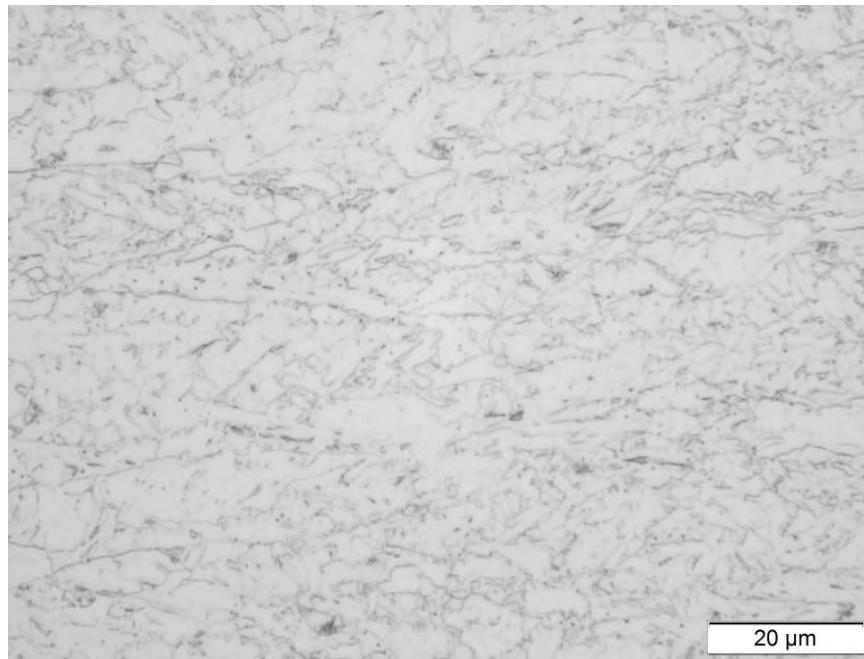
Figure 53. High magnification light photomicrograph of Mount M1 showing the typical base metal microstructure of the U/S Joint (PS B, 2% Nital Etchant).

Figures 53 and 54 of the DNV Metallurgical Analysis Report (Section 3.4) characterize the microstructure of the upstream and downstream pipe. Analysis of these photomicrographs indicate a significantly larger amount of ferrite than pearlite, which is consistent with the expected microstructure for pipe with the specified minimum yield strength and vintage of the Delhi 24-inch pipeline. Compared with photomicrographs of metal samples provided through industry literature, the microstructure of the 24-inch pipeline has a low carbon content, consistent with other X-80 pipelines. The microstructure of the failed girth shows similar characteristics (see Figure 62 of the DNV Metallurgical Analysis Report).

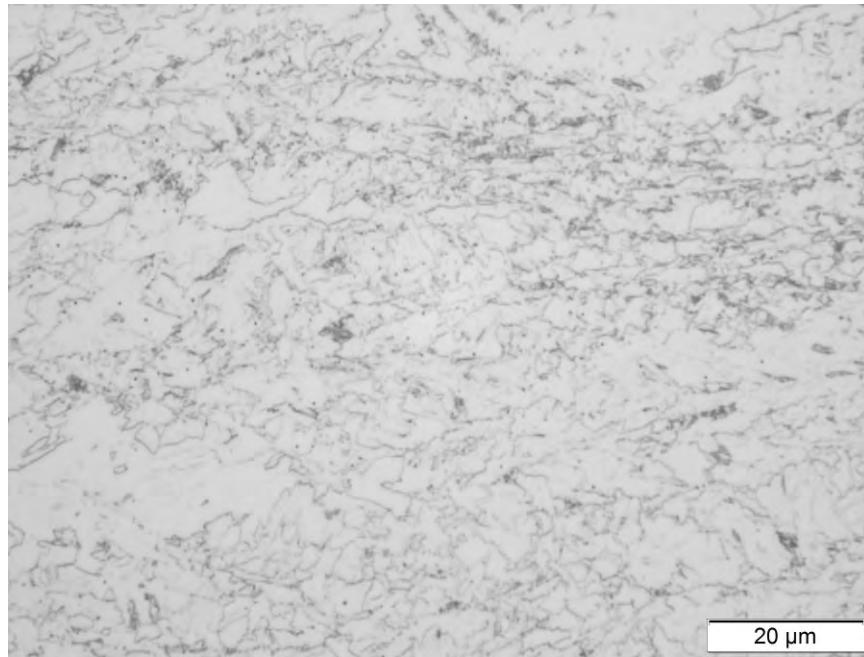
Figure 54. High magnification light photomicrograph of Mount M1 showing the typical base metal microstructure of the D/S Joint (PS A, 2% Nital Etchant).

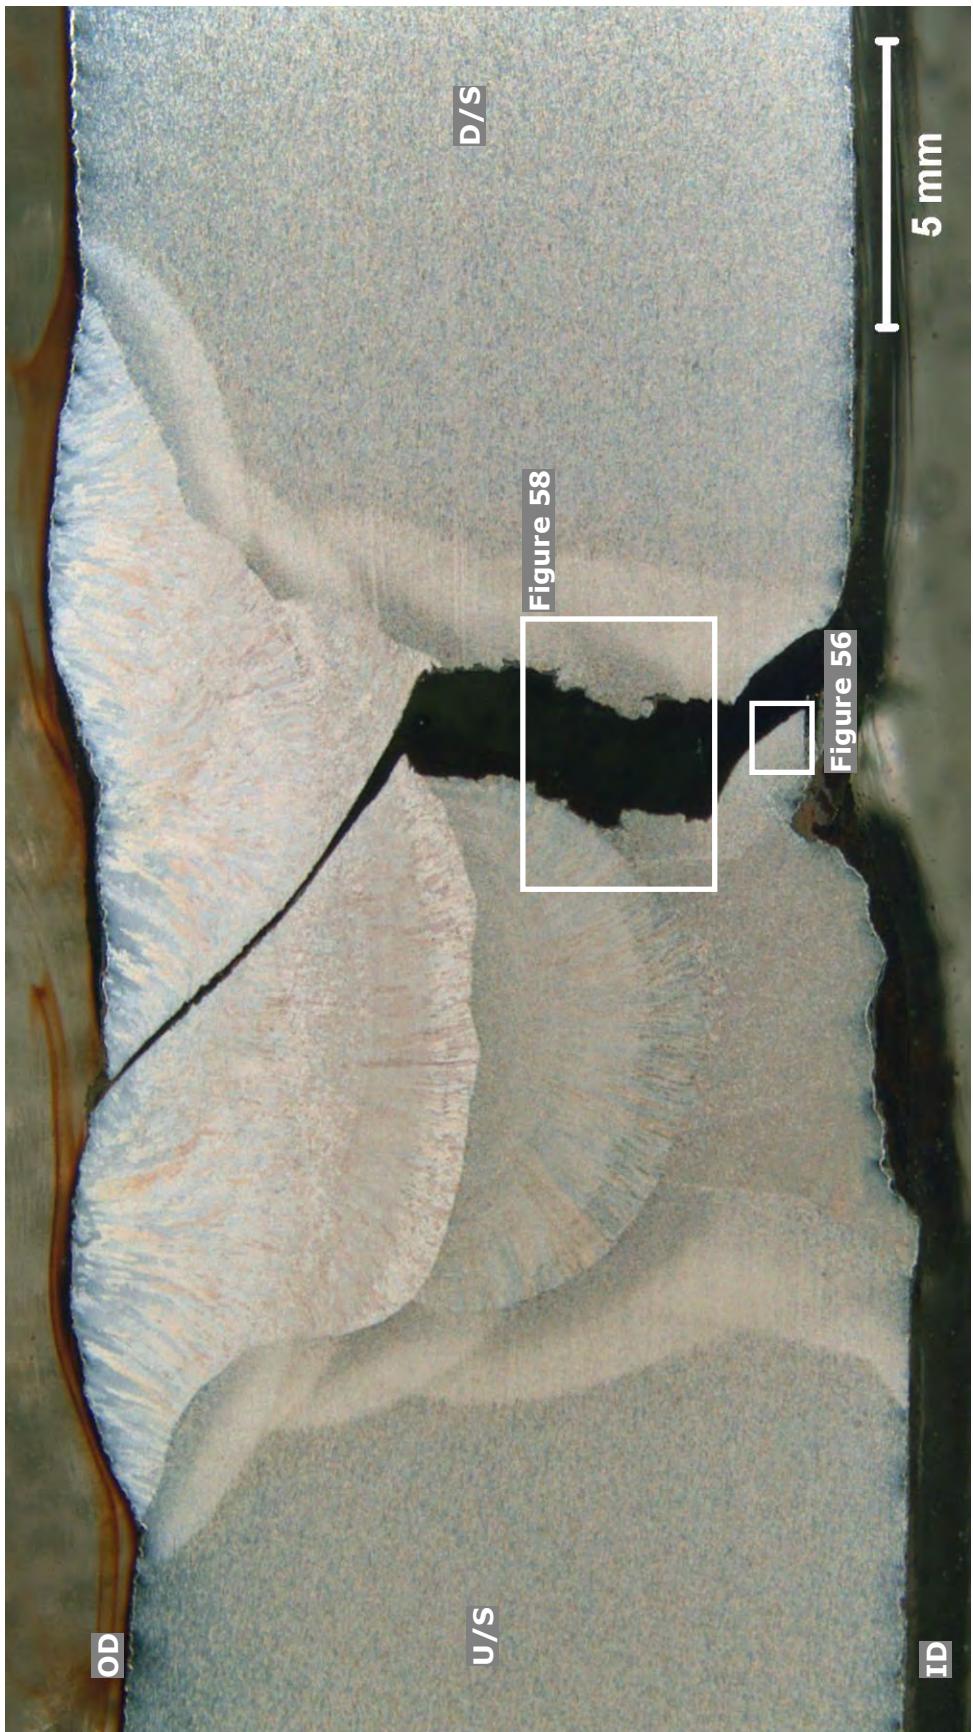
Figure 55. Light photomicrograph of Mount M2 (axial cross-section), which was removed from the GW at the 3:55 orientation; refer to Figure 1, Figure 12, and Figure 23 for location (2% Nitral Etchant).

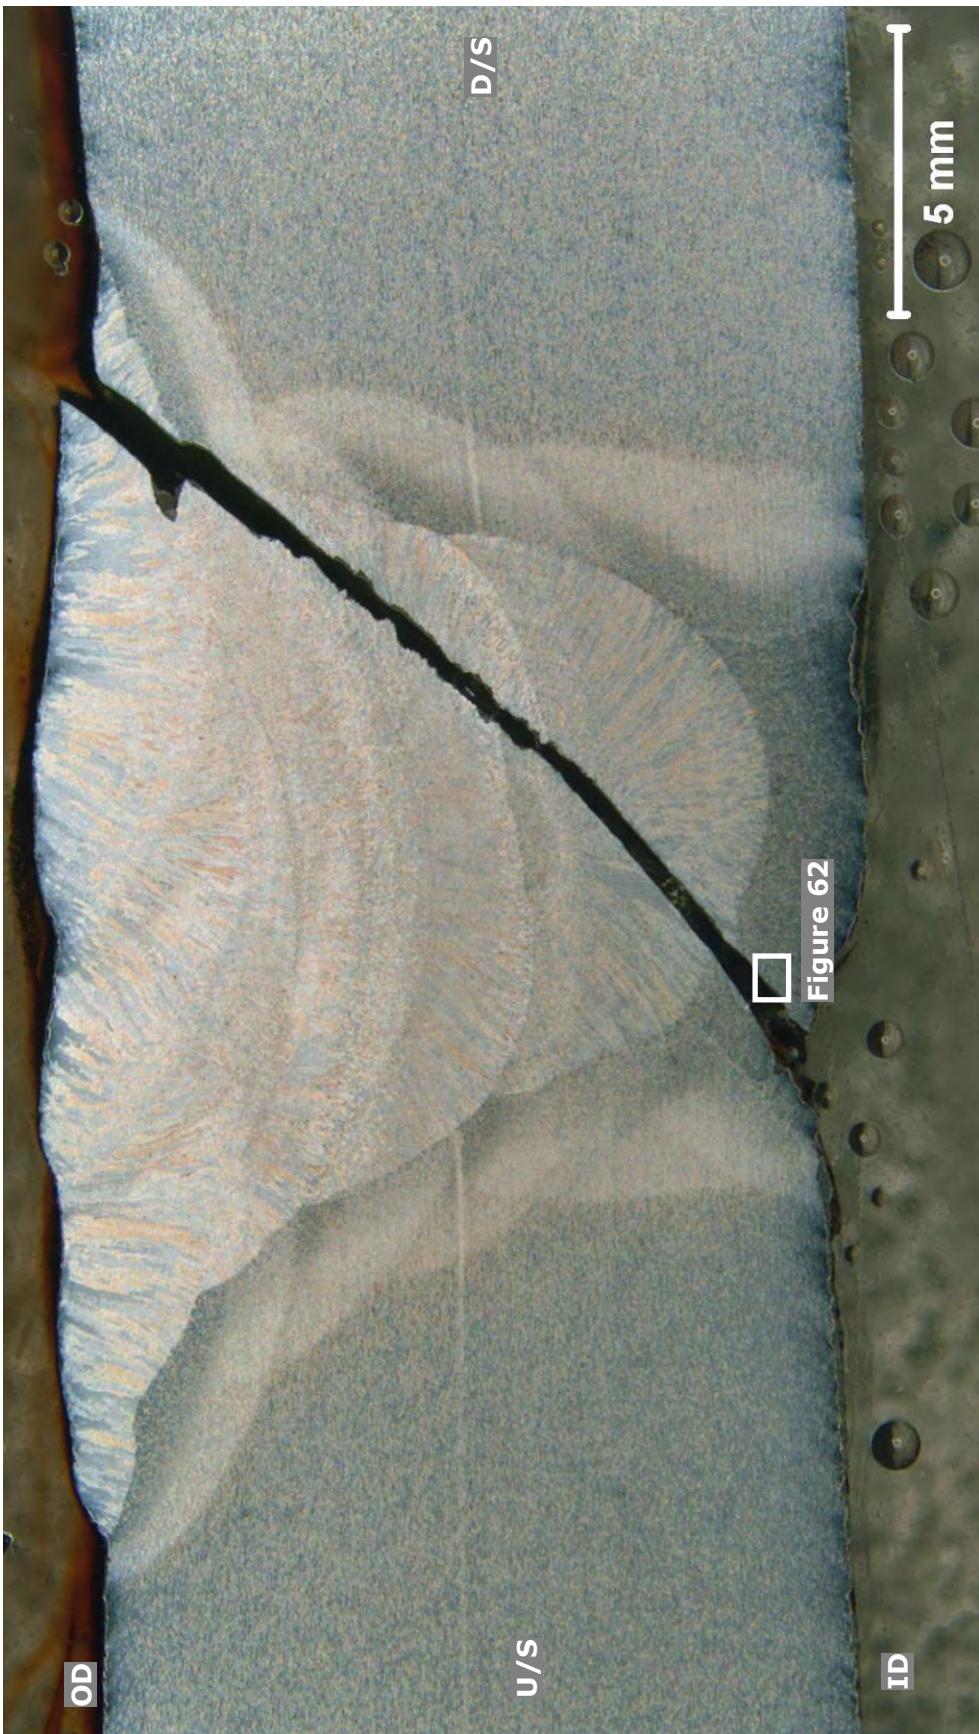
Figure 61. Light photomicrograph of Mount M3 (axial cross-section), which was removed from the GW at the 8:35 orientation; refer to Figure 1, Figure 13, and Figure 28 for location (2% Nital Etchant).

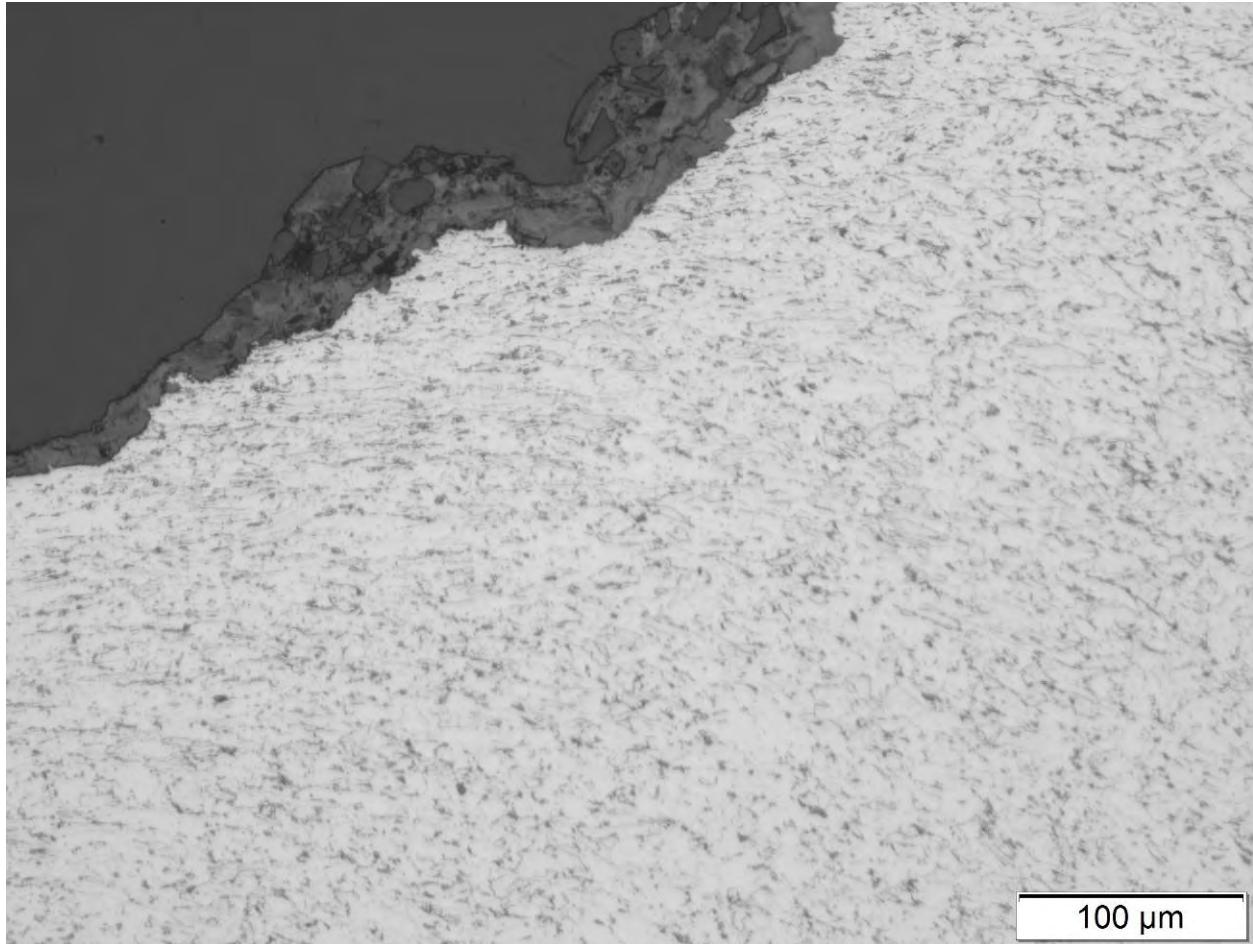
Figure 62. Light photomicrograph of Mount M3 adjacent to the fracture surface, near the ID surface (2% Nital Etchant); area indicated in Figure 61.

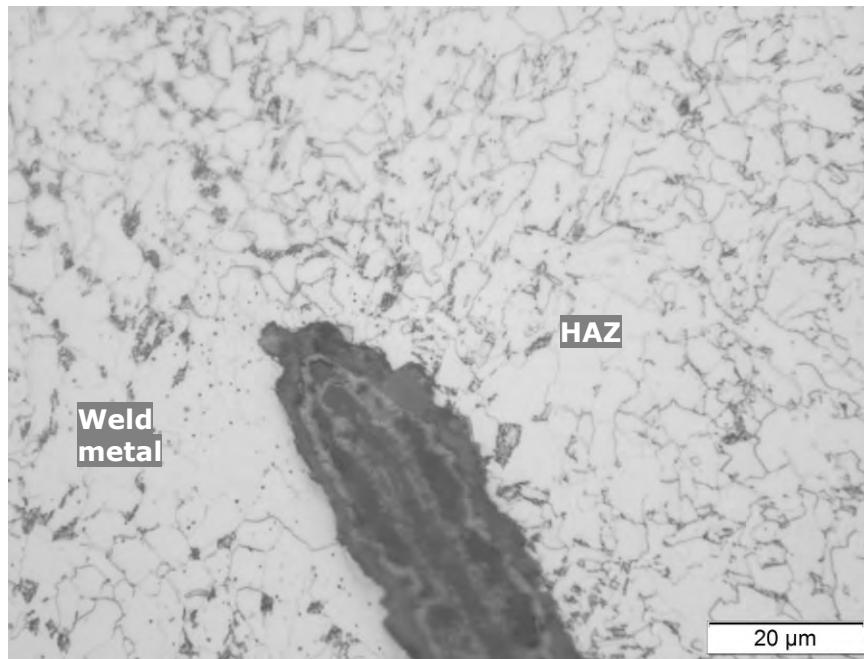
Figure 72. High magnification light photomicrograph of Mount MU1 at the tip of a shallow incomplete fusion (IF) flaw (2% Nital Etchant); area indicated in Figure 71.

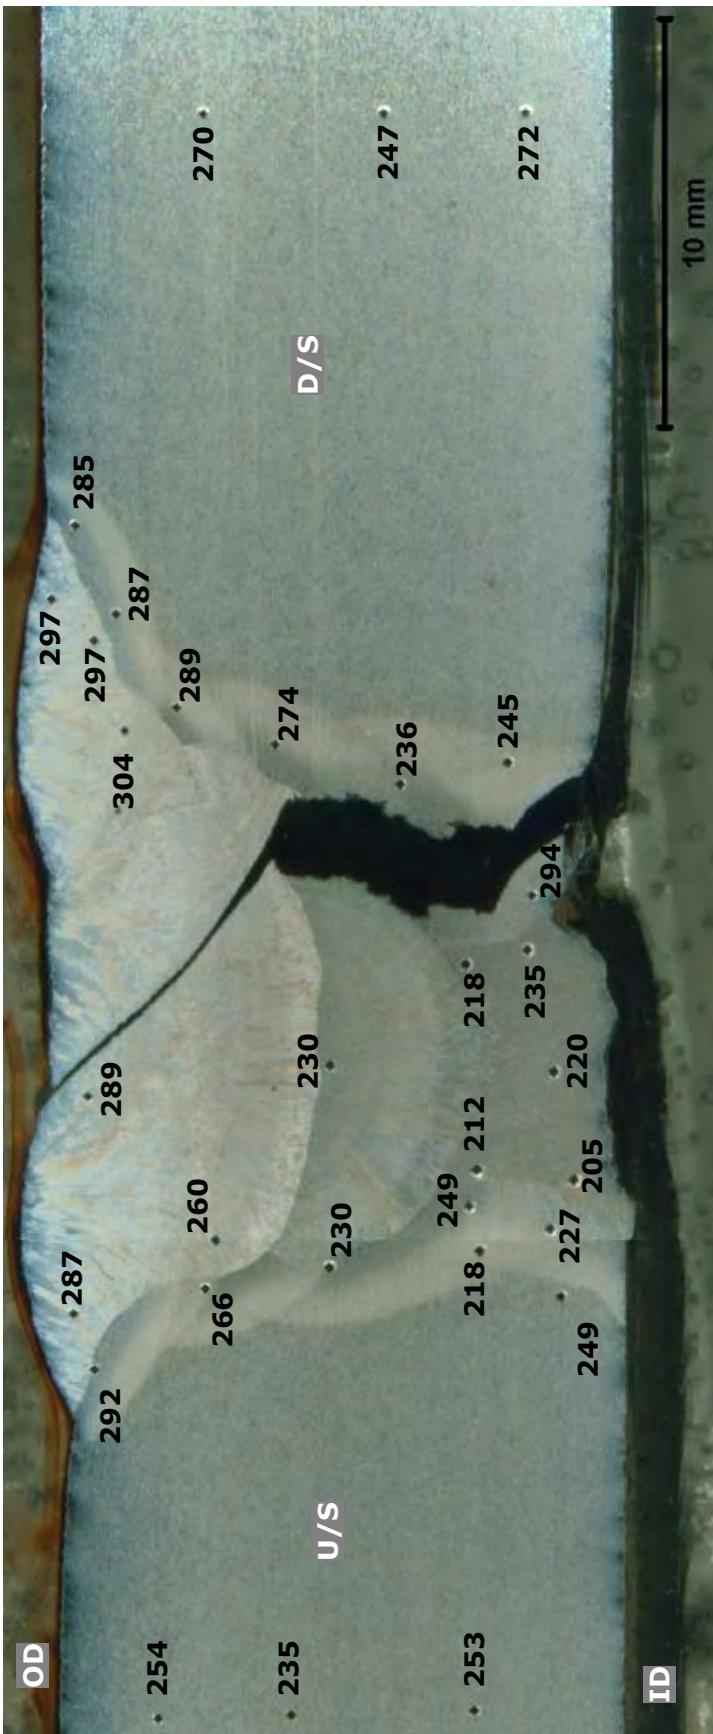
A 10 kg load was used on Mounts M2, M3, and M5 (all from the failed girth weld) and indents were performed at approximately 20 to 30 locations. Figure 74, Figure 75, and Figure 77 are light photomicrographs of the mounts showing the indents and hardness values. The hardness values are between 205 and 304HV. The lowest values are at the ID weld metal (root pass, similar to the hardness maps), and the highest values are in the weld metal cap pass. The base metal is generally harder than the root and fill passes, and similar to or sometimes less than the cap pass.

Figure 74. Light photomicrograph montage of Mount M2 (axial cross-section), showing the hardness indentations and the hardness values in HV (2% Nital Etchant).

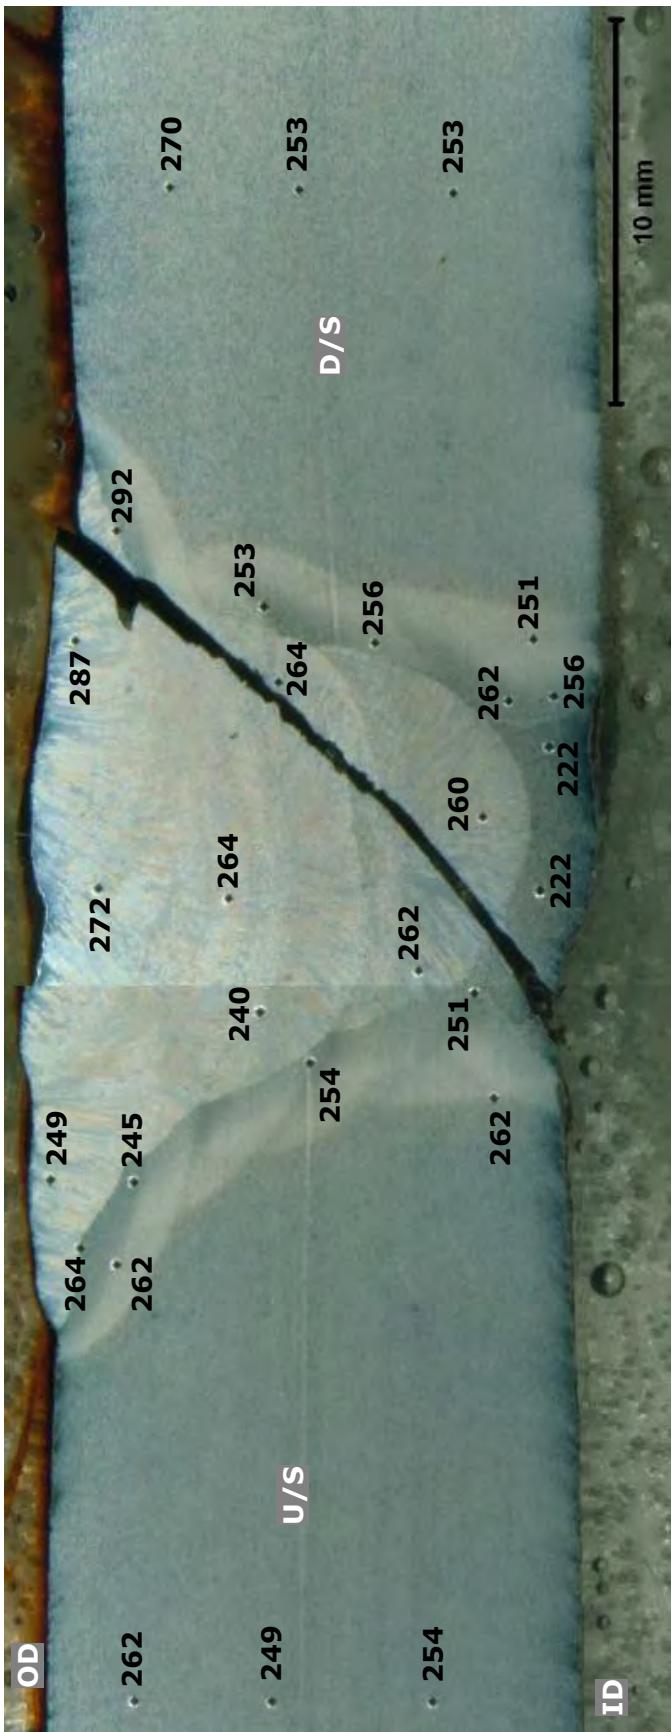
Figure 75. Light photomicrograph montage of Mount M3 (axial cross-section), showing the hardness indentations and the hardness values in Hv (2% Nitral Etchant).

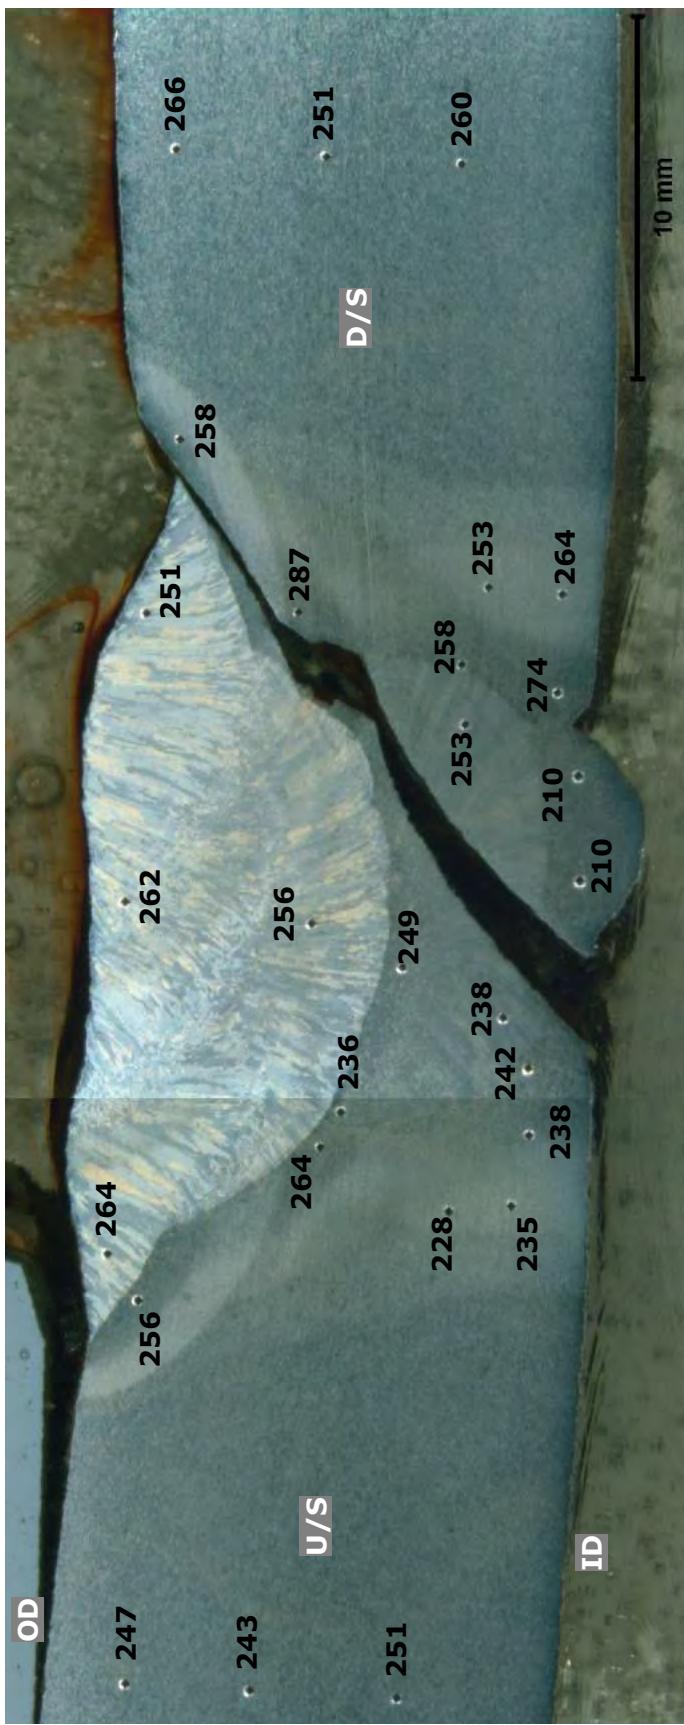
Figure 77. Light photomicrograph montage of Mount M5 (axial cross-section), showing the hardness indentations and the hardness values in HV (2% Nital Etchant).

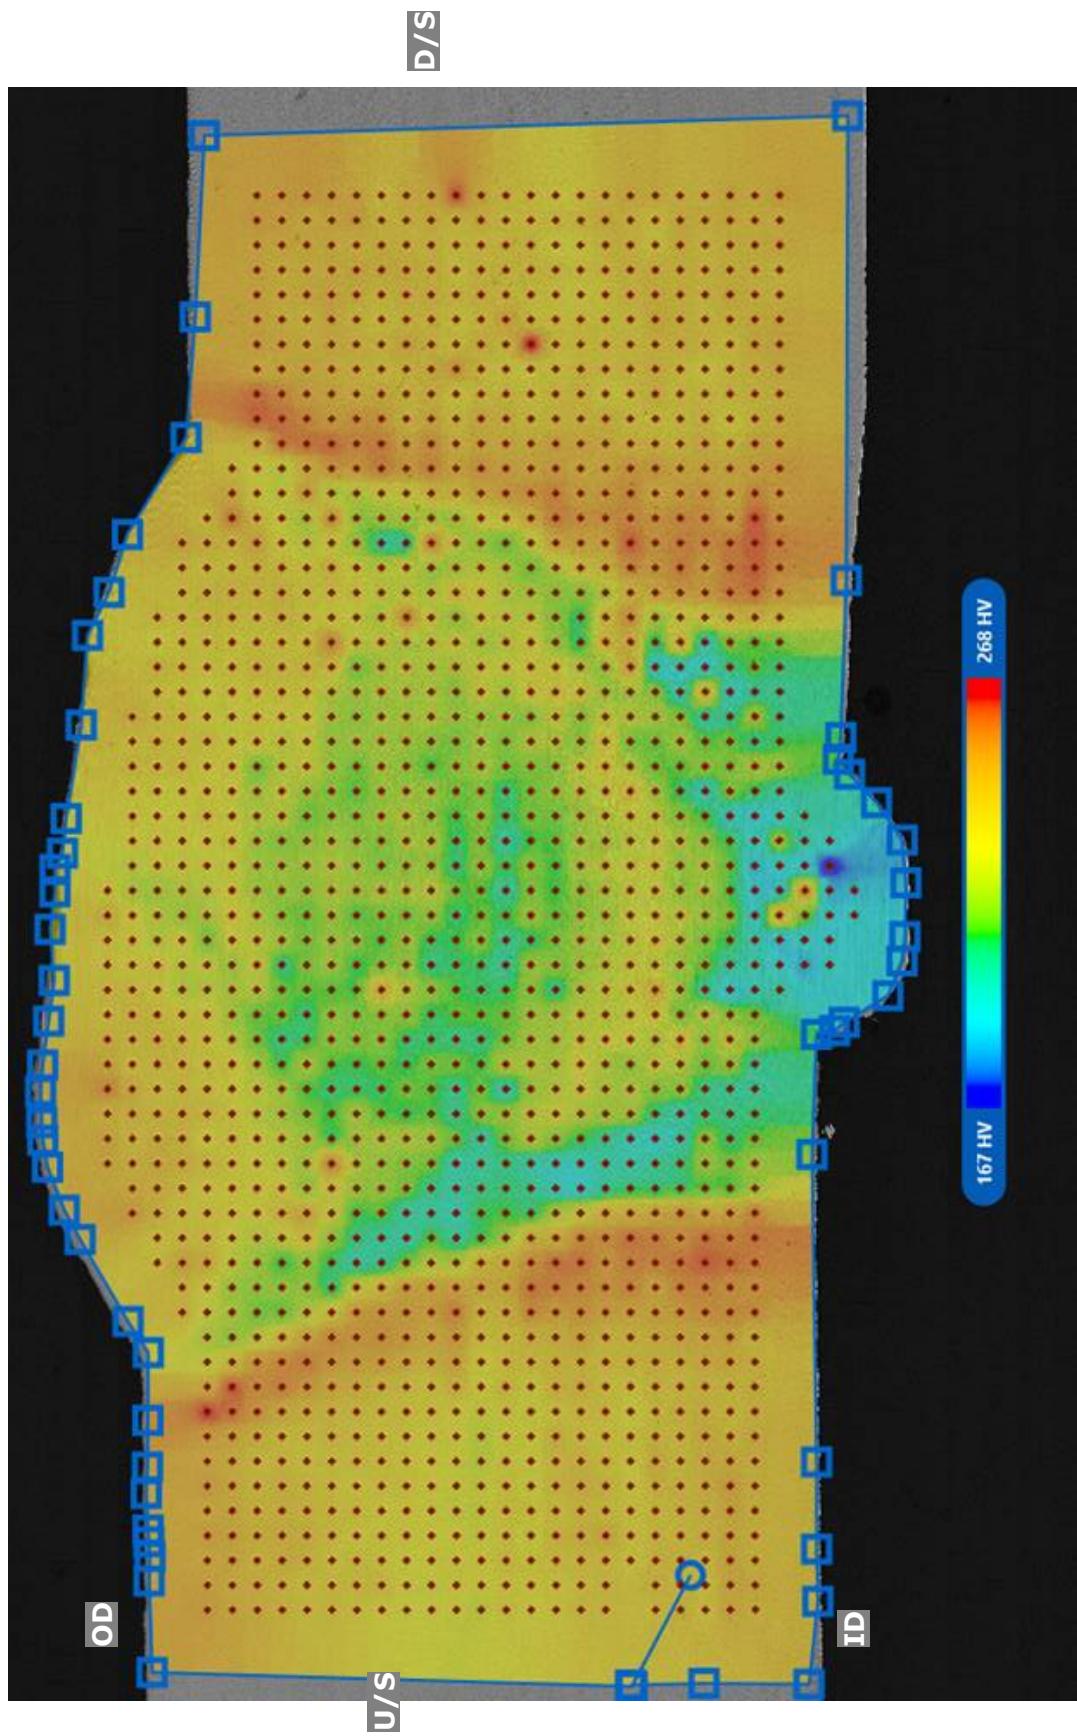
The hardness of the intact girth weld (Figure 78) is a better representation of the hardness of all the welds prior to the failure. For the intact girth weld, the values appeared to follow a more consistent pattern. Figure 78 clearly shows that the root pass of the weld metal is the softest and the surrounding base metal (adjacent to the HAZ) is harder than the weld metal. Hardness typically correlates with ultimate tensile strength (UTS) fairly well, thus the data indicates that the weld metal is weaker than the surrounding pipe material. The higher hardnesses measured in the failed welds, and the large variation and lack of a consistent pattern, is a byproduct of the cold work the material experienced during the failure.

Figure 78. Hardness map overlay following hardness testing (Vickers 1 kg load) performed on Mount MU1.

The hardness montage for mount MU1 is provided in Figure 78 of the DNV Metallurgical Analysis Report (Appendix C).
