DOT	US Department of Transportation
PHMSA	Pipeline and Hazardous Materials Safety Administration
OPS	Office of Pipeline Safety – Accident Investigation Division
Principal Investigator	Wesley Mathews
Acting Accident Investigation Director	Chris Ruhl
Date of Report	May 26, 2022
Subject	Failure Investigation Report - Denbury Gulf Coast Pipelines, LLC – Pipeline Rupture/ Natural Force Damage

Failure Investigation Report – Denbury Gulf Coast Pipelines LLC

Pipeline Rupture/Natural Force Damage

February 22, 2020

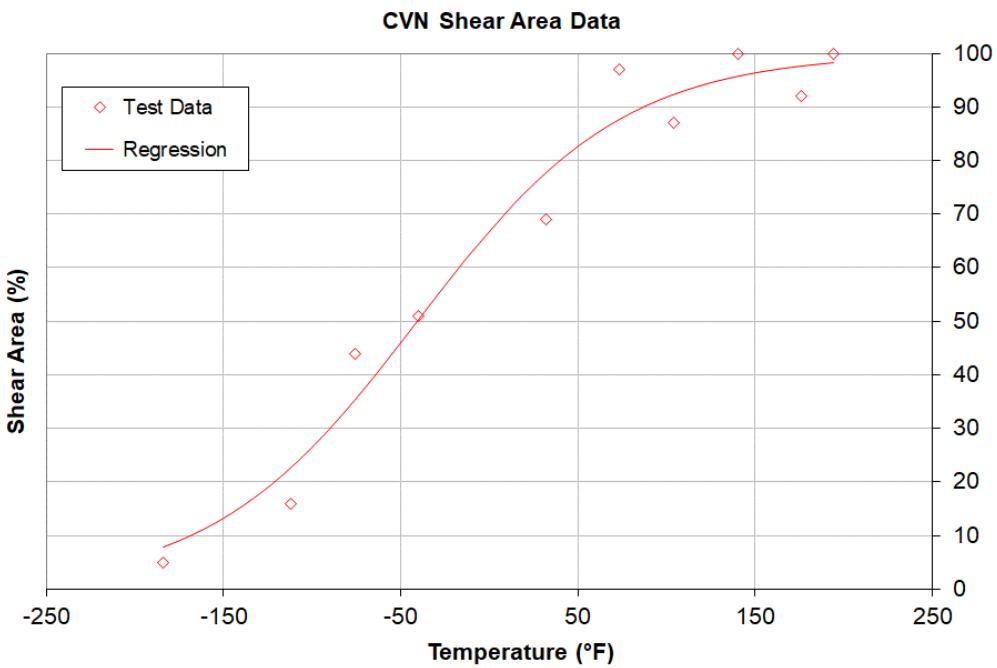
Table 6 shows the results of CVN testing for axial specimens removed from the intact girth weld (notch in the HAZ from PS C), while Figure 79 and Figure 80 show the Charpy percent shear and impact energy curves. An analysis of the data for the girth weld specimens indicates that the 85% FATT is 59.9°F and upper shelf Charpy energy is 114 ft lbs, as shown in Table 7. Both values are good for line pipe steel.

Figure 79. Percent shear from Charpy V-notch tests as a function of temperature for axial/cross-girth weld (HAZ notch) specimens removed from Pipe Section C.

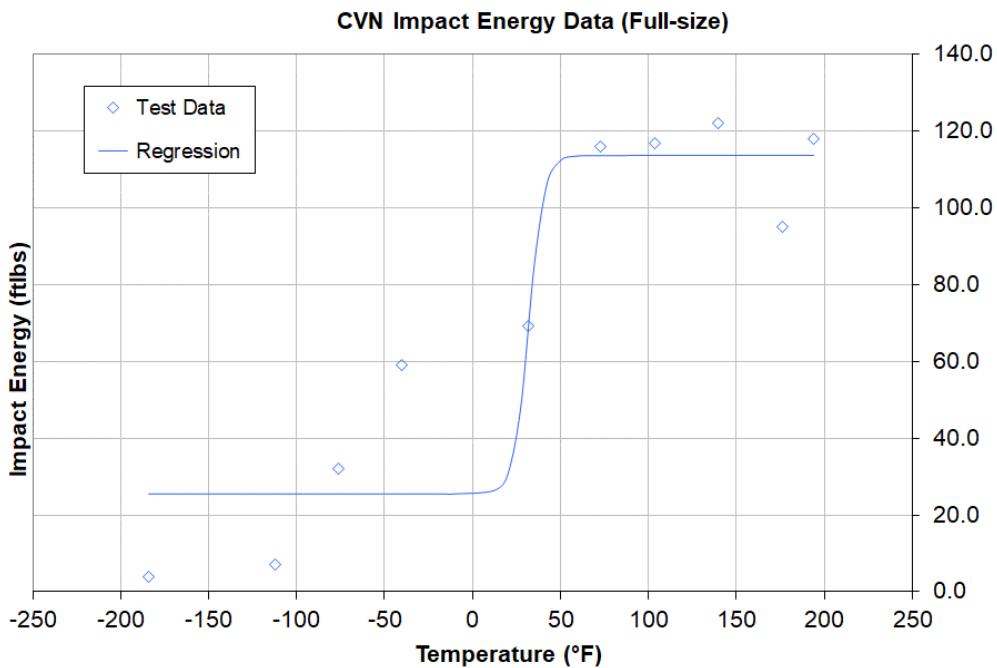
Figure 80. Charpy V-notch impact energy as a function of temperature for axial/cross-girth weld (HAZ notch) specimens removed from Pipe Section C.

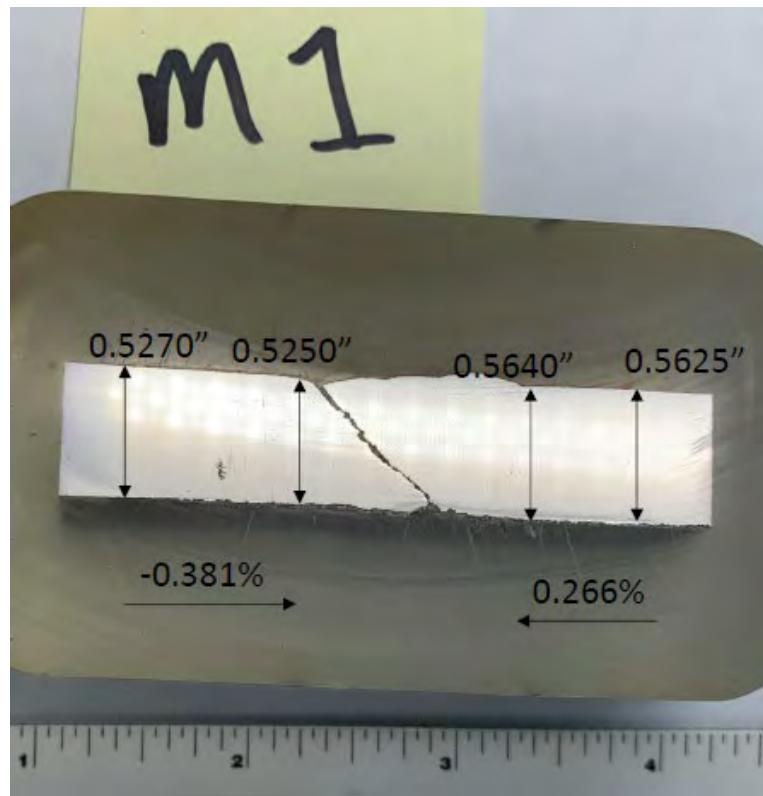
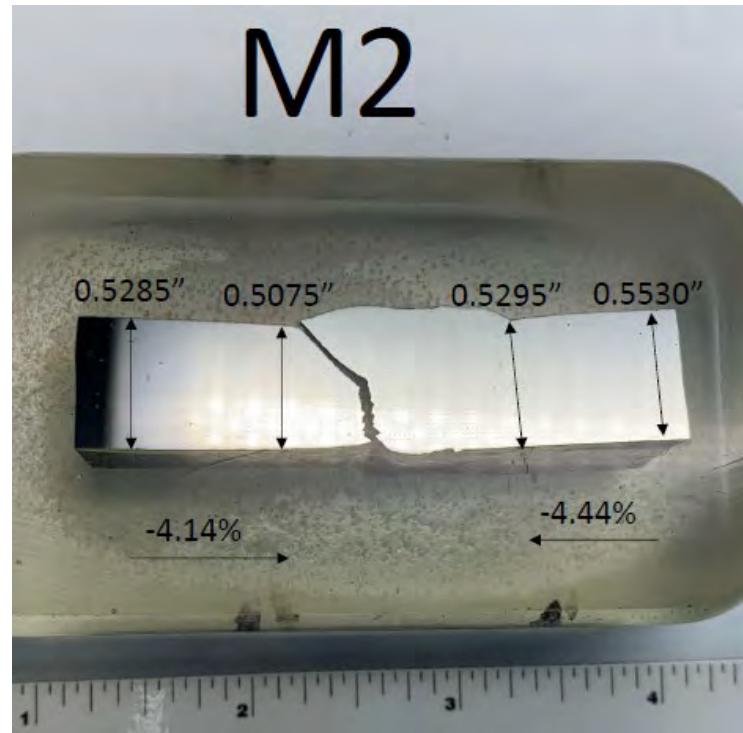
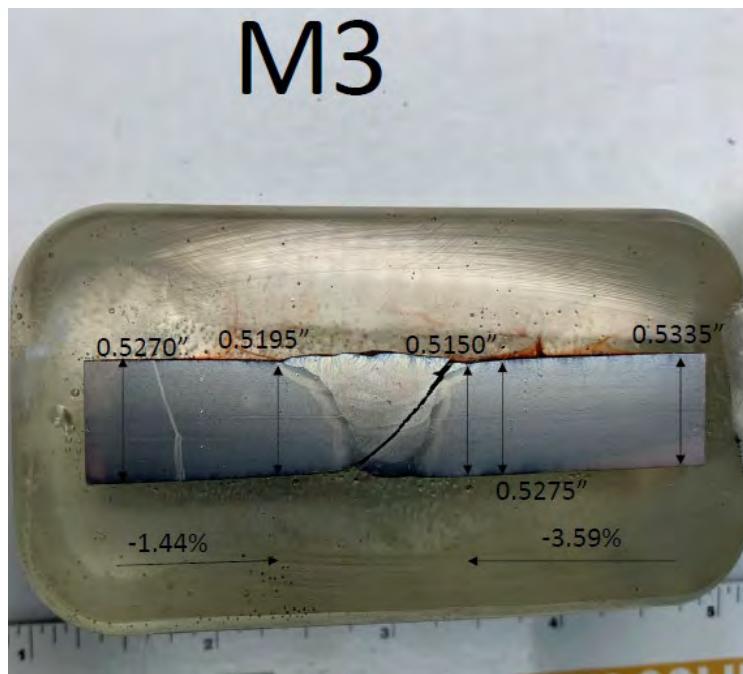
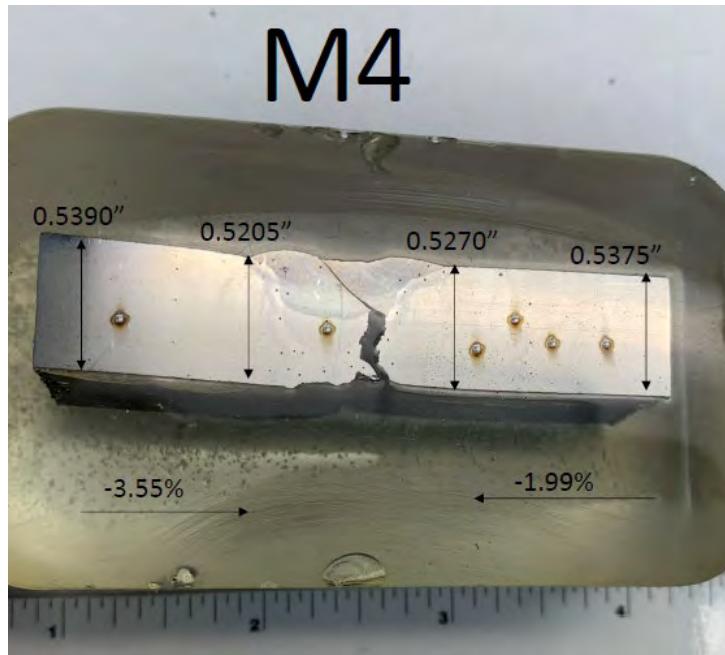
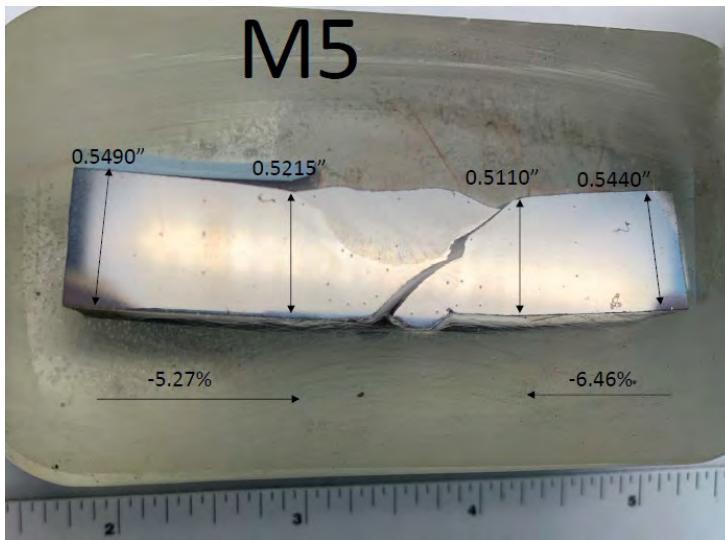
Evaluation of the metallurgical samples indicated slight reduction in wall thickness in each sample, ranging from 1.44% to 6.46%. Photos and measurements are provided in figures 1 through 5 below:

These results are consistent with the characteristics of API X80M PSL 2 Line pipe.

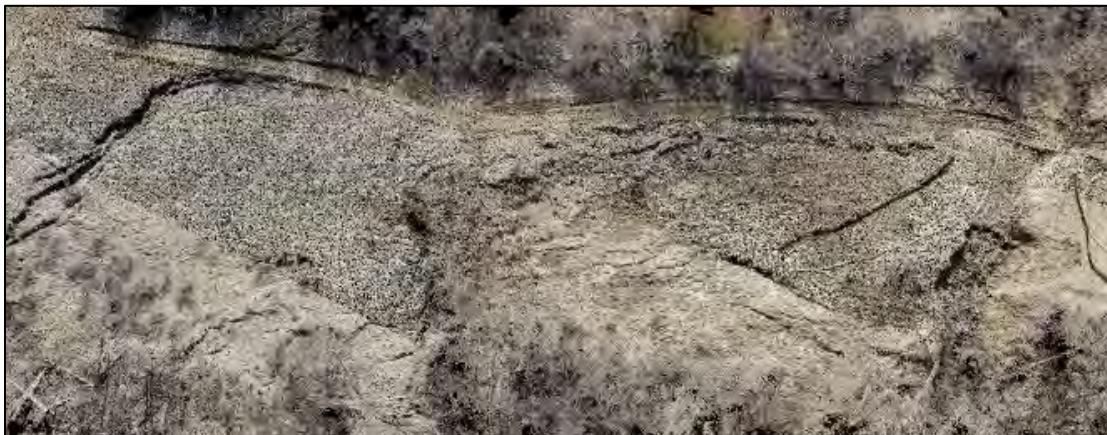
FIGURE 1: SOIL MOVEMENT PLAN VIEW

During the initial site visit, Mott MacDonald noticed evidence of soil movement along the ROW. The soil failure planes in the ROW extended approximately 900 ft at varying angles from 45° to 90°. Figure 1 and Figure 2 below show 3D photogrammetry scans taken of the ROW and displays the long linear failures.

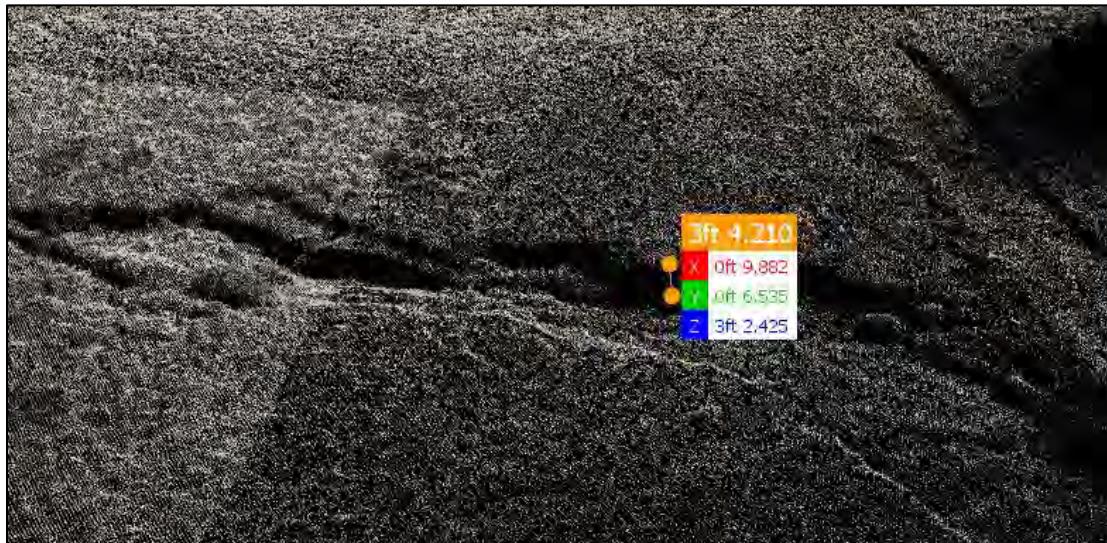
FIGURE 3: SOIL FAILURE DEPTH

The depth of the soil failures varied throughout the ROW, but as shown in Figure 3, the high level of detail captured with the 3D photogrammetry allowed for accurate measurements.

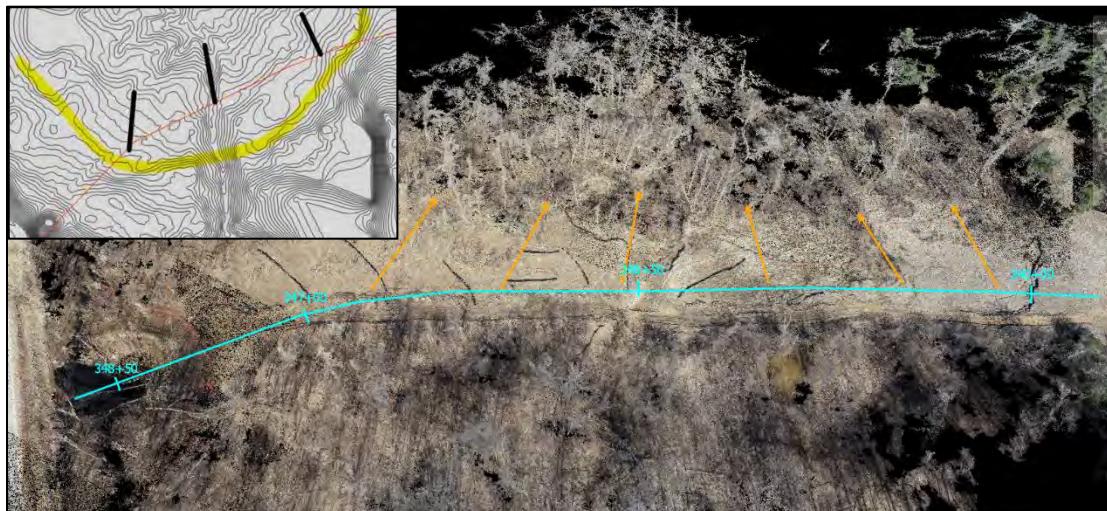
FIGURE 4: SOIL MOVEMENT DIRECTION

The distributed loads were applied in the model based on understanding of the topography in the area as shown in the Figure 4 below.

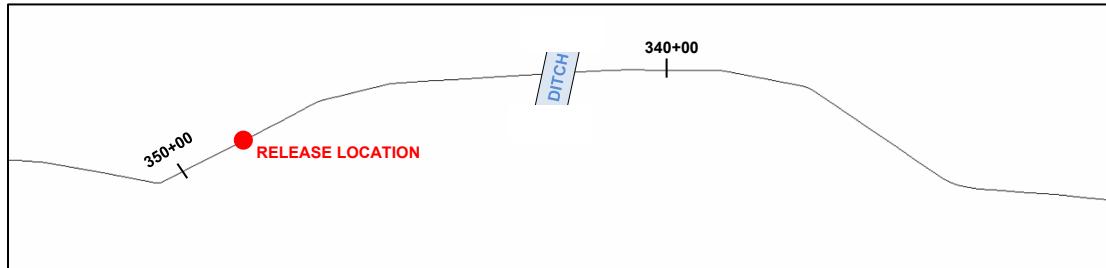
FIGURE 5: AUTPIPE MODEL

The pipeline was modeled as per the above listed design information. Though not all of the model is shown the below Figure 5, Figure 6 and Figure 7 display the area of concern.

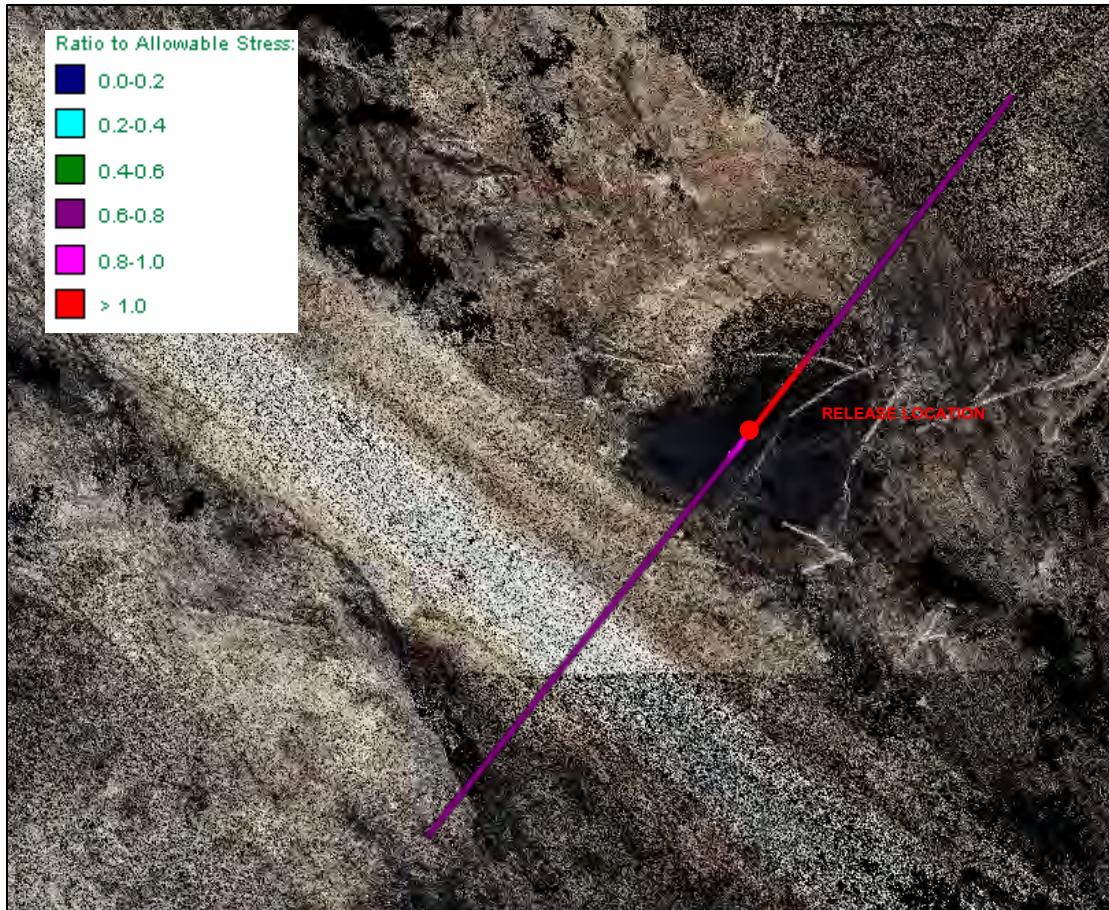
FIGURE 10: FAILURE LOCATION

As shown in Figure 10 below, the pipeline release location experienced excessive stress. The focal point of the stress at this location shows a maximum stress ratio of 1.43.

Table 7: Loads Experienced at Pipeline Release Location		
X-Direction	Y-Direction	Z-Direction
-848,020 lbf	7,229 lbf	-46483 lbf
-54,921 ft-lb	-706,996 ft-lb	36,274 ft-lb

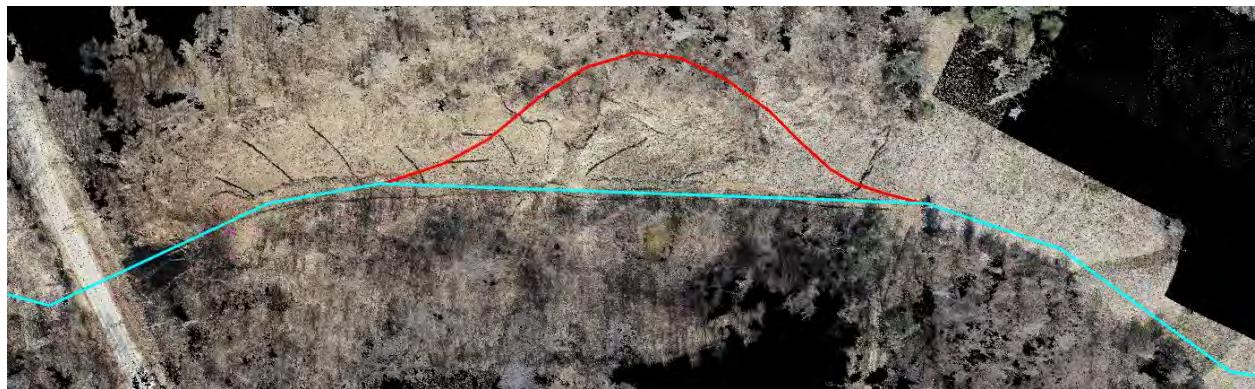
FIGURE 11: DEFLECTION CURVE

Figure 11 below shows an exaggerated deflection curve of the pipeline.

Mott MacDonald examined results as full design group to analyze the failure types and deflection curves. It was established that forces applied to the pipeline from the soil movement were significant enough to exceed the allowable stress limit of the Delhi Pipeline and likely was a contributing factor to the rupture.

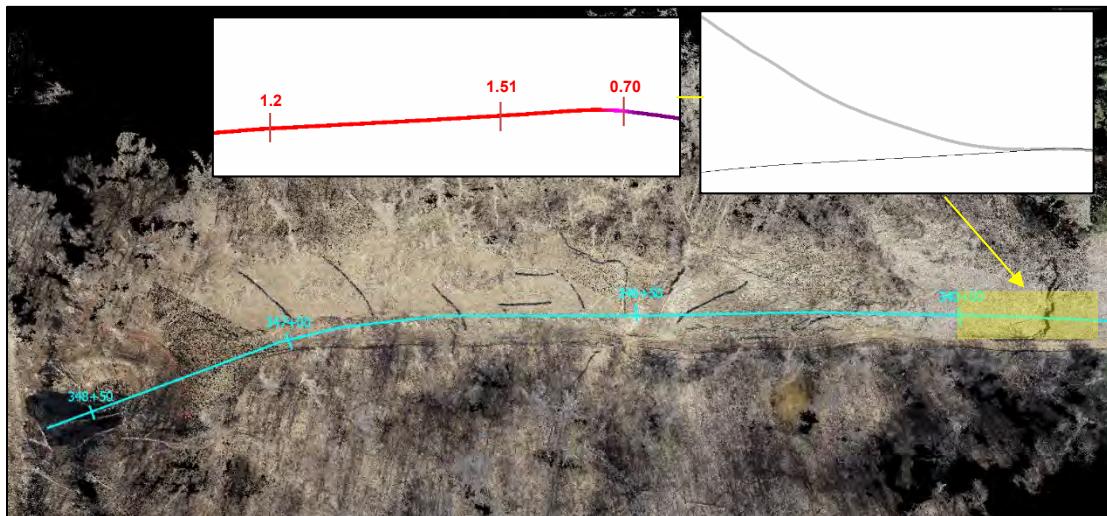
FIGURE 12: RECOMMENDED

The stress on the downstream side of 339+00 was caused by the restrained/unrestrained boundary condition created by the soil movement. This bending stress is the target of the relief exercise. The area shown in Figure 12 below, show a sharp rise in stress from a ratio of 0.70 to 1.51 in less than 50 ft. This boundary condition at the soil failure plane did not relieve after the pipeline failure and will have to be repaired.

Exposing at least 135 ft and removing and replacing as least a 10 ft section of pipe as recommended in the repair alleviates the overstressed boundary condition left by the soil movement and allows for safe transition between the two soil conditions. This recommendation is with the understanding that the remainder of the area of concern will be hydrotested as per ASME B31.4 to ensure the integrity of the pipe that experienced high tensile loads.
